Service Bulletin

Bulletin No.: 20-NA-150

Subject: Glow Plug Control Module Update for P133x and/or P067x

Brand:	Model:	Model Year:		VIN:		Engine:	Transmission:
		from	to	from	to		
Chevrolet	Silverado	2017	2019			L5P	All
	Silverado 4500HD/ 5500HD/6500HD	2019	2020			L5D	
GMC	Sierra	2017	2019			L5P

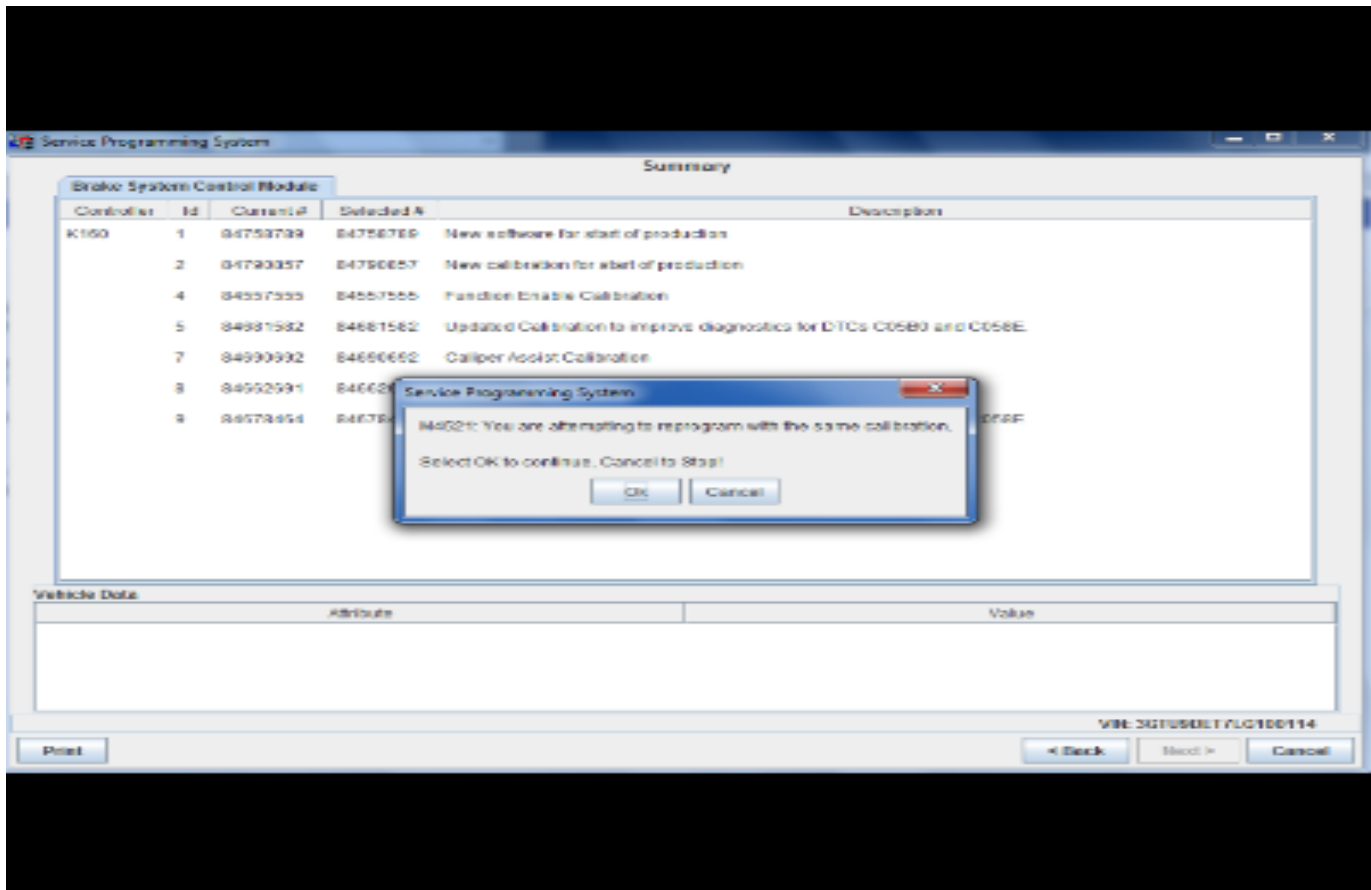
Important: TIS2WEB screen shown. Techline Connect screen is similar and will be included soon.

Important: If the Same Calibration/Software Warning is noted on the SPS screen, select OK and follow screen instructions. After a successful programming event, the WCC is located in the Service Programming System dialogue box of the SPS Summary screen. No further action is required. Refer to the Warranty section of the bulletin.

1. Reprogram the Glow Plug Control Module. Refer to *K34 Glow Plug Control Module: Programming and Setup* in SI.

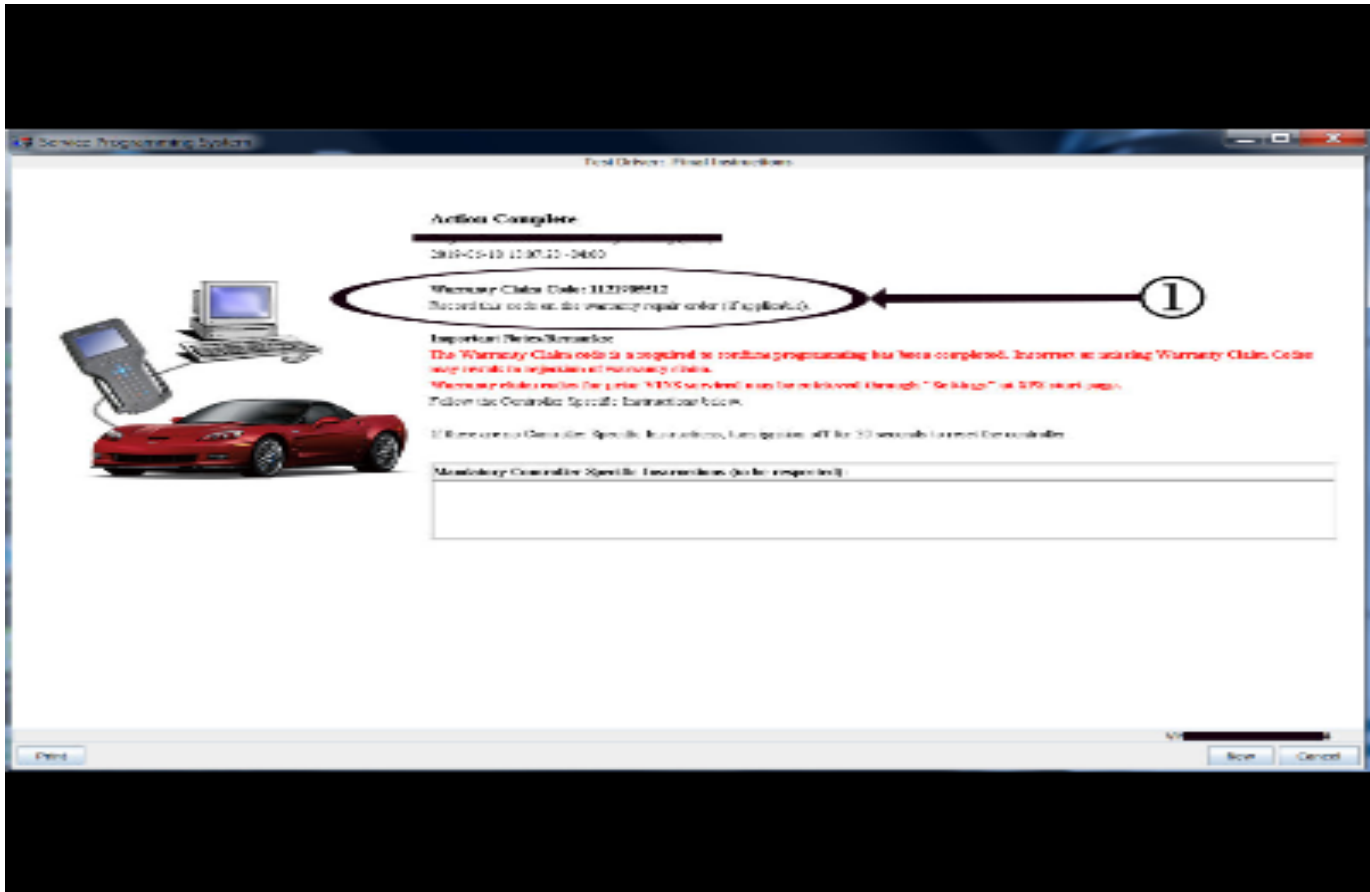
5431209

Important: TIS2WEB screen shown. Techline Connect screen is similar and will be included soon.

Important: To avoid warranty transaction rejections, you **MUST** record the warranty claim code provided on the SPS Warranty Claim Code (WCC) screen on the job card. Refer to callout 1 above for the location of the WCC on the SPS screen

2. Record SPS Warranty Claim Code on job card for warranty transaction submission.
