01 MIL on, DTCs P218100, P017B00, P308100, and/or P01E400 are stored in the ECM

01 20 82 2058767/6 August 26, 2020. Supersedes Technical Service Bulletin Group 01 number 20-65 dated June 8, 2020 for reasons listed below.

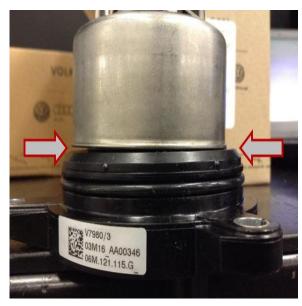
- DTC P218100 (fault in cooling system).
- DTC P017B00 (sensor for cylinder head temperature, implausible signal).
- DTC P308100 (engine temperature too low).
- DTC P01E400 (sender 3 for coolant temperature, implausible signal).

Figure 1. Gap between chamber and seal.

- 1. Remove the thermostat and check whether it closes completely. If the coolant is still warm, put the thermostat in cold water to restore its original condition. If there is a gap between chamber and seal, the thermostat is faulty and needs to be replaced.
- 2. Attach photos to the repair order which clearly shows that the thermostat does not close neatly.

After the repair, fill with G12evo coolant in the coolant circuit.
