Technical Service Bulletin

17 MIL on or noises from the crankcase breather, DTC P052E00 is stored in the ECM

17 20 10 2060033/2 August 26, 2020. Supersedes Technical Service Bulletin Group 17 number 20-07 dated July 21, 2020 for reasons listed below.

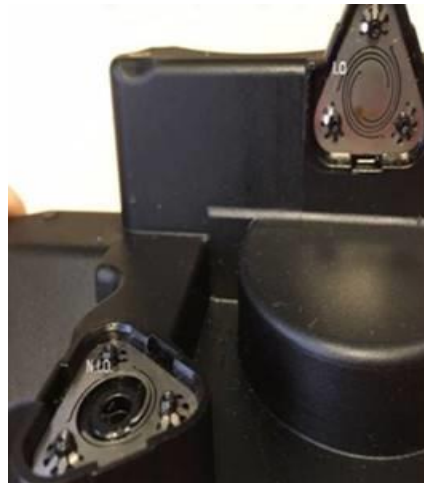
Figure 1. Metal plates.

Fuel additives can cause the membrane to crack.

1. Using the hand vacuum pump VAS 6213 check the membrane of the crankcase breather for leaks; a leak can mean a faulty membrane or elbow piece.
2. Remove the compressor/intake manifold and check the membrane for leaks directly on the crankcase breather. Remove the crankcase breather and check the two metal plates for damage (Figure 1).
If one plate is defective then always replace the complete crankcase breather.
