FT4935 VIP relay failure

Service Instruction

QJ 7621- 2021 - VIP Relay FAILURE

System Name	VIP Relay
Option	517101.841 , 517101.843 , 517101.959 , 517101.A73 , 517101.B29 , 517101.C78
Drawing	517101NB92, 517101NB13, 517101NB14, 517101NB15, 517101NB111
Part	N80973

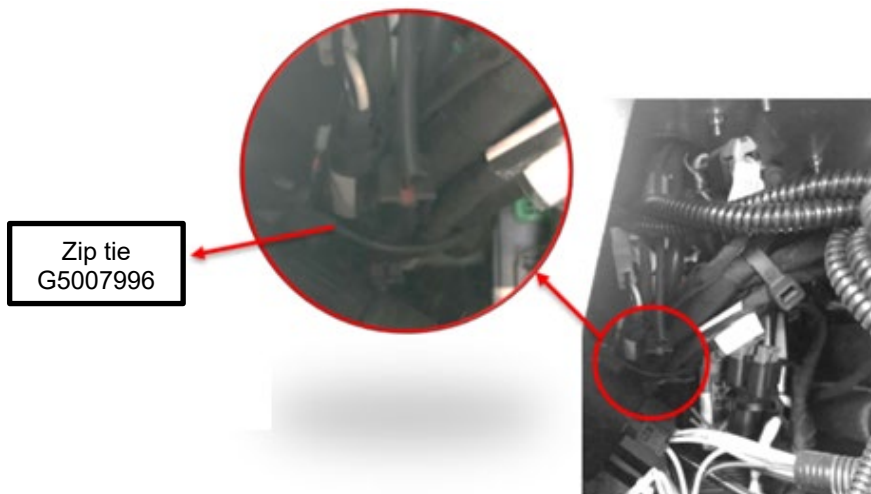
Step # 5:

Since the customer installs the radio, we need to know how much harness is required to make good connections without stressing the connectors. We will be following the bus until it is shipped to the customer. After receiving information from the field, they need 8-9 inches of harness.

Our production line stated this has been a past issue and the BOM T008L was updated. It clearly states that 8 inches of extra length from the face of the housing.

Cut the zip Tie (P/N G5007996) and pull the harness to achieve the required length (8 – 9 inches) from the housing
