FT4924 Curbside Exterior Mirror Water Intrusion

Service Instruction

QJ 7621- 2085 – Curbside Exterior Mirror Loose and Water Intrusion

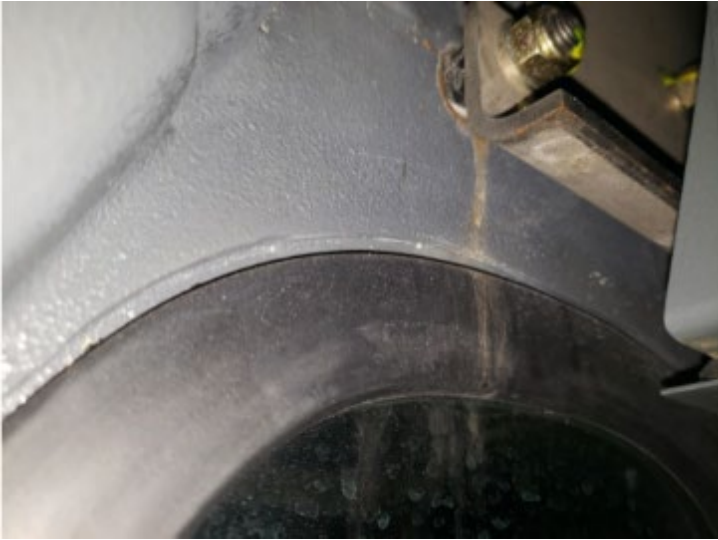
2. Inspect for presence of water traces inside the A pillar. If water found, go to level 2

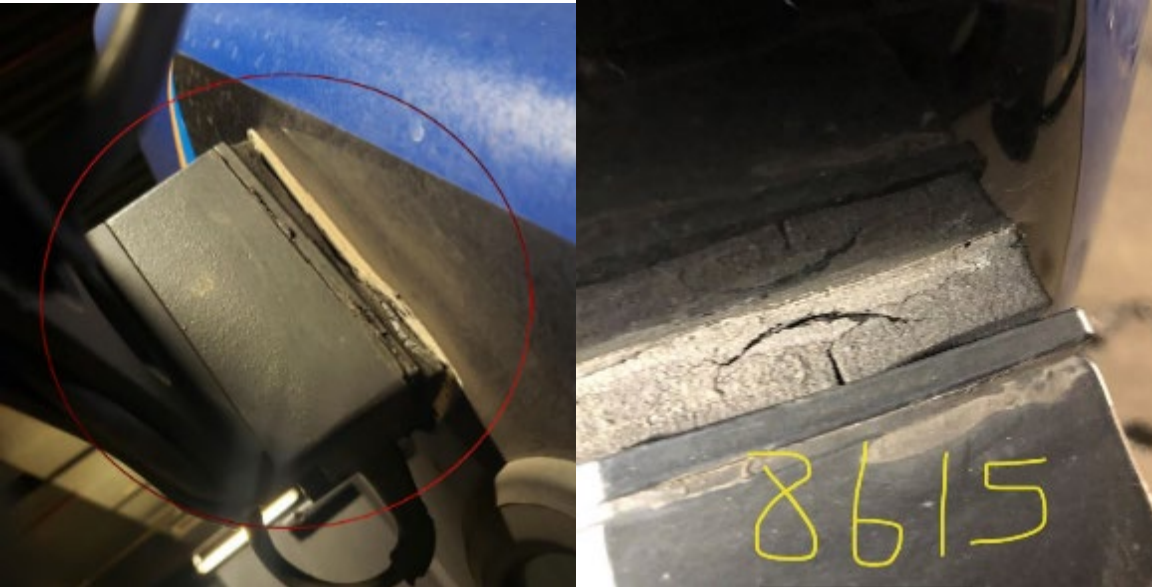
8615 = LA76-107
8744 = LC32-111

3. Visually inspect the condition of the gasket. If gasket is damaged, go to level 2

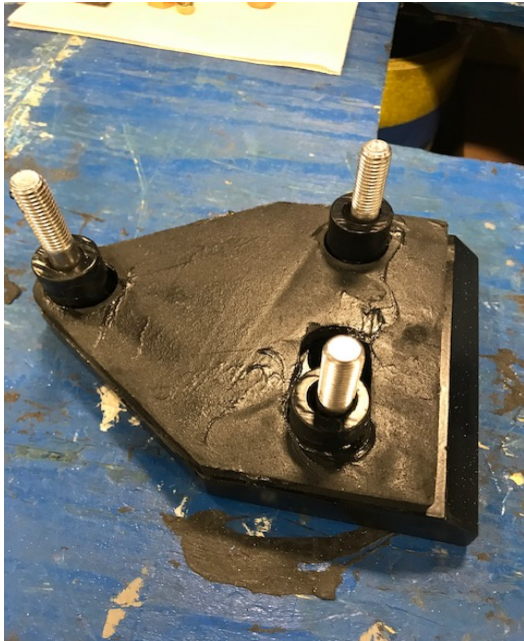
Incorrect application of butyl (complete layer)

10. Reapply butyl N32989 on the perimeter and around the holes on both surfaces on the gasket N65176 and N35120 (for mirror N90681) or N91045 (for mirror N78549)
