Complaint - Vibrations in Passenger Compartment at 2,000 - 3,000 RPM (93/20)

Vehicle Type: **Macan S (95B)**

Model Year: **As of 2019 up to 2020**

Subject: **Boost pressure hose between charge-air cooler and throttle valve**

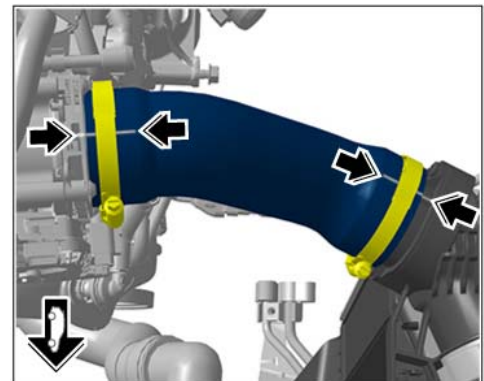
Installation position of charge air hose

Information: **Unfavorable routing of the boost pressure hose can cause vibrations that may be transmitted into the passenger compartment.**

Work Procedure: 1 Check installation position of the charge air hose and check whether the charge air hose is attached and installed correctly at the specified end points on the throttle valve ⇒ *Installation position of charge air hose* and on the charge-air cooler ⇒ *Connection point for charge air hose on charge-air cooler*.

- If the charge air hose is installed correctly, continue with ⇒ *Technical Information '505619 Turning charge air hose'*.
- If the charge air hose is not installed correctly, install the charge air hose correctly and check whether this corrects the problem.

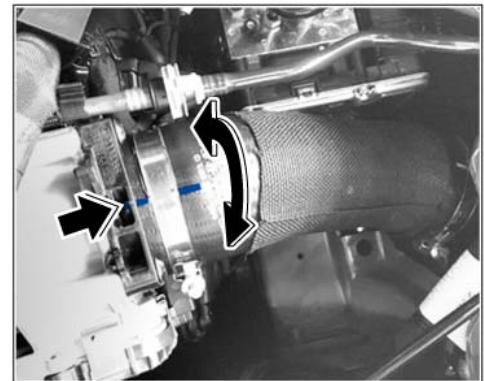
Connection point for charge air hose on throttle valve

Turning the charge air hose should relieve tension on the charge-air cooler mount in order to prevent this problem.

Work Procedure: 1 Loosen the hose clamp on the charge air hose, move the charge air hose at the throttle valve approx. 7 mm (0.28 in) from the alignment point ⇒ *Connection point for charge air hose on throttle valve* **by turning it clockwise** and secure the charge air hose. Then, check whether the problem is corrected.

- If the problem is corrected, no further action is required.
- If this is not the case, repeat the procedure and move the charge air hose again **by turning it approx. 7 mm (0.28 in) anti-clockwise**. Then, check again to see whether the problem is corrected.
