WKL3 - Replacing Ball Pins on Rear Lid (Workshop Campaign)

Model Line: **Cayenne (9YB)**

Model Year: **As of 2020 up to 2021**

Subject: **Replace ball pin on rear lid**

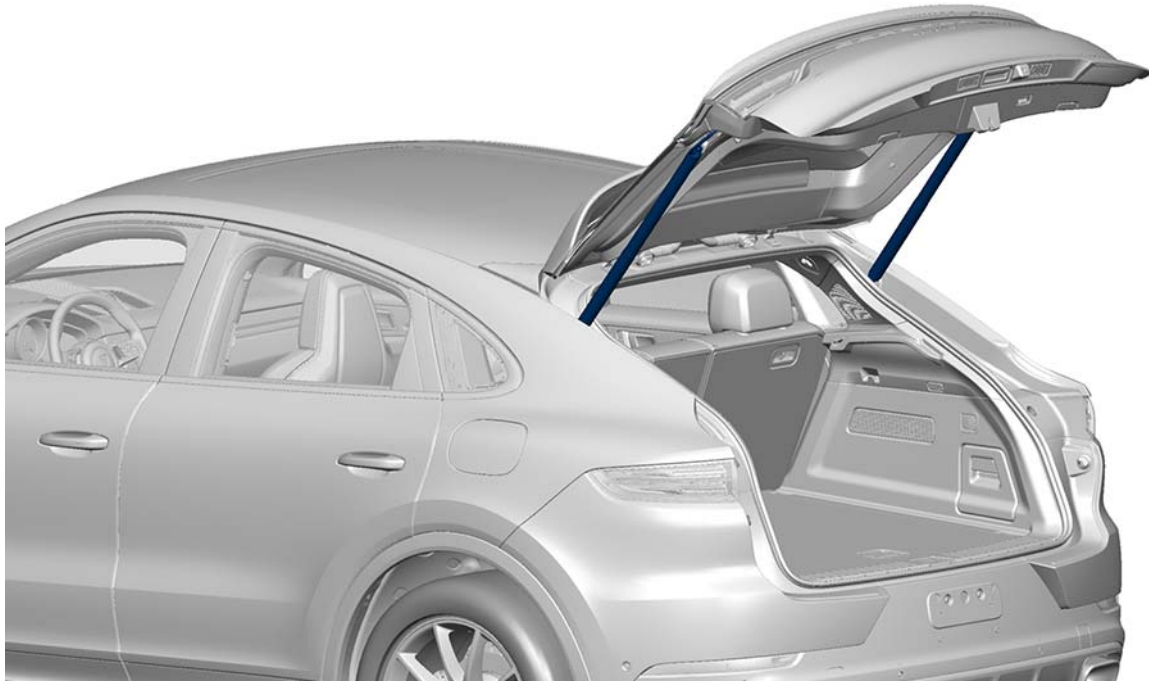
Installation
position:

Installation position of ball pins for actuating cylinder
