Service Alert

Subject: MAZDA RADAR CRUISE CONTROL (MRCC) DISABLED UNDER 20 MPH	Service Alert No.: SA-062/20
	Last Issued: 08/13/2020

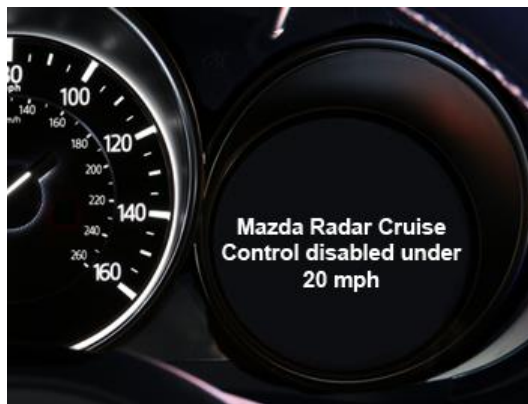
Some customers may complain about the following message displayed in the Multi-Information Display:

In the following cases, the MRCC with Stop & Go function system is canceled when the vehicle is traveling at 19 mph (30 km/h) or less:

- **Yes:** Diagnose according to the instructions on MGSS.
- **No:** In most cases, no repair is needed. Simply clean the windshield and front radar sensor to eliminate the Multi-Information Display message.
