SERVICE BULLETIN

APPLICABILITY: 2014-19MY Crosstrek
 2014-19MY Forester
 2014-19MY Impreza
 2014MY WRX

NUMBER: 05-76-20
DATE: 08/31/20

SUBJECT: Front Wheel Hub Assembly- Design Change

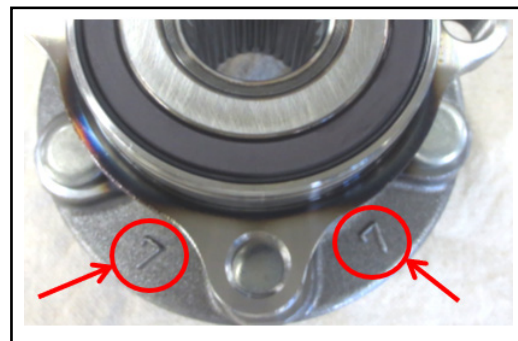
NOTE: The new part can be easily identified by “7”s made onto the back of the flange as shown here.
