**SERVICE BULLETIN**

**APPLICABILITY:** 2017-18MY Impreza  
 2018MY Crosstrek  
 2018MY Legacy and Outback  
 2018MY BRZ\*

**NUMBER:** 15-211-17R  
**DATE:** 06/13/17  
**REVISED:** 08/31/20

**SUBJECT:** Reprogramming File Availability for Additional Optimization of Harman Gen 3 Audio and Navigation Head Units

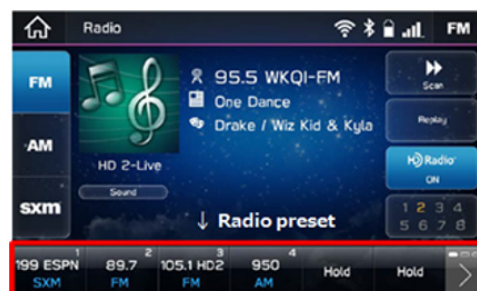
- Update to address some or all AM/FM station presets becoming lost and replaced by “Hold”

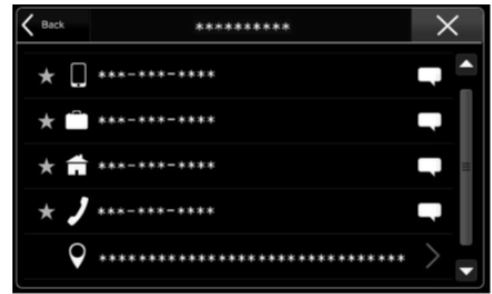
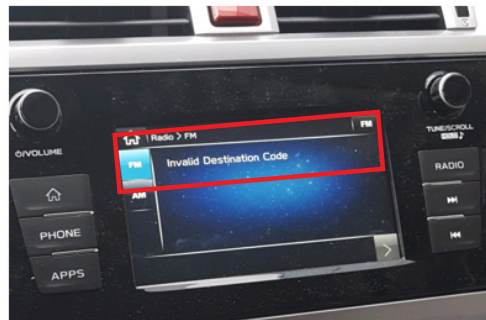
- Update to address display of “Invalid Destination Code” message

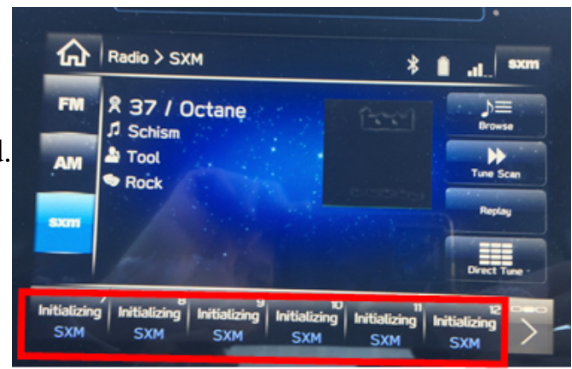
- On 2018MY Legacy / Outback models with Navigation (High) head units, the update corrects a condition where the head unit remains powered even after the ignition is OFF and the driver door is opened.
- Update for a condition where the SXM presets become lost and only “Initializing” appears as shown below.
- Update for condition where only the star field background is displayed (without icons) after the HOME button is pressed.

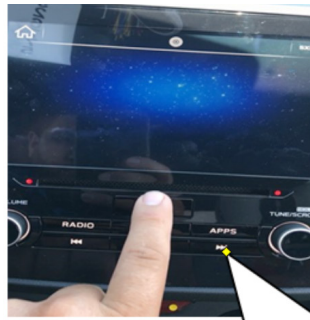
Background shown, but no icons

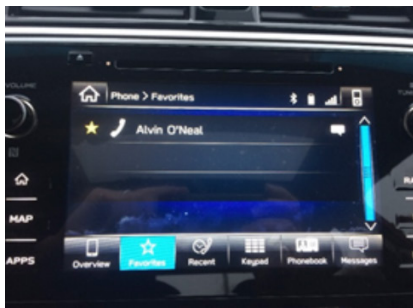
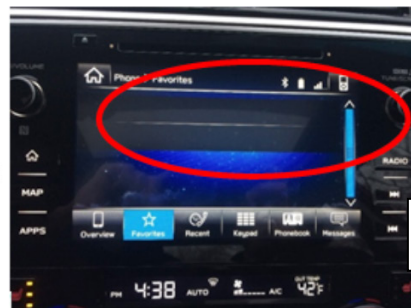
- Update for a “Pop” or “Crackling“ sound concern when listening to AM radio.
- Update for a concern of the head unit continually resetting itself.
- Update for a concern of after selecting a contact to be a “Favorite” and the “Favorite” list display is blank.

List is blank

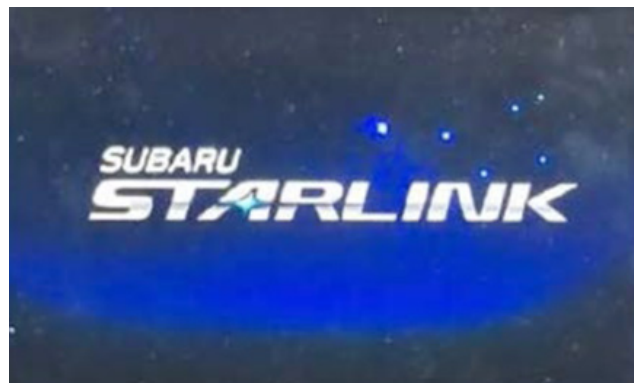
- 3- The screen freezes when the STARLINK screen is displayed.
