EL20-026

ITB20-021

SOFTWARE UPDATE FOR INFOTAINMENT ISSUES

APPLIED VEHICLES: 2020 Q50 (V37)
2020 Q60 (CV37)
2020 QX50 (J55)
2020 QX80 (Z62)

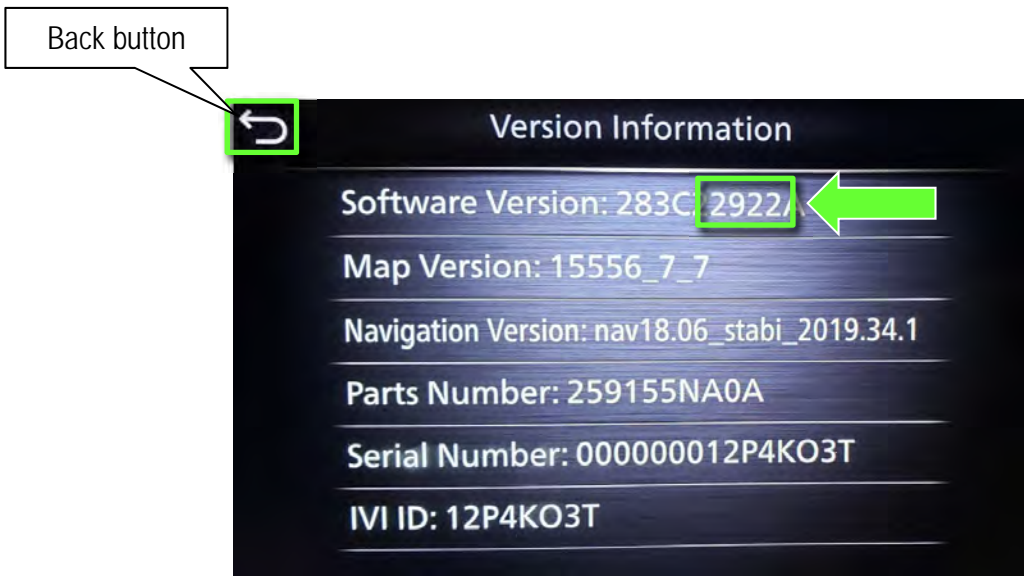
Figure 5

4. Confirm the **Software Version** number (Figure 5).

- If the Software Version (digits 6-9 as shown in Figure 6) is **lower** than xxxxx**2959**x, select the back button and continue to step 5 on the next page.
- If the Software Version is xxxxx**2959**x or higher (digits 6-9), select the back button; this bulletin does not apply. Refer to ASIST for further diagnostic information.

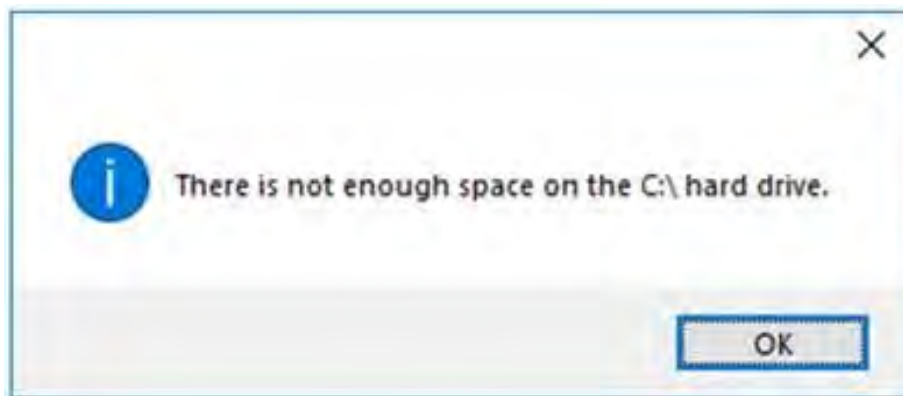
Figure 8

- The update is estimated to take **6 hours** to download to the USB drive.
- If while attempting to download the software to the ASIST Station, you receive the message shown in Figure 8:
 - a. First attempt to clear space on the ASIST station hard drive (40 GB required).
 - b. If space cannot be cleared and a second CONSULT PC\Unit is available with space, use it and start over from step 5.
 - c. If a second CONSULT PC\Unit is not available, and space on the hard drive cannot be cleared, email Bosch at nissan.dealers@us.bosch.com for additional options.
