# SERVICE BULLETIN

Classification:	Reference:	Date:
BT19-014a	NTB19-070a	August 13, 2020

## RATTLE FROM HEAT SHIELD

**APPLIED VEHICLES:**            2018 – 2020 Armada (Y62)

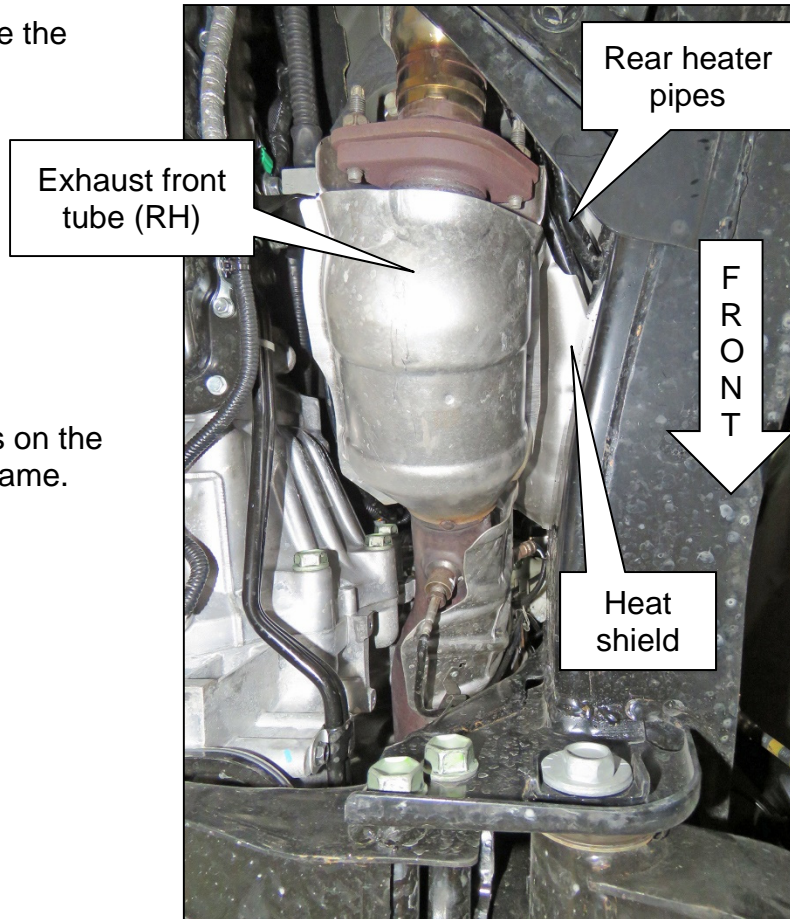
Figure 1

1. Locate the heat shield above the exhaust front tube (RH).

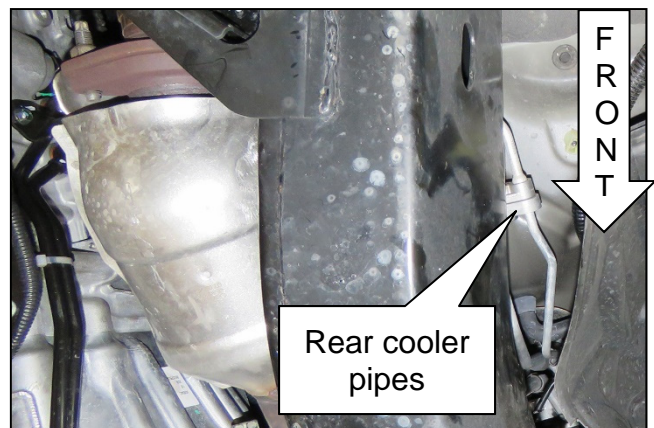
Figure 2

2. Locate the rear heater pipes on the upper **inboard** side of the frame.

3. Locate the rear cooler pipes on the upper **outboard** side of the frame.
