# SERVICE BULLETIN

Classification: EL20-020c	Reference: NTB20-046c	Date: August 26, 2020
------------------------------	--------------------------	--------------------------

## VOLUME KNOB DOES NOT FUNCTION PROPERLY

- APPLIED VEHICLES:**
- 2019-2020 Altima (L34)
  - 2018-2020 Kicks (P15) – SV and SR
  - 2019-2020 Murano (Z52)
  - 2019 Sentra (B17) – SV, SR, SR Turbo, SL, and NISMO
  - 2020 Versa (N18) – SV and SL

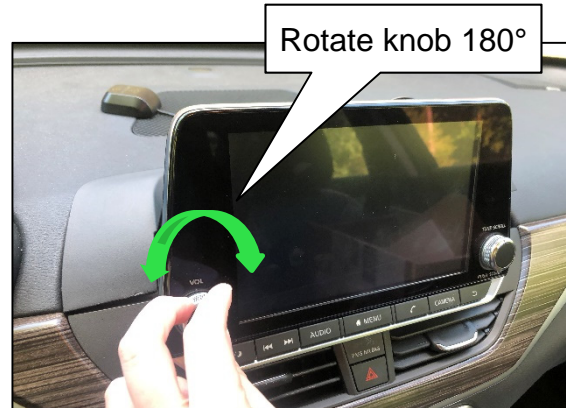
Figure 2  
(Altima shown, other vehicles are similar)

The customer states the speaker volume does not change or changes erratically when rotating the volume knob.

**NOTE:** To ensure a successful repair, steps 2, 3, and 4 **MUST** be performed to remove contaminate build-up on the full 360° radius of the electrical components internal to the volume knob.

1. Turn the audio and the ignition OFF.
2. Rotate the volume knob clockwise and counterclockwise approximately 180° as rapidly as possible for 30 seconds (Figure 2).
3. Rotate the volume knob 180° from its current position to remove the contaminate from the opposite side of the electrical component internal to the volume knob.
4. Rotate the volume knob clockwise and counterclockwise as rapidly as possible for another 30 seconds.
