SERVICE BULLETIN

Classification: EL20-021	Reference: NTB20-058	Date: August 12, 2020
-----------------------------	-------------------------	--------------------------

2016-2019 TITAN/TITAN XD; REAR SONAR SENSORS DO NOT DETECT OBJECTS/OBSTRUCTIONS WHEN IN REVERSE

APPLIED VEHICLES: 2016-2019 Titan/Titan XD (A61)

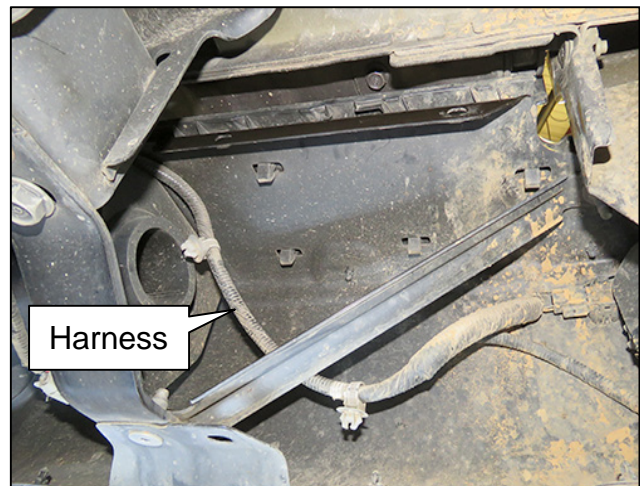
Figure 2 shown with the harness unclipped.
