Technical Service Bulletin

| SUBJECT: | | No: TSB-20-42A-005 | |
| BODY PANEL PAINT STAIN | | DATE: August 2020 | |

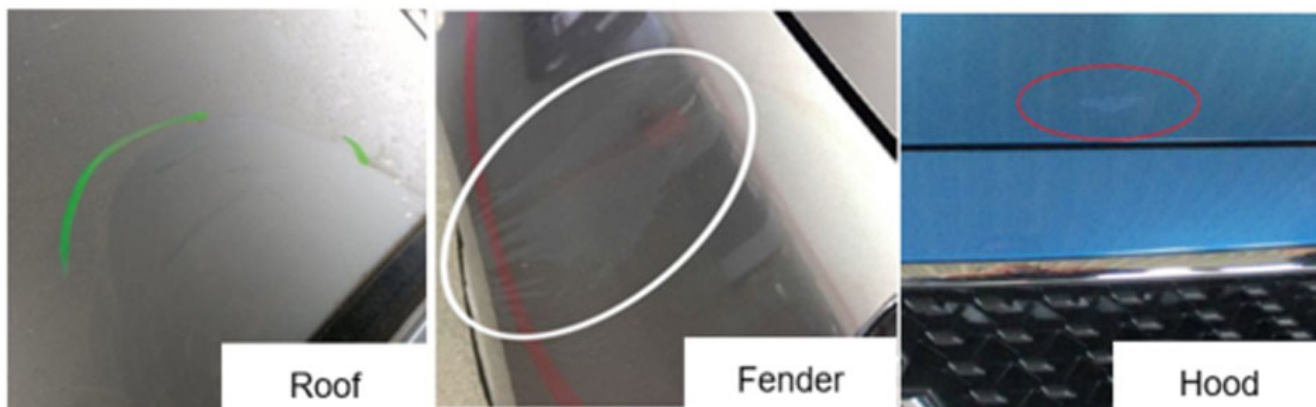
A dealer may find a stain or cloudy spot on the body panels after removing the transportation film. Due to improper installation of the film wrap, a bubble may be present and allow moisture such as humidity to remain on the painted surface for a long period of time. As a result, a stain or cloudy spot may appear on the clear coat.

DO NOT REPAINT THE VEHICLE FOR THIS CONDITION.

Dry the stain (cloudy spot) by applying heat from a ultraviolet heat lamp or blow dryer set on hot or high heat.
