September 11, 2020

Version 8

Firm 2nd to 3rd Gear Upshifts Under Certain Driving Conditions

Supersedes 15-040, dated March 22, 2017, to revise the information highlighted in yellow

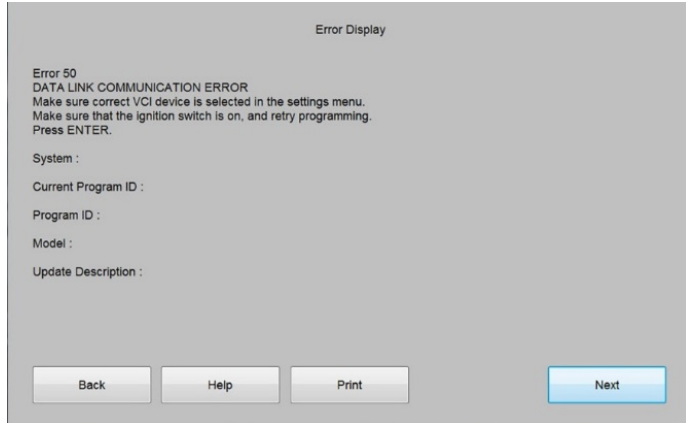
- To prevent transmission control unit damage, do not operate anything electrical (headlights, audio system, brakes, A/C, power windows, door locks, etc.) during the update.
- If you see the following Error Display, check that you are using the correct tool (MVCI or DST-i) with the i-HDS.
