# XENTRY TIPS

Engine power output is reduced and/or engine indicator lamp lights up, various fault codes present in area of exhaust gas recirculation (EGR system) or in charge air system

Topic number	LI14.20-N-071638
Version	1
Function group	14.20 Exhaust gas recirculation
Date	08-21-2020
Validity	MODEL 906 with ENGINE 642 MODEL 907 with ENGINE 642
Reason for change	Model Validity Adapted
Reason for block

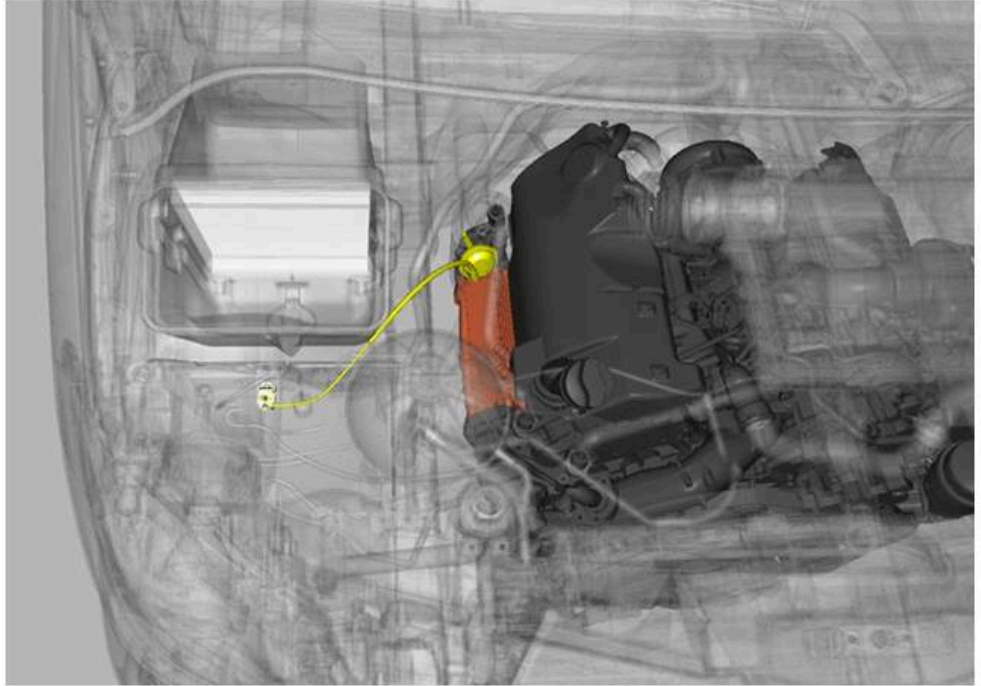
01.jpg:

The exhaust gas recirculation cooling solenoid valve (Y27/13) may stick in the valve seat and fails to admit the vacuum for the vacuum unit of the bypass flap.

This can cause sooting in the EGR or charge air tract.

Attachments	
File	Description
01.jpg	Exhaust gas recirculation system (EGR), charge air system

- Only replace components which do not function as designed due to sooting.
  - Cleaning the components is not permissible.
1. Check vacuum unit for bypass flap at EGR cooler for leaks (see 01.jpg).

Note: To do this, a vacuum of 600 mbar must be built up at the EGR cooler bypass flap vacuum unit using the vacuum pump (W 001 589 73 21 00).

- The vacuum must be held for a period of 5 s and may drop by no more than max. 5 mbar.

- If the results deviate from the specified values, the bypass flap vacuum unit must be replaced (see AR14.20-D-7661SG).

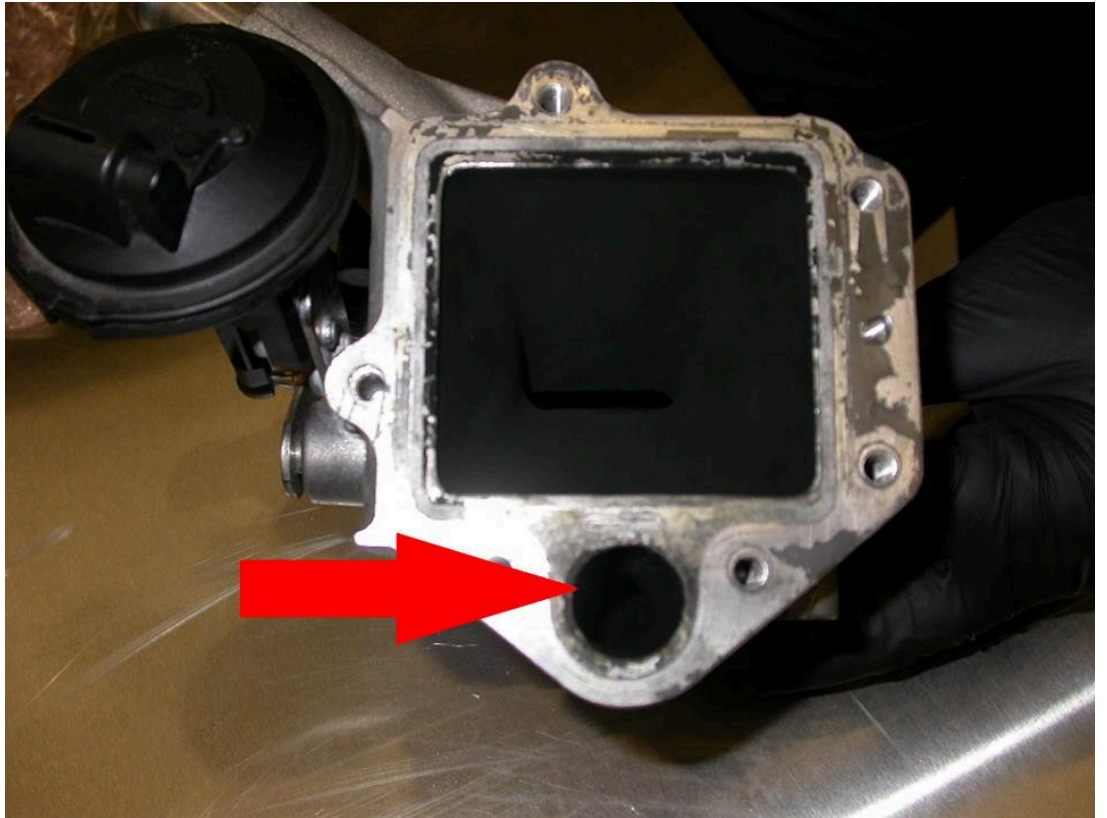
02.jpg:

Attachments	
File	Description
02.jpg	Bypass line of bypass flap
