Technical Service Bulletin

20 MIL on, DTC P310B00, P008700, P014800, P120F00 or P030000 stored in the ECM

20 20 30 2060377/2 September 18, 2020. Supersedes Technical Service Bulletin Group 20 number 20-29 dated August 13, 2020 for reasons listed below.

Model(s)	Year	VIN Range	Vehicle-Specific Equipment
A8, S8	2019	All	4.0 TFSI
A8, S8	2020	000001 – 013065 Or 000001 - 013756	4.0 TFSI

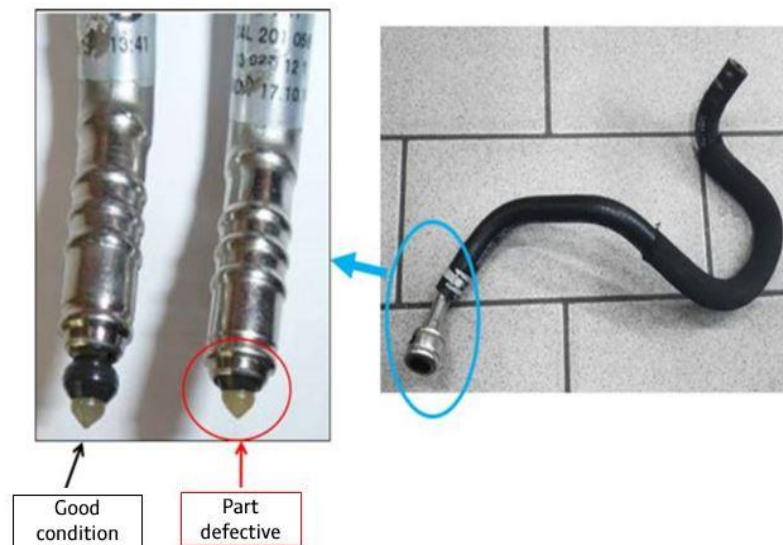
1. Check the fuel line 06M 133 986 AD (Quick Connector) for a defect. Compare with Figure 1.

Figure 1. Good condition part or defective part.

3. Should you find an irregularity, then replace the damaged component.
4. Please take photos and upload them into DOC-IT with the repair order. Photos should:
- Have a date stamp and VIN reference.
 - Be taken in focus and with sufficient light.

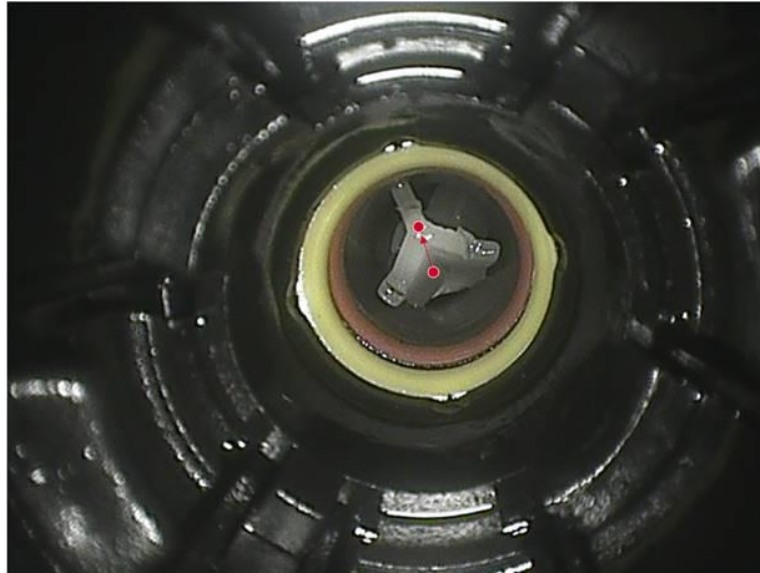
2. A non-concentric fit of valve stem can be a further indication of internal component damage. Compare with Figure 2.

Figure 2. Check the valve stem fit.
