Technical Service Bulletin

90 Audi pre sense - restricted function icon is displayed after engine starts

90 20 68 2059891/2 September 15, 2020. Supersedes Technical Service Bulletin Group 90 number 20-54 dated June 29, 2020 for reasons listed below.

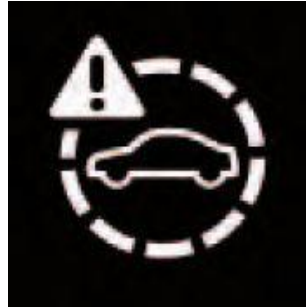
- One of the symbols for “Audi pre sense not available at the moment” is shown for about 20 seconds after engine starts and then it disappears (Figures 1 - 2).
- In some models, the vehicle must be moved before the initialization indicator goes out.

Figure 1. Symbol for “Audi pre sense not available at the moment”.

This icon is shown for about 20 seconds after switching on the ignition, because Audi pre sense is not available at the time. The front camera for driver assist systems R242 needs about 20 seconds, or, in some models, a velocity signal, to start up.

1. Do not perform any repairs. Any repairs for this concern may be denied.
2. Inform the customer that it takes the front camera for driver assist system (R242) about 20 seconds to start up and the icon informs the driver of this fact. This is normal behavior.
