STAR ONLINE PUBLICATION

Case Number: S2008000113

Symptom/Vehicle Issue: No Start Intermittently, Vehicle Requires Multiple Keyless Push To Start Attempts To Start Vehicle

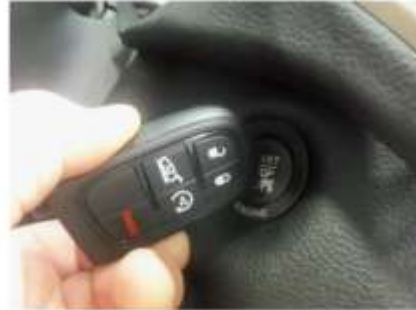
If the FOB battery has a low battery level which prevents the RF-Hub/KIN from performing the normal RF based Keyless Go authentication, the KIN module has a back-up means to perform the FOB authentication:

- The RF-Hub will flash the Start/Stop Button at a rate of 1Hz with a 50% duty cycle when no valid key is detected
- Press the FOB on the center of the Start/Stop Button, perpendicular to the surface of the button
- Briefly hold the FOB in place after pressing the Start/Stop Button to complete authentication of the FOB

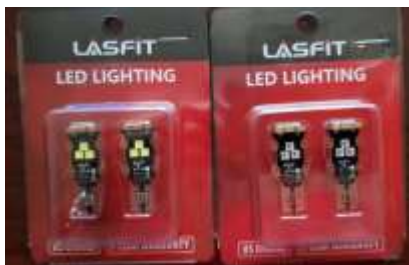
Aftermarket equipment should be considered with or without faults when checking for interference

LED replacement bulbs

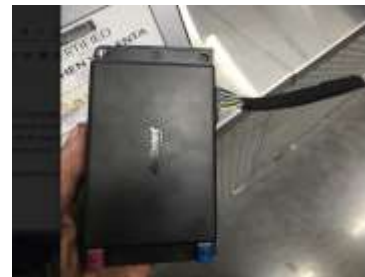
Autonet Mobile (wireless) installed into the CAN C BUS
