Mercedes-Benz

Campaign No. 2020070008, August 2020

SUBJECT: **Model 447 (Metris), Model Year 2019**
Inspect Propeller Shaft

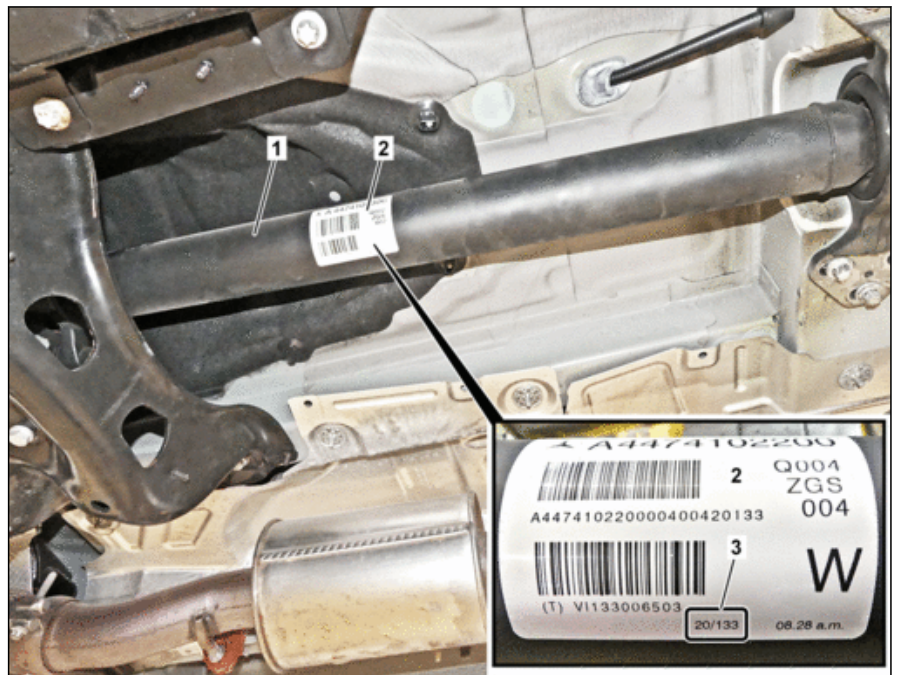
S41.10-A008-76

- 1 Propeller shaft
- 2 Adhesive label
- 3 Manufacturing date (example)

The manufacturing date (3) of the propeller shaft (1) is on the adhesive label (2).</p> <p>

The date entry "18/333" means: manufacturing date (3) of the propeller shaft (1) is calendar year 2018 on day 333.</p> <p>The date entry "18/337" means: manufacturing date (3) of the propeller shaft (1) is calendar year 2018 on day 337.</p> <p>If the manufacturing date (3) of the propeller shaft (1) is within the date range "18/333" to "18/337",</p> <p style="text-align: center;">↓</p> <p>replace drive shaft (1).</p> <p>

In this case, continue with operation step 4.</p> <p>If the manufacturing date (3) of the propeller shaft (1) is outside the date range "18/333" to "18/337",</p> <p style="text-align: center;">↓</p> <p>the vehicle is not affected by the measure and can be handed over to the customer.</p> <p>

replace drive shaft (1). Notes on threaded connections fastened using a tightening angle-based tightening process	<p>i Removal: Dispose of removed propeller shaft (1) properly. Observe the applicable legal requirements and specifications of the relevant country.</p> <p>i Installation: Replace the four screws securing the flex disk to the transmission and the four screws securing the flex disk to the rear axle differential.</p>	AH00.00-P-0020-01A AR41.10-S-0050E
5
