P21CA00 And Other Power Faults Leading To Communication Faults And SCR Inducement (Derate)

FSB 284-069, Exhaust Particulate Sensor, Repair (2017 Vehicles)

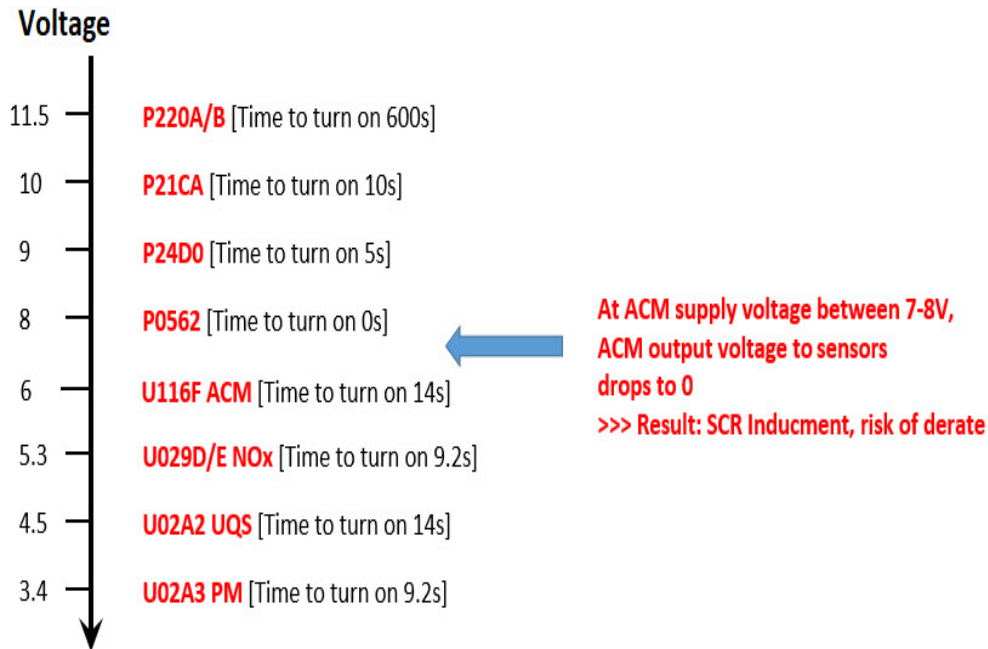
The graphic below shows the voltage related DTCs for emissions components, as well as the voltage at which they will set and the amount of time that voltage must remain at that level for the fault to

log. **This graphic is for informational purposes only and should not be used for diagnosis.**

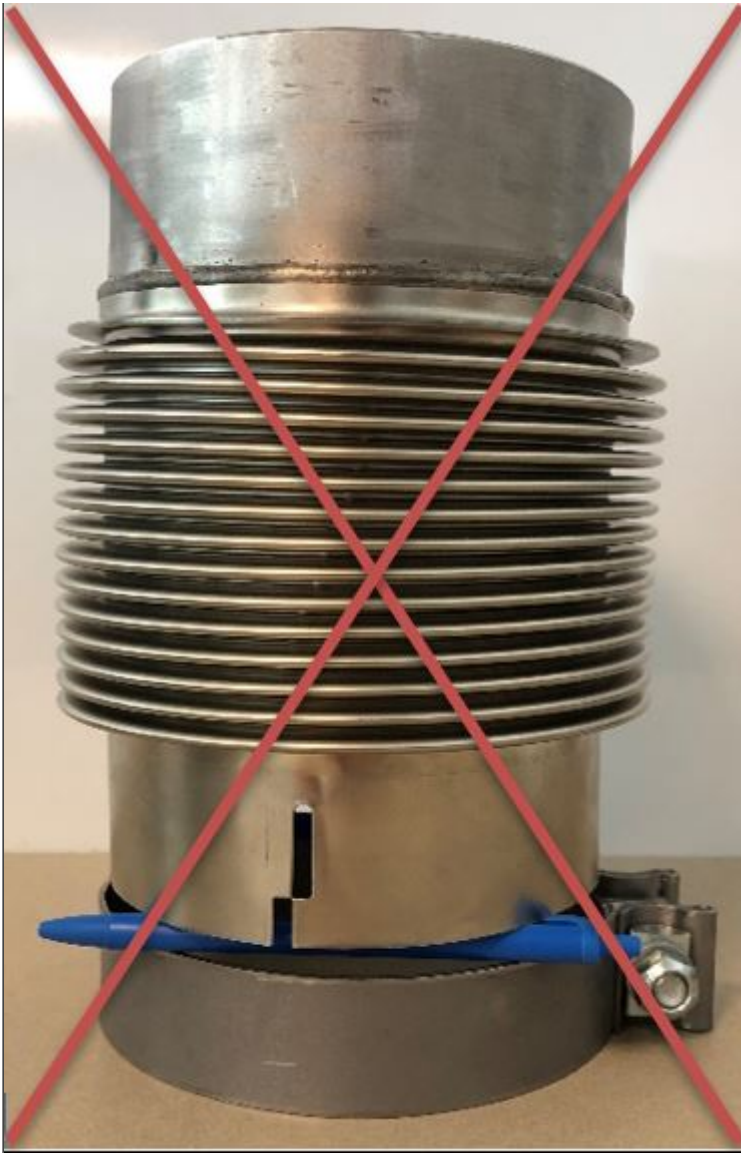
<p>Scenario 1</p> <p>This style Flex Pipe and Clamp will no longer work with the upper adjacent connecting pipe. The below parts in scenario 2 are required to perform this FSB.</p>
--	---

Determine which Flex Pipe and Clamp the truck currently has installed on it. If the truck you are repairing has the Flex Pipe and Clamp shown in scenario 1, you will need to order the improved Flex Pipe (P/N 21142254) and Clamp (P/N 25172497). If the truck you are repairing has the Flex Pipe and Clamp shown in scenario 2, this truck already has the improved parts and ordering a new Flex Pipe and Clamp is NOT required.

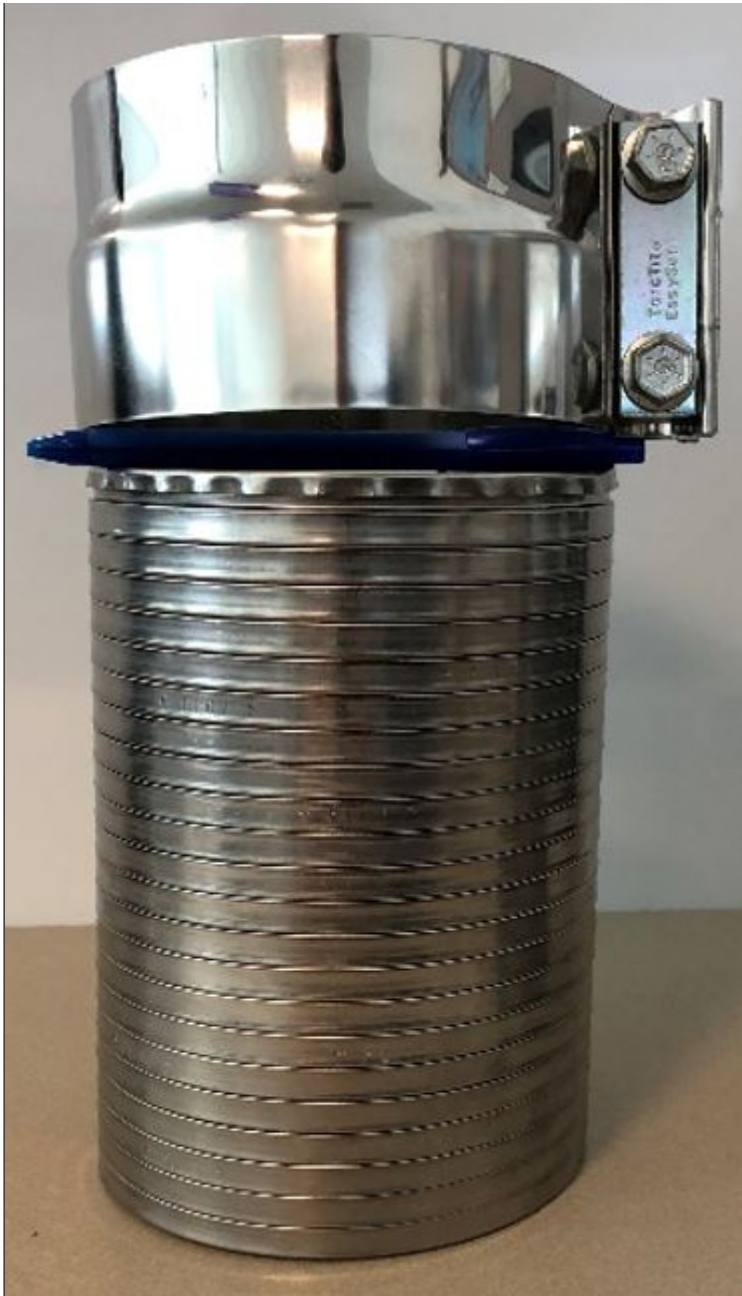
Scenario 2

This style Flex Pipe and Clamp only needs the upper adjacent pipe replaced. Reuse the existing Flex Pipe and Clamp, or order as needed.
