Checking Dual-Mass Flywheel (DMF) on Vehicles with PDK (11/14)

Model Line: **Panamera (970)/Panamera (971)**
911 Carrera (991)
Boxster (981)
Cayman (981)

Concerns: **Dual-mass flywheel (DMF)**

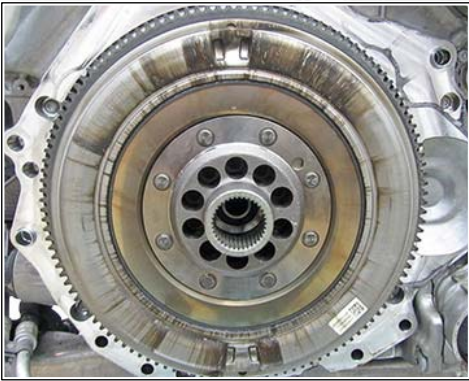
<p><i>Figure 1</i></p>

b) Dual-mass flywheel is removed :	
<ul style="list-style-type: none"> Visual inspection: 	
<p>A small amount of grease is leaking out:</p> <p>A small amount of grease is leaking out of the dual-mass flywheel ⇒ <i>Figure 1</i> and there is a ring of grease in the clutch housing ⇒ <i>Figure 2</i>.</p>	<p>⇒ Replacement of the dual-mass flywheel is not justified.</p> <p>Function OK</p> <p>Grease leaking from the dual-mass flywheel is function-related and does not result in function restrictions, noises or vibrations. The grease leak may be due to vibrations caused by a rough-running engine, for example.</p> <p>If a significant amount of grease is leaking out, the cause of the engine problems must first be detected and corrected.</p> <p>⇒ Remove grease and clean the clutch housing.</p> <p>A ring of grease as shown in <i>Figure 2</i> is considered acceptable and does not justify replacing the dual-mass flywheel. More dynamic driving can cause grease to leak out like this. After removing this excess emerging grease, it is unlikely that it will happen again. For this reason, we do not recommend that you install a new part. However, the dual-mass flywheel must be checked based on the other inspection criteria listed in this assessment in order to determine whether it needs to be replaced.</p>

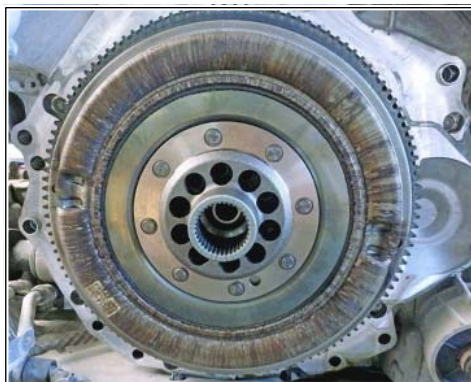
Figure 3

<p><i>Figure 2</i></p>	
<p>A large amount of grease is leaking out:</p> <p>A large amount of grease is leaking out of the dual-mass flywheel ⇒ <i>Figure 3</i> and there is a full ring of grease in the clutch housing ⇒ <i>Figure 4</i>.</p>	<p>⇒ Replacement of the dual-mass flywheel is justified.</p> <p>Function not OK</p> <p>⇒ Remove grease and clean the clutch housing.</p>

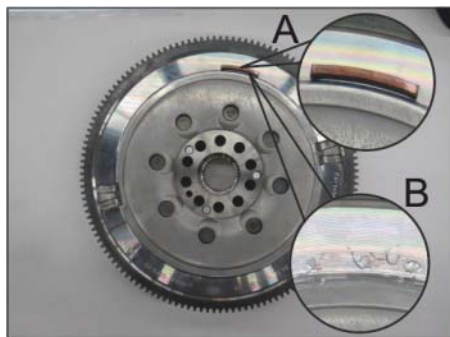
A balancing weight is missing and only the bonding points are left ⇒ Figure 5 .

⇒ Replacement of the dual-mass flywheel is justified.

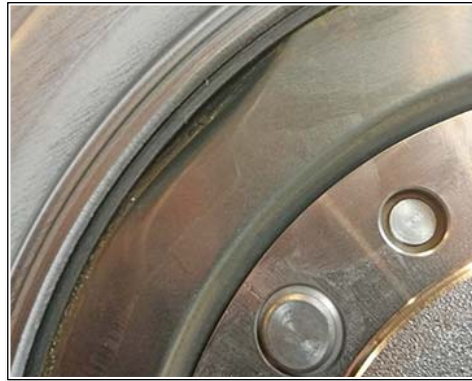
*Figure 6*

The cup spring diaphragm is damaged ⇒ Figure 6 .

Damage to the cup spring diaphragm occurs as a result of improper removal of the transmission (tilting).

⇒ Replacement of the dual-mass flywheel is justified.

⇒ **Make sure not to tilt the transmission during removal.**

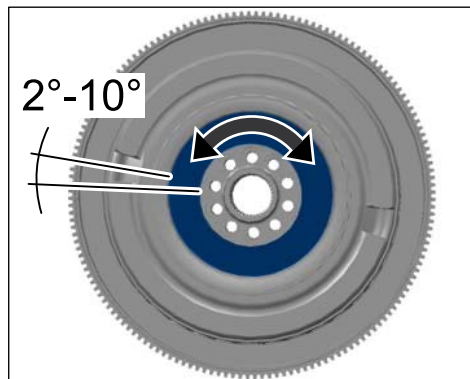
*Figure 7*

The flange must turn torsionally, but must not turn back automatically.

The possible turning angle (clearance angle) is approx. 2° - 10° ⇒ *Figure 7*.

⇒ **Replacement of the dual-mass flywheel is not justified.**
