DTC (Code) P0402 - 00 Codigo:	Bulletin: RD20-002 Date Fecha: August 03, 2020
Description:	Engine Exhaust Gas Recirculation Differential Pressure - Mechanical system not responding properly
Application:	US13 – US20 Emissions

EGR Differential Pressure Sensor, Replacement

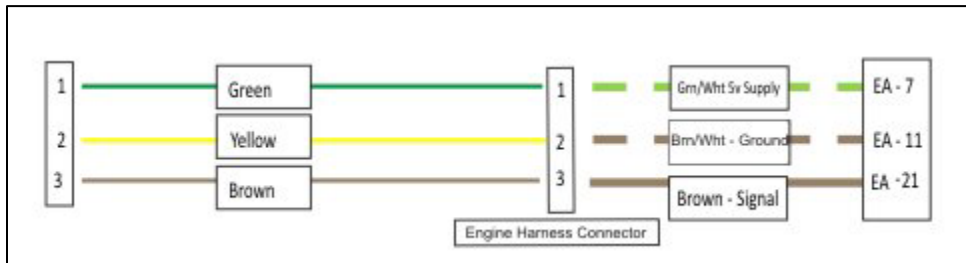
Note: The new engine harness connector pin locations when replacing old style EGR differential pressure sensor with the new style sensor in kit are:

- Pin 1 — Green/White
- Pin 2 — Brown/White
- Pin 3 — Brown

1. Clip applicable cable ties and remove P-clamps securing the EGR differential pressure sensor harness leg.
2. Use extractor tool (part number 9812483) in kit 88890037 to relocate the engine harness connector pins.
Special tools: 9812483
3. Connect the EGR differential pressure sensor jumper harness to the engine harness.
