Service Alert

Subject: "IN-VEHICLE NETWORK MALFUNCTION" INSTRUMENT CLUSTER WARNING MESSAGE	Service Alert No.: SA-029/20
	Last Issued: 09/10/2020

2019-2020 Mazda3
2020 CX-30

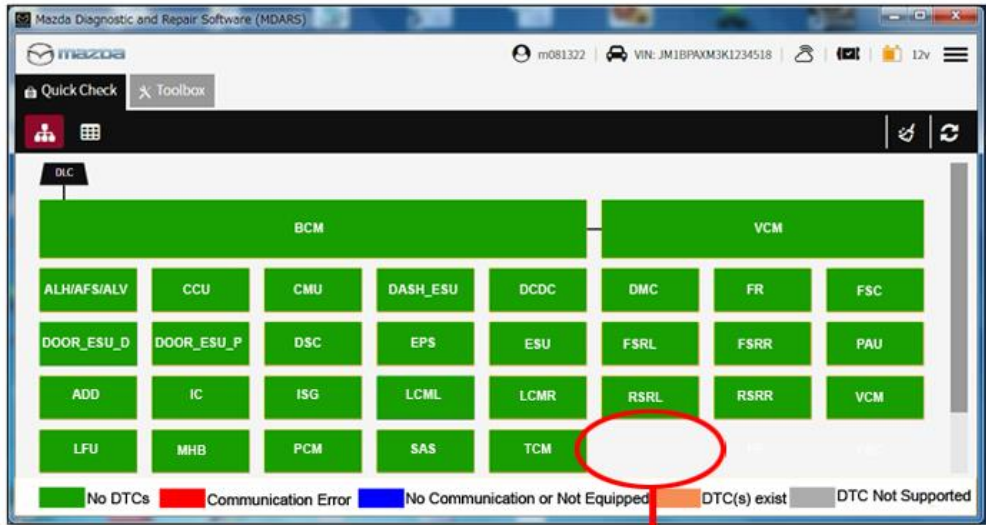
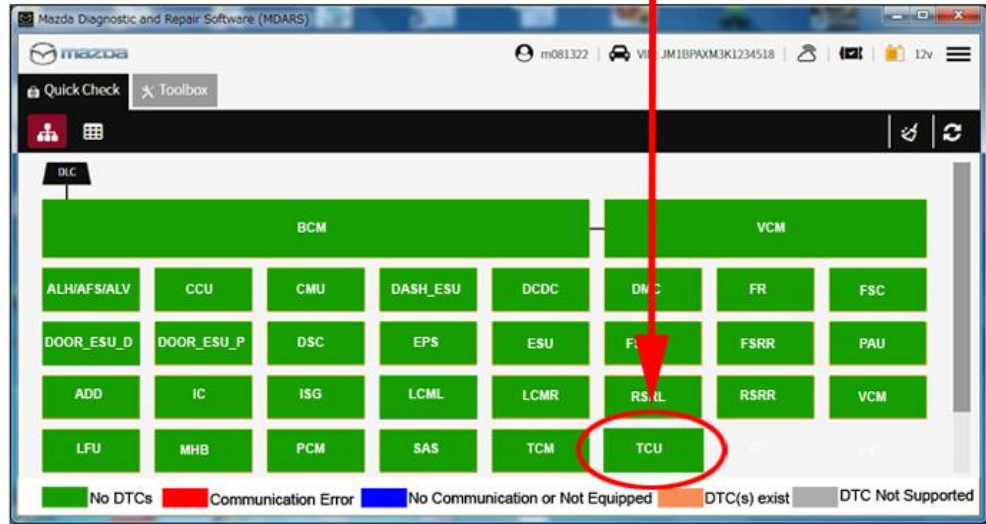
TCU appears

d. IG ON while refreshing DTC.

e. TCU now appears. Go to step 3.
