Subject: X12 Alternator Cable Support Bracket Shim Retrofit								
Field Change Program:	FCP Number:	Revision:	Date:					
Field Campaign	484	Α	09/17/2020					
Coach Section:	P/N:		Type:					
07- Electrical	07-10-0	0023	Product Integrity

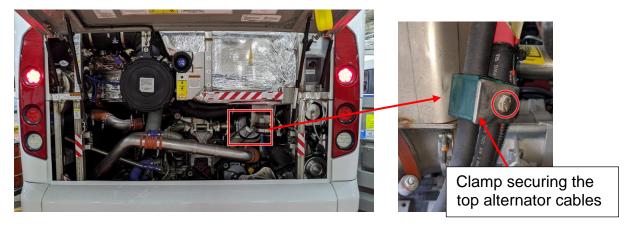
Open the engine door and locate the clamp securing the top alternator ground and power cables.
