Federal Recall Information

20PBE

Watson Chalin Lift Axle Pivot Bolts - NHTSA: 20V506 / TC: 2020-399

9/16/2020

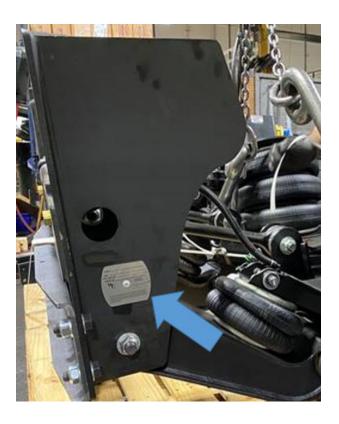
Figure 1

- 1. Review the attached Pivot Bolt Inspection Procedure.
- 2. If the thread engagement of the pivot bolts does not meet the requirements as described in the Pivot Bolt Inspection Procedure, follow the procedure in the attached Pivot Bolt Replacement Procedure.
- 3. It is required that the following are attached to the claim:
 - A clear photo showing the bolt and the nut with insufficient thread engagement.
 - The model of the truck.
 - The serial number for the axle see serial number location in Figure 1.
