## Technical product information

<b>Topic</b>	Emergency Assistance (SOS) - System Unavailable
<b>Market area</b>	China 796 VW Import Comp. Ltd (Vico), Beijing (6796),United States E05 Bentley USA and rest America (6E05)
<b>Brand</b>	Bentley
<b>Transaction No.</b>	2060444/2
<b>Level</b>	EH
<b>Status</b>	Approval
<b>Release date</b>

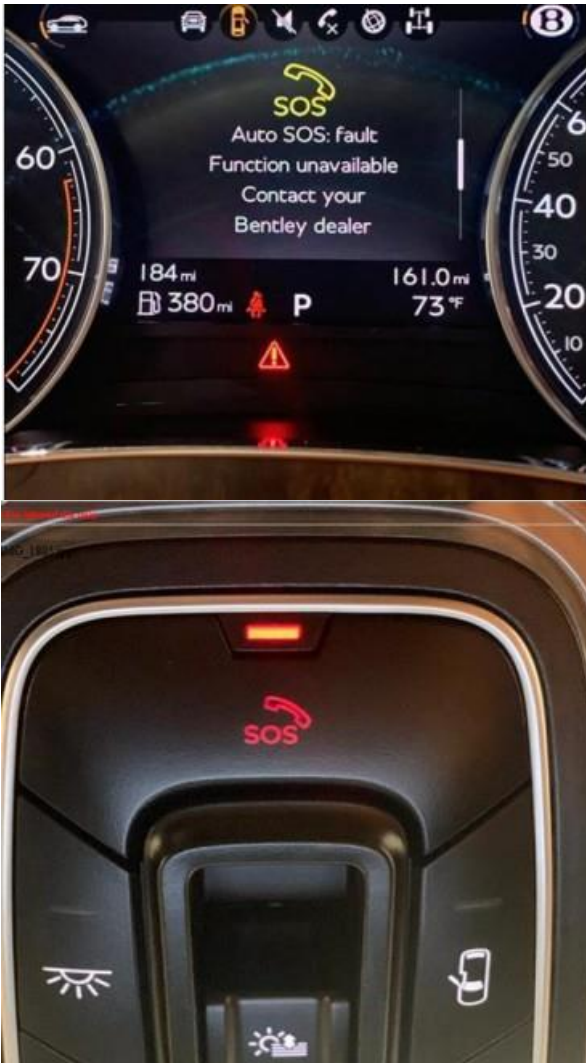
Warning on Driver Instrument Panel (DIP): *Auto SOS: fault. Function unavailable. Contact your Bentley dealer* in conjunction with the Emergency Assistance (SOS) switch in the roof console illuminating Red. The warning message on the DIP remains when the Emergency Assistance (SOS) switch has returned to Green.

Diagnostic Trouble Code (DTC) *U153E00 - Emergency call module and communication unit. Recognition in mobile communications network not possible*, stored in Address 75 – Telematics Communication Unit (TCU).

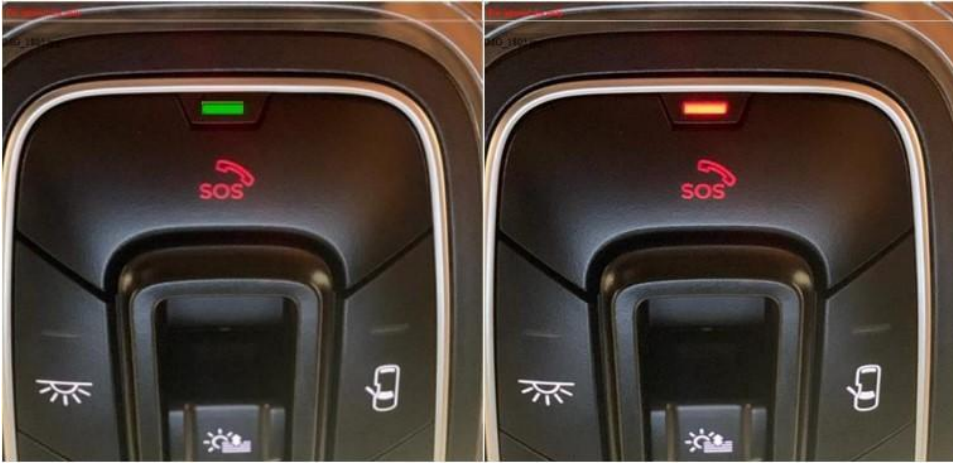
- Confirm “*Auto SOS: fault. Function unavailable. Contact your Bentley dealer*” warning is currently, or was previously displayed

on the DIP, in addition note the colour of the Emergency Assistance (SOS) switch in the roof console (Red or Green).

- If the DIP warning is present and the Emergency Assistance (SOS) switch is illuminated Green, the system is active and a connection is being made to the Emergency Assistance system.

- Carry out an ignition cycle (off/on), the DIP warning will then clear. If required, clear the stored DTC (U153E00) using ODIS.
- If the DIP warning is present and the SOS switch is illuminated Red, check and record the following *Measured Values - Address 75 – Telematics Communication Unit (TCU)*.

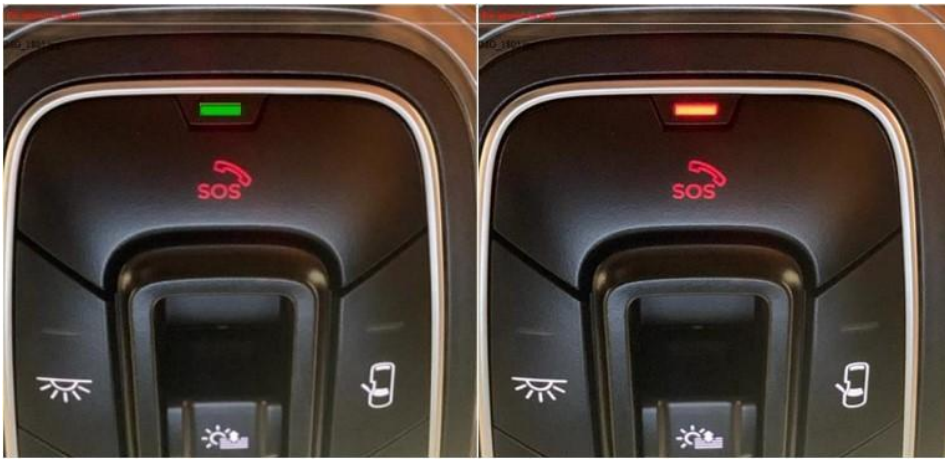
Inform the Customer that the colour of the Emergency Assistance (SOS) switch in the roof console confirms the connection status of the system. If the switch is illuminated Green, the system is active. If the switch is illuminated Red, the system is not active due to the vehicle being in an area with poor network signal strength. When the network signal strength improves, the switch will automatically display Green and Emergency Assistance will be available.
