Location: Chassis - Steering

Topic: Oil residue at steering rack rubber boot

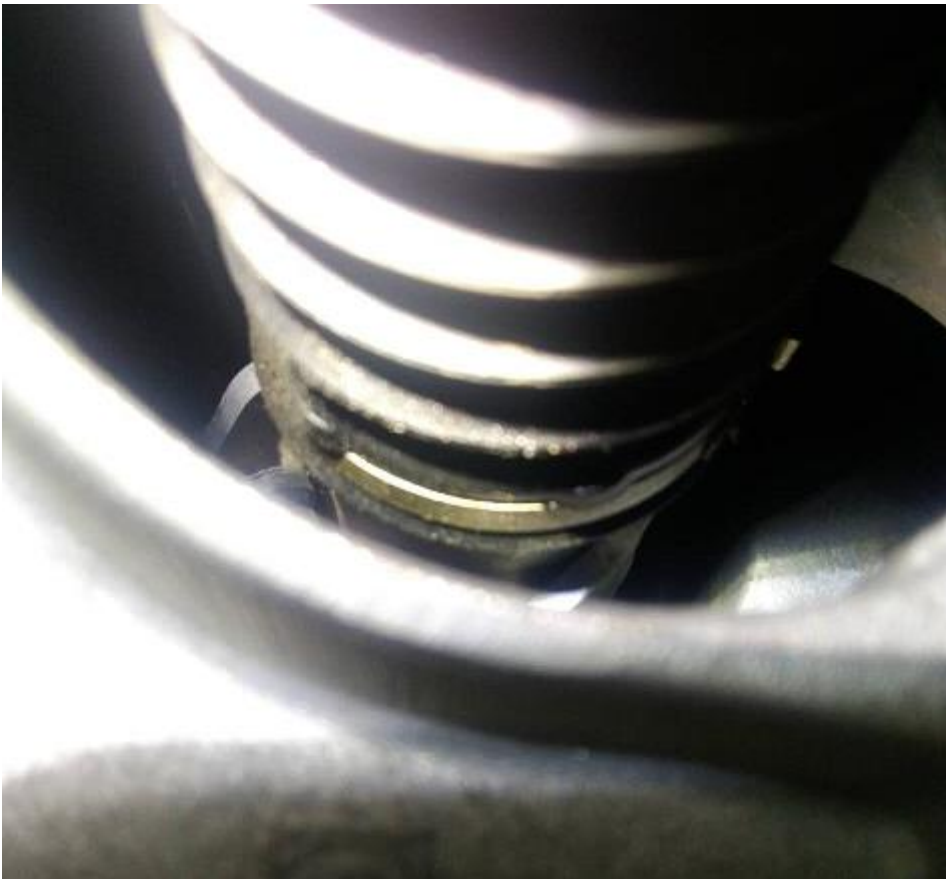
If during inspection oil residue is found around the end of the steering rack rubber boot (picture in the attachments section), do NOT replace the steering rack unless the following are confirmed;

If none of the above are valid, the oil residue around the steering rack rubber boot is grease that is used during assembly at the manufacturer and not power steering fluid. Therefore the operation of the power steering system is not affected.

Clean the oil residue and operate the steering from lock to lock for 10 times. Re-check the area and release the car if no power steering fluid leak is present.

- If power steering fluid has leaked the fluid level would be low and evidence of fluid will be present under the steering rack. In this event, proceed and replace the steering rack.
