Document Information

Location: Body BIW - Floors

Topic: Wind noise

Condition: Primarily at high speed

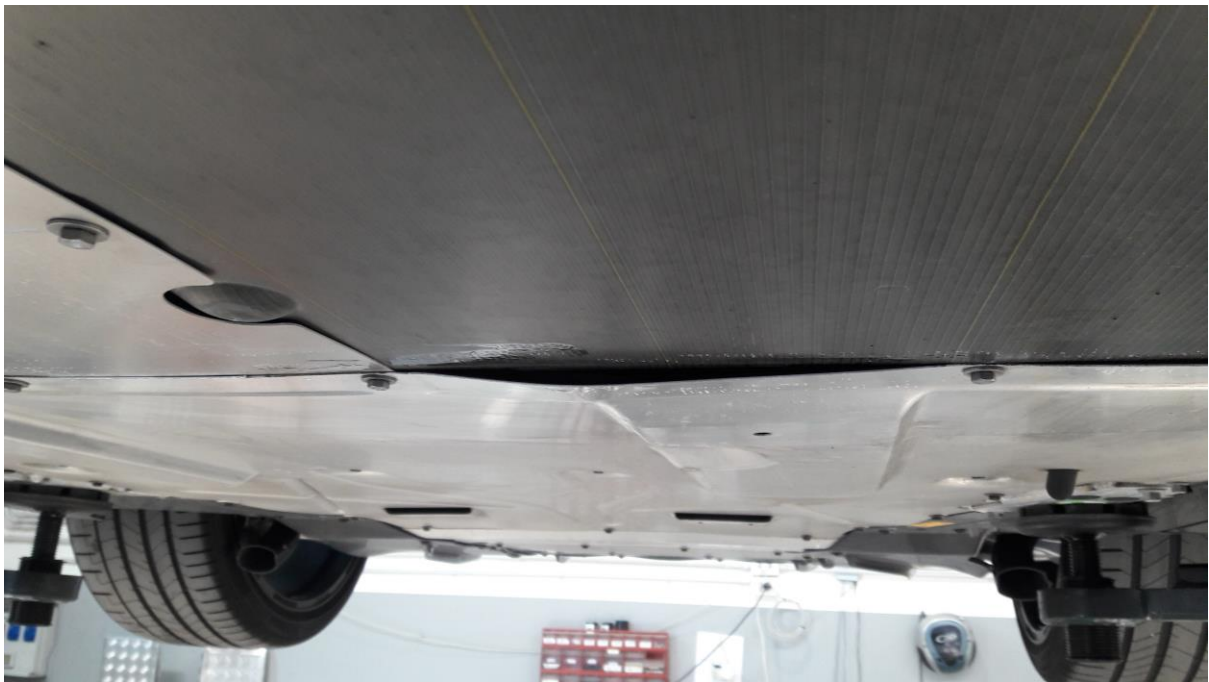
In the event of a customer complaint for wind noise and/or vibration when driving at high speed, raise the vehicle on the lift and inspect the engine floor.

If the floor is distorted as shown in the picture below, remove the floor and repair the deformed area of the floor.

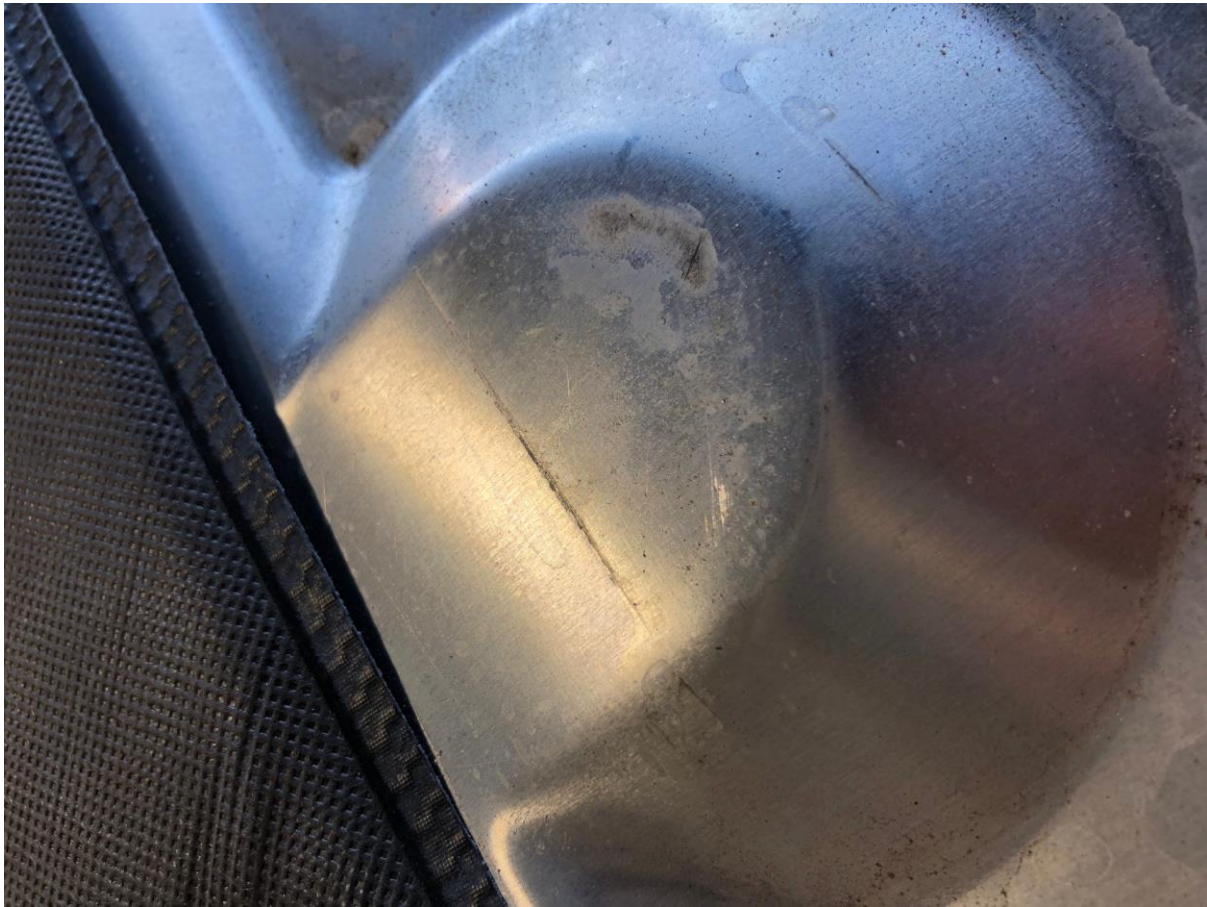
In addition, further inspection is required at the inner engine floor surface as there may be contact between the floor and the fuel tank strap, see picture below.
