EC16-035c

ITB17-042c

INFINITI; DTC P0456 CAUSED BY EVAP LEAK AT VENT CONTROL VALVE O-RING

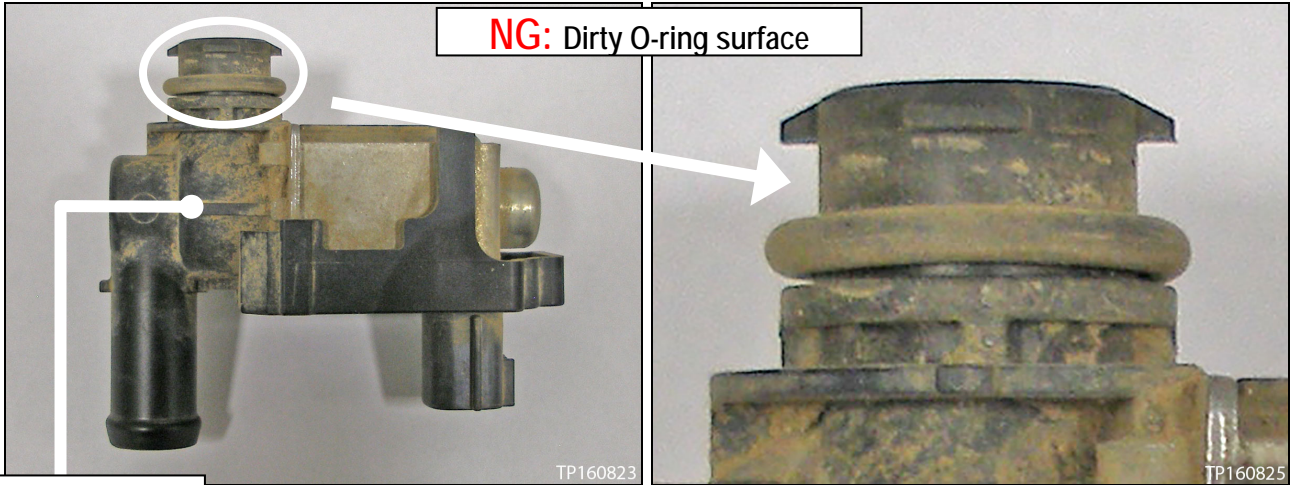
Vent control valve

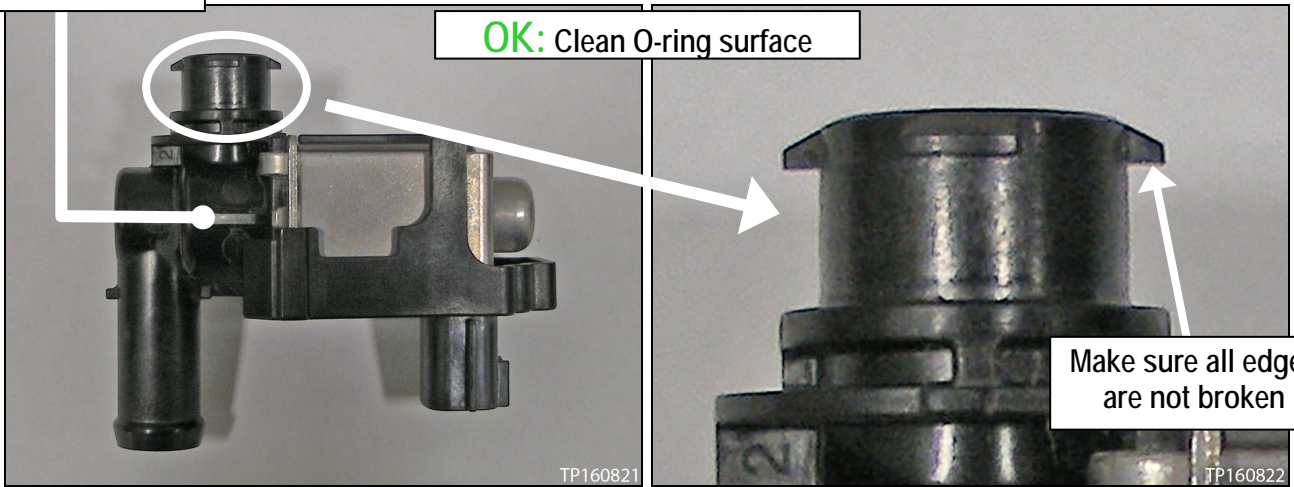
Where vent control valve mounts in canister

Canister

This surface must be clean all around

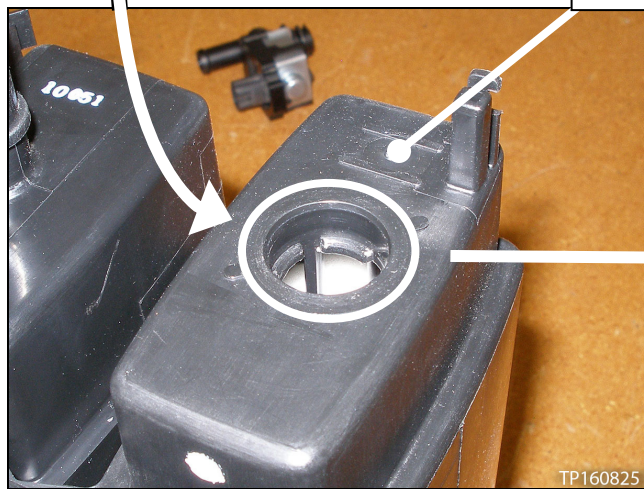
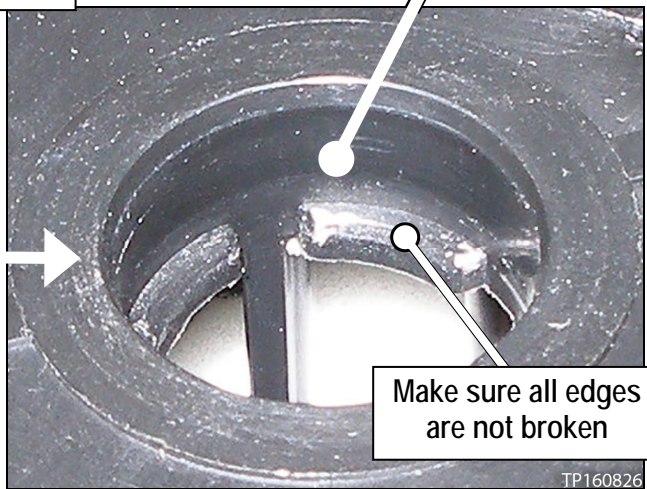
When fully seated (no gaps), O-ring is not twisted or rolled over

No gap all around

O-ring
