BT20-010

ITB20-022

2016-2017 Q50; RUST ON TRUNK LID ABOVE INNER REAR COMBINATION LAMP

APPLIED VEHICLES: 2016-2017 Q50 (V37)
 2016-2017 Q50 Hybrid (VH37)
APPLIED DATE: Built before April 24, 2017

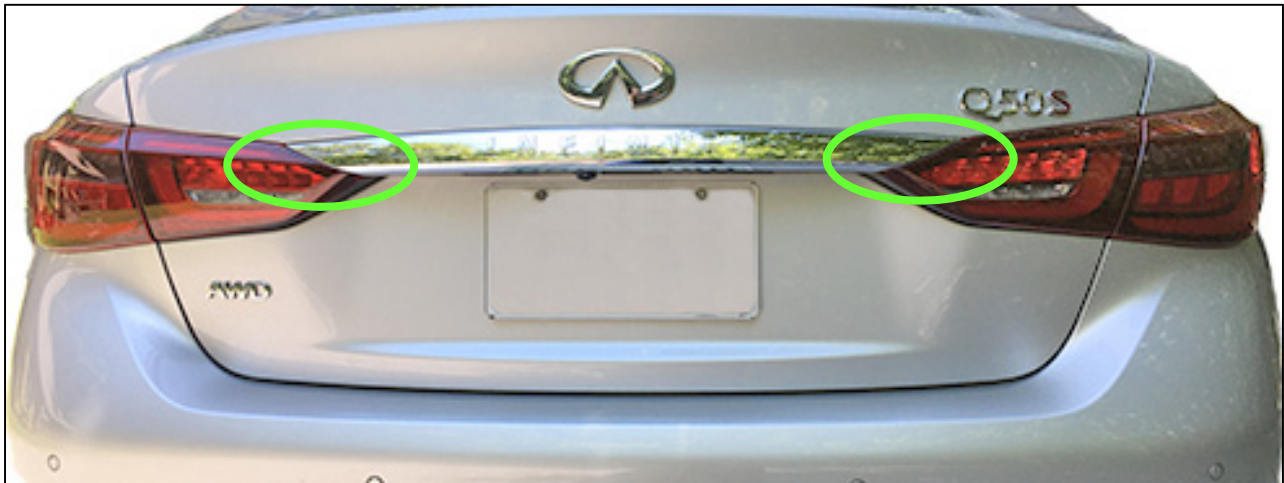
Figure 1

Client states that corrosion is present on the trunk lid, at or near the rear combination lamps, circled in Figure 1.

1. Repair the trunk lid as needed.
2. Add the rubber spacers and the washers, listed in the **PARTS INFORMATION** on page 3, to the rear combination lamps.
