HYUNDAI Technical Service Bulletin	GROUP CAMPAIGN	NUMBER 20-01-022H-2
	DATE SEPTEMBER, 2020	MODEL(S) NEXO (FE) PALISADE (LX2) SANTA FE (TM)
SUBJECT: POWER TAILGATE SPINDLE WIRE HARNESS INSPECTION/REVISION (SERVICE CAMPAIGN T4X)

Description: Some 2019 - 2020 MY Nexo (FE), 2020 MY Palisade (LX2), and 2019 MY Santa Fe (TM) vehicles equipped with the power tailgate may not operate. This bulletin provides the service procedure to inspect and when necessary perform the power tailgate spindle wire harness revision.

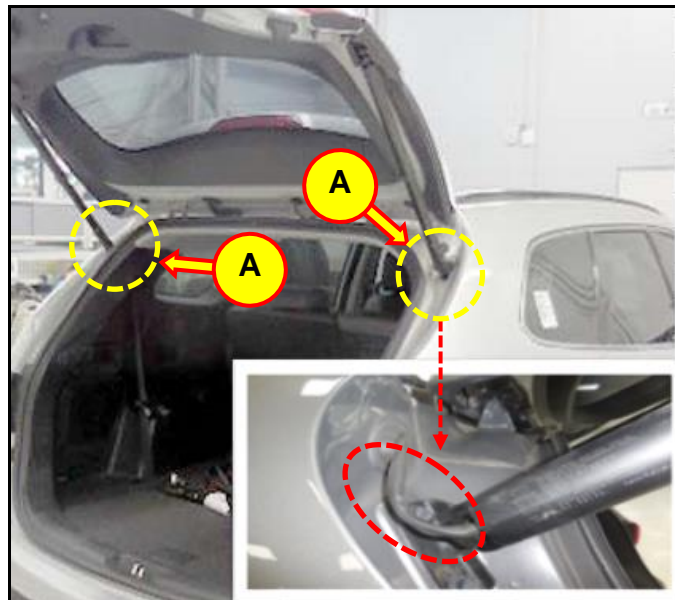
1. Open the tailgate to inspect the LH/RH power tailgate spindle wiring harness (A).

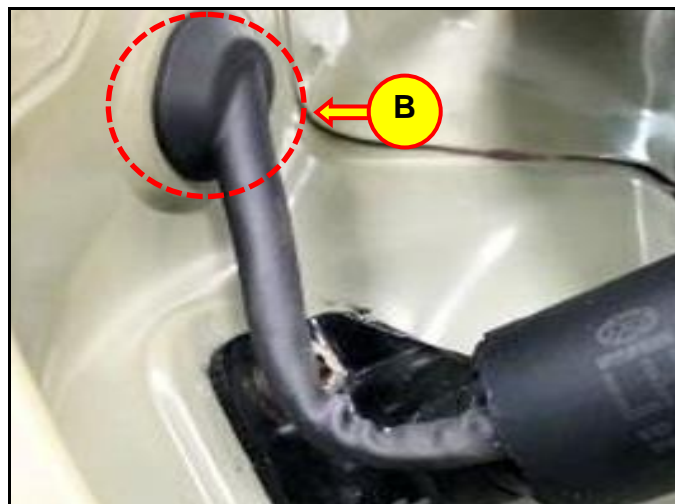
2. Remove the rubber grommet (B) of the tailgate spindle wiring harness and inspect the material.

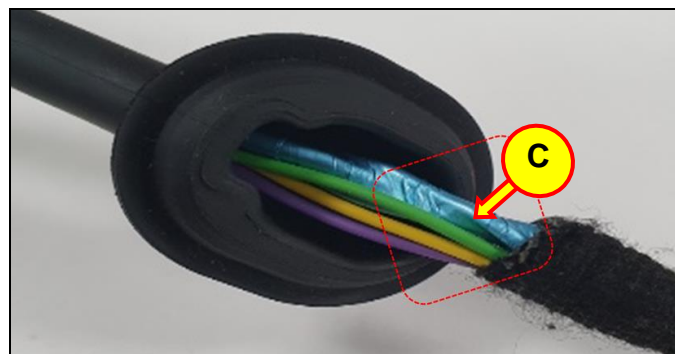
If the wire harness has a metallic shield (C), no further action is required.

If the wire harness shield does not have the metallic shield, perform the power tailgate spindle wire harness revision on page 4.

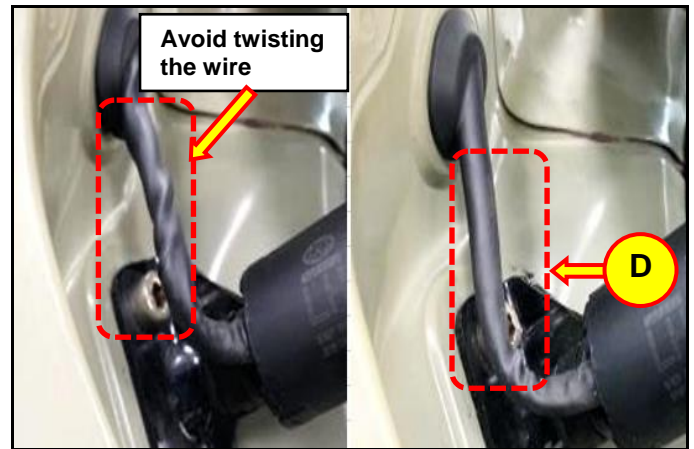
After inspecting the power tailgate spindle wire harness, **reinstall and ensure the wire harness is not twisted (D) as shown in the picture to the right.**

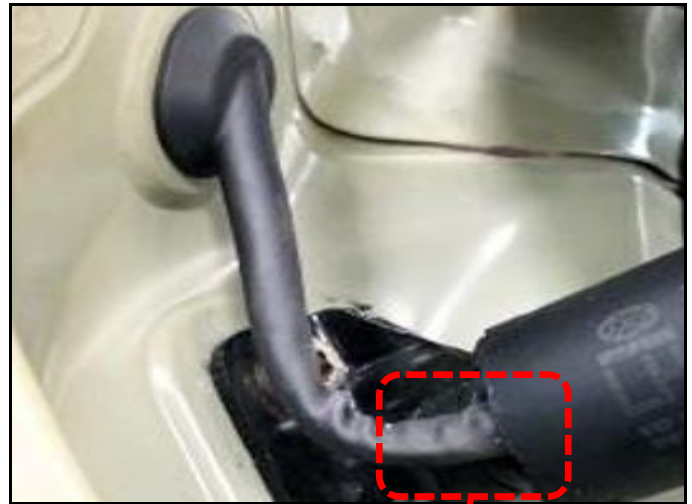
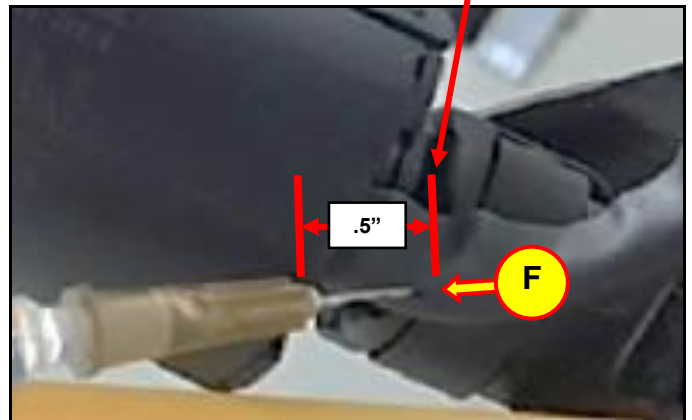
- Carefully insert the syringe into the spindle wire harness sleeve approximately .5 inches away from the spindle (F). Inject 0.2ml of Loctite 401 into one side of the spindle wire harness, and the remaining 0.2ml into the other side.

Be careful not to pierce the wire. Inject the Loctite 401 into the wire harness sleeve only.
