QUALITY ACTION

CAMPAIGN BULLETIN Windshield

Reference: PC756
Date: September 25, 2020

PC756- 2020 PATHFINDER WINDSHIELD GLASS REPLACEMENT

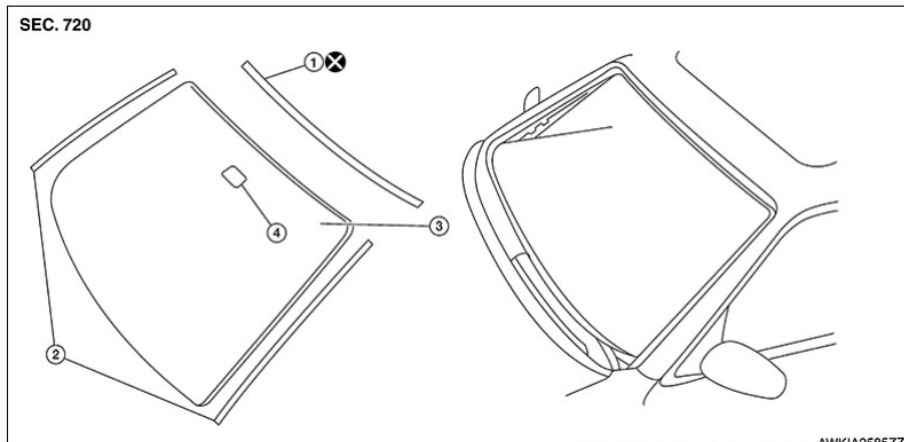
1.	Windshield glass upper molding	2.	Windshield side finisher (LH/RH)	3.	Windshield glass
4.	Mirror base

1. Replace the windshield glass per the ESM: BODY EXTERIOR, DOORS, ROOF, & VEHICLE SECURITY > GLASS & WINDOW SYSTEM > REMOVAL AND INSTALLATION > WINDSHIELD GLASS > Removal and Installation.

WARNING: Driving the vehicle before the urethane adhesive has completely cured may affect the performance of the windshield in case of an accident.

CAUTION: The vehicle should not be driven for at least 24 hours or until the urethane adhesive has completely cured. Curing time varies depending on temperature and humidity. The curing time will increase under lower temperatures and lower humidity.
