Technical Service Bulletin

01 "Switch off the engine and check coolant" message in the instrument cluster, DTC P00000 is stored in the ECM

01 20 91 2058890/3 October 7, 2020. Supersedes Technical Service Bulletin Group 01 number 20-73 dated July 24, 2020 for reasons listed below.

Model(s)	Year	VIN Range	Vehicle-Specific Equipment
A4	2017 - 2019	All	3.0 TFSI
A5, Q5	2018 - 2019	All	3.0 TFSI

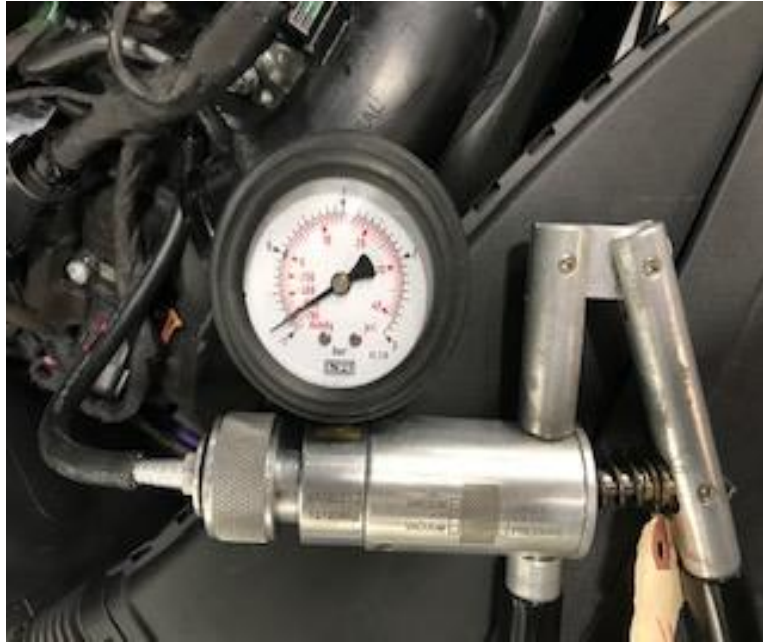
A. Check for vacuum (using VAS6213) at the output port of solenoid N649 which commands the water pump sleeve (Figures 1 and 2). The engine needs to be cold to generate a command signal to the N649 solenoid to switch to a vacuum. **With the engine cold,** start the engine briefly and monitor that vacuum is created.

Figure 1. Checking the vacuum at the output port of N649.

B. If there is no vacuum measured at the output port of N649, the cause of the fault could be related to the solenoid valve N649 or the vacuum hoses (check for leaks). In this case, repair and check the operation of the vacuum system.

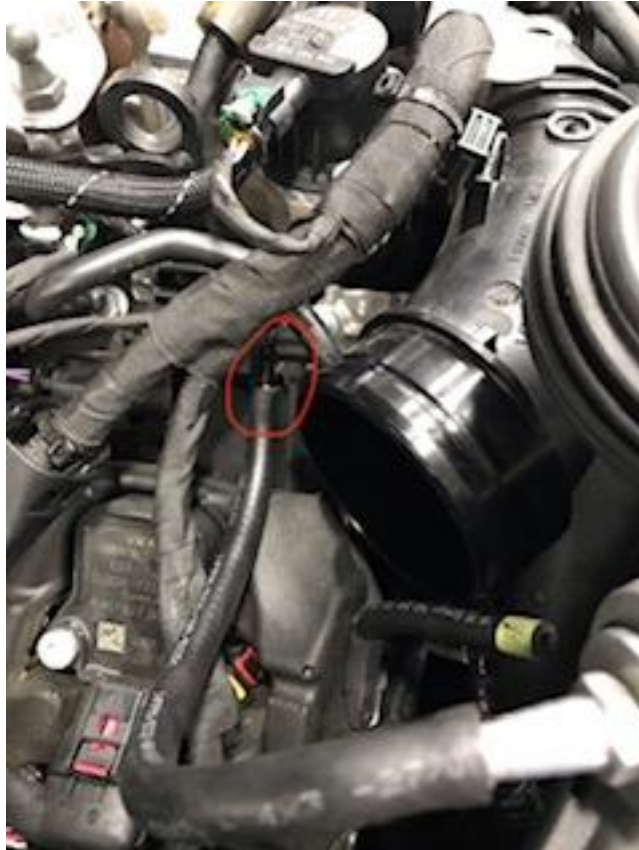
Figure 2. The output port of N649 (close-up picture).

4. If there are no malfunctions found in the vacuum system, check the operation of the water pump sleeve by applying a vacuum to the hose going to the water pump (hose connected to the output port of N649). When applying a vacuum to the pump, pay attention to the clicking sound of the water pump sleeve. If no clicking is heard or felt, replace the mechanical coolant pump.
