Technical Service Bulletin

15 Oil leak from the cylinder head - 2.9 and 3.0TFSI only

15 20 35 2053278/4 October 8, 2020. Supersedes Technical Service Bulletin Group 15 number 20-34 dated April 28, 2020 for reasons listed below.

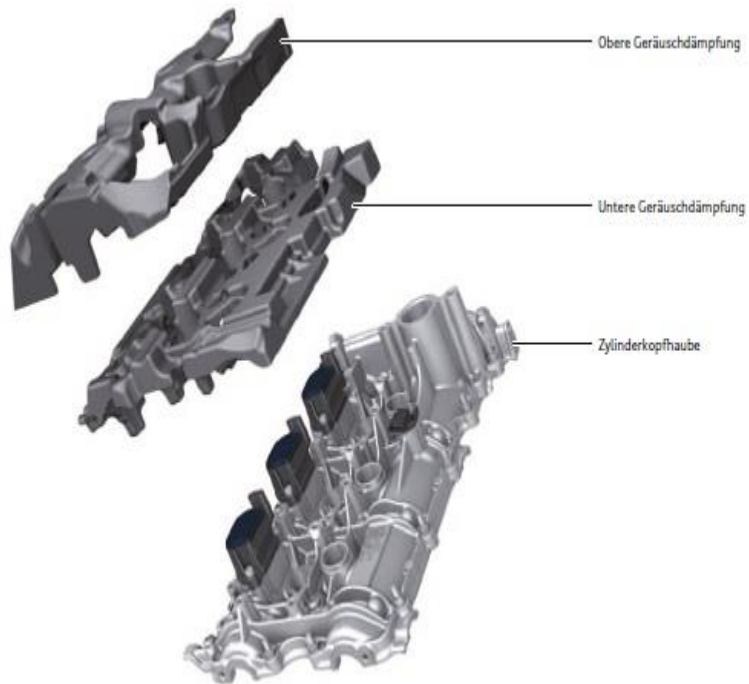
Figure 1. Removing the upper noise insulation.

1. Remove the engine compartment cover and the heat shield below it.
2. Remove the upper noise insulation of the affected cylinder bank (Figure 1).

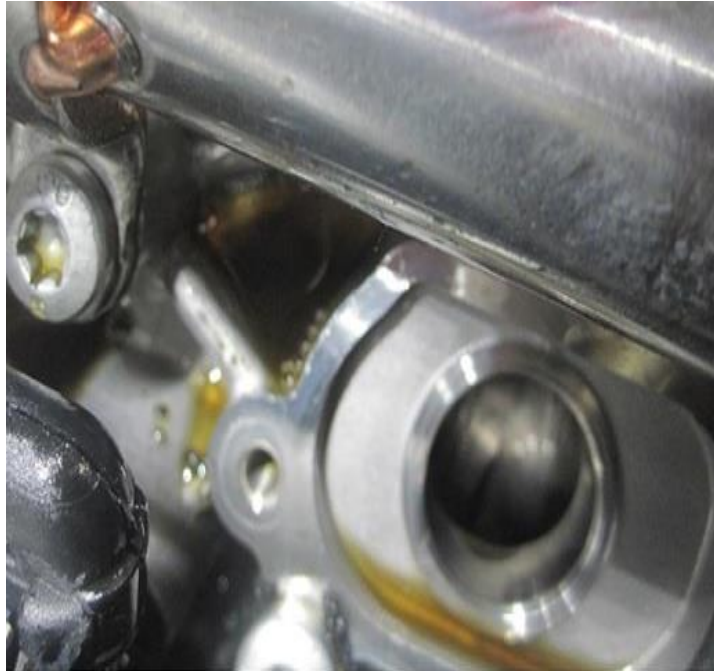
A. If there is a substantial quantity of oil below the Audi valvelift system actuator (illustration), the cause of the leak is the O ring of the Audi valvelift system actuator.

Figure 2. Oil in the Audi valvelift system.

Replace the Audi valvelift system actuator with O ring, clean the engine compartment and if necessary replace the noise insulation (if it is full of oil) (Figure 2).

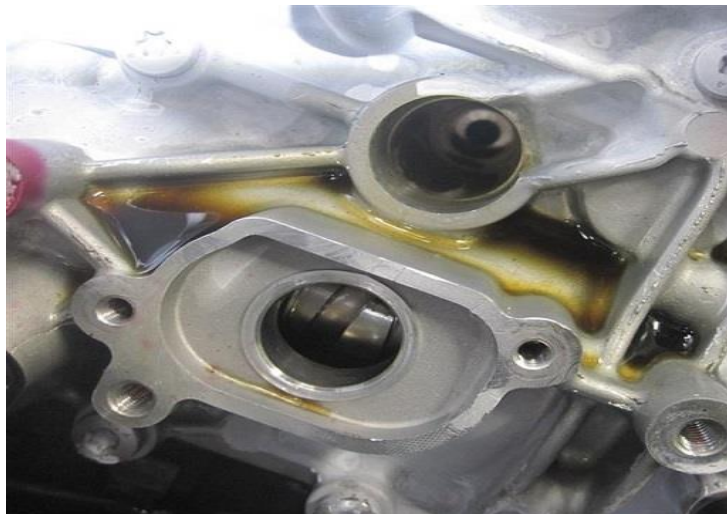
5. Locate the affected cylinder. Here oil should have gathered in the area of the injector (Figure 3) and the noise insulation should also be full of oil.

Figure 3. Locating the affected cylinder.

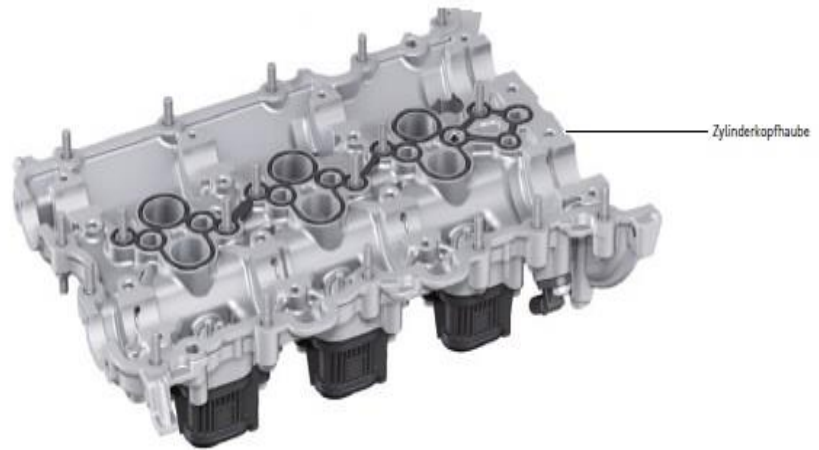
Figure 4. Remove the cylinder head cover.

6. Remove the cylinder head cover and the seal (Figure 4).

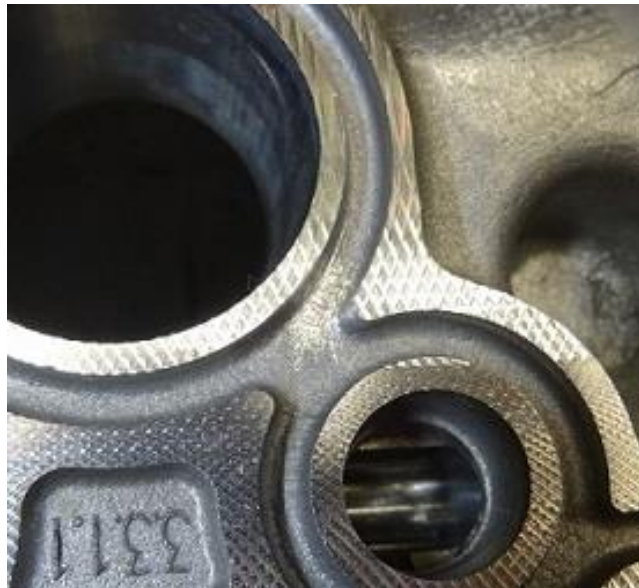
Figure 6. After the repair.

7. Inspect the seal groove in the cylinder head cover and remove any cast metal debris (Figure 5). The debris can be removed with a small flat screwdriver (Figure 6).

8. Install a new seal, re-assemble camshaft cover, clean the engine compartment, and if necessary replace the noise insulation (if it is full of oil).
