Bulletin No.: PIT5759D

PIT5759D Service Safety Restraints System With DTC B14DC SYM 1B and/or 13

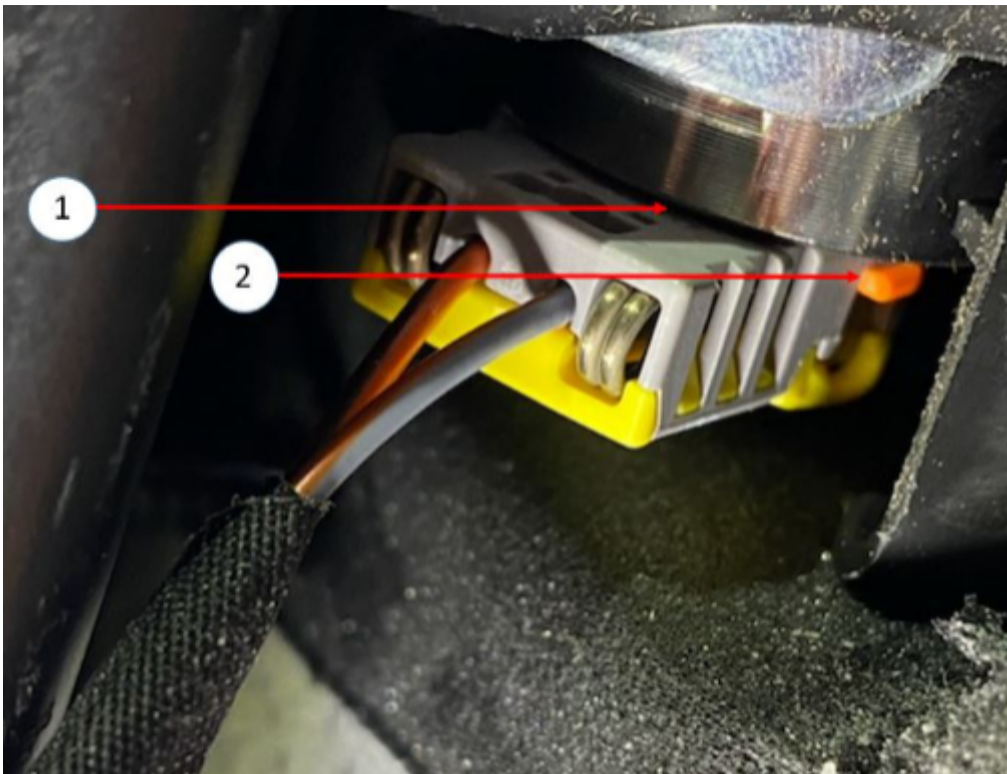
- It has been found that the F106DA Driver's front seat inboard air bag connector could be the cause of the high resistance. Inspect the F106DA Driver's front seat inboard air bag connector (shown below) to make sure it is fully seated tightly up against the airbag (1). Also, make sure the orange CPA is fully seated (2).

Note: The driver's seat does NOT need to be removed to complete this PI. Disengage the front seat back cover lower J-channel retainers and unzip the seat back cover zippers.
