Preliminary Information

PIP5737A Diagnostic Tip: Inspect Engine Oil Dipstick Tube O-ring And Areas Above Lower Oil Pan Sealing Surface For Potential Engine oil Leaks

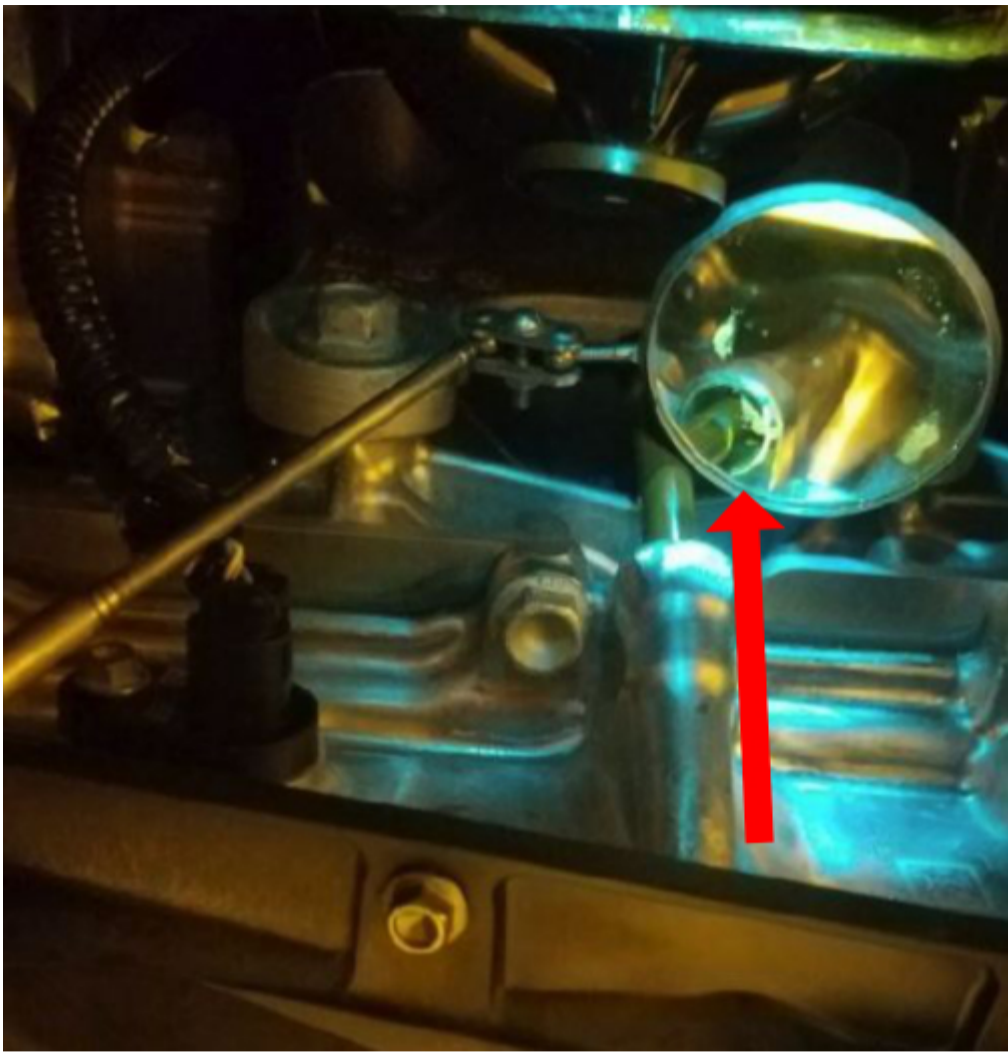
| Cause: | Possible Dipstick Tube O-ring Leaking Engine Oil |

Picture below shows oil leak from dipstick tube O-ring (looking through inspection mirror)

There may be no oil residue around the dipstick tube O-ring area, but remove the dipstick tube and inspect the dipstick tube O-ring for damage and replace as needed.

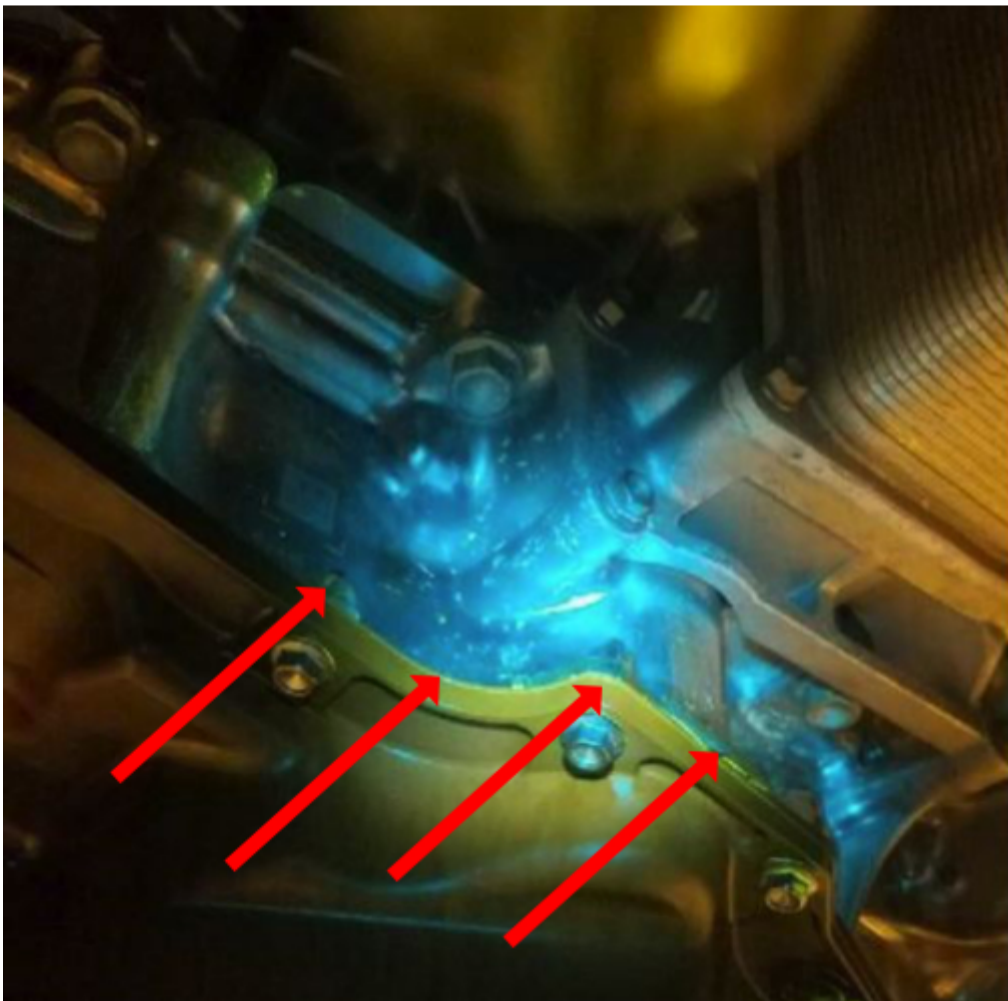
Picture below shows oil leak from composite oil pan sealing surface (shown with black light and tracer dye)

Note: The use of engine oil dye and trace powders are recommended to assist with isolating engine oil leak points. Be sure to clean suspected leak areas thoroughly before using trace powders.
