SIB 11 02 08

2020-09-10

Power Reduction, FC2A82 Intake VANOS and/or FC2A87 Exhaust VANOS Camshaft Fault

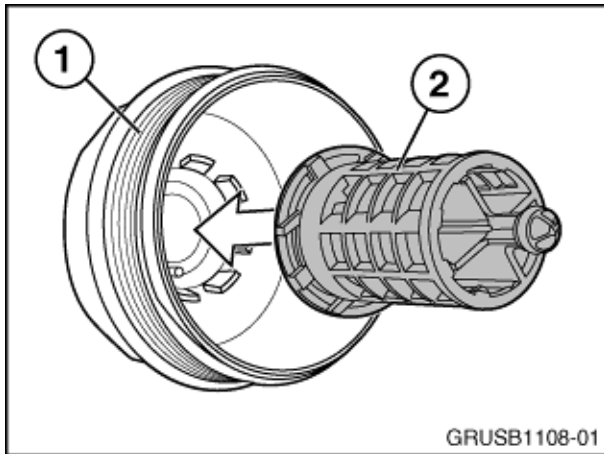
2. The oil filter cap insert may have been inadvertently removed during the vehicle's last oil service. If this insert is not installed, it will result in non-filtered engine oil being supplied to the engine, thus possibly clogging or damaging the VANOS solenoids.

If the oil filter cap insert is found to be missing, the entire oil filter housing cap must be replaced (refer to the EPC).

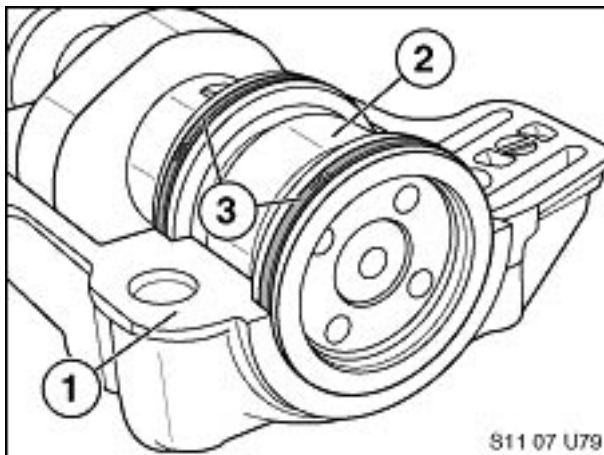
Note the deep grooves worn into the camshaft bearing ledge by the camshaft hook ring seals. The camshaft bearing ledge is worn.

Do not replace the intake or exhaust camshafts. If applicable, only replace the bearing ledge and rectangular hook rings on the affected camshaft for the VANOS fault(s) stored in DME Memory.

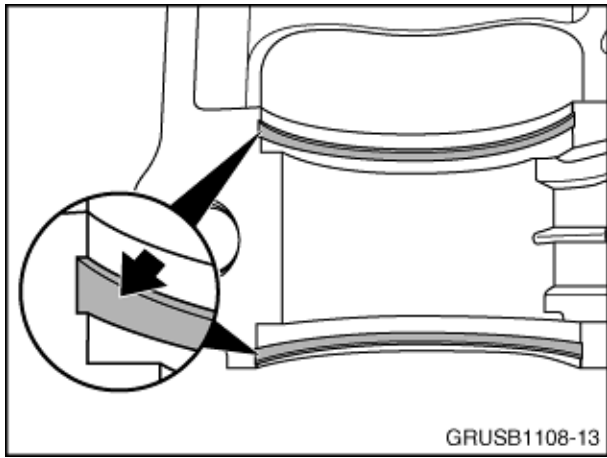
The magnification call-out shows a detailed description of the wear.

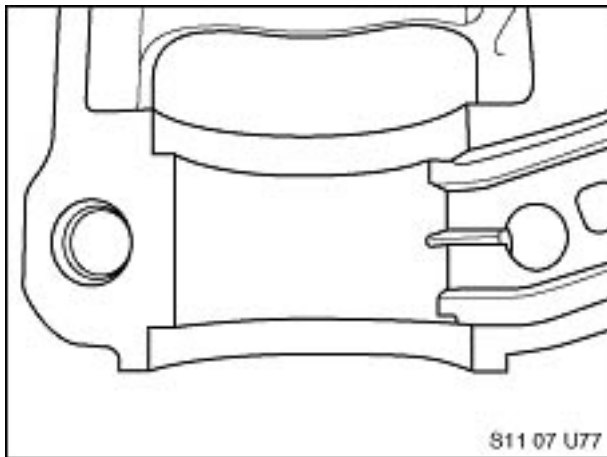
Acceptable camshaft bearing ledge – minor gray wear marks from the rotation of the camshaft are normal. If deep grooves are not apparent, the camshaft bearing ledge is acceptable and should not be replaced.

Do not replace parts that are not worn.
