Technical Service Bulletin

55 Various rear lid malfunctions, rear lid to body gap dimensions incorrect

55 20 49 2060901/1 October 15, 2020.

Model(s)	Year	VIN Range	Vehicle-Specific Equipment
Q3	2015 - 2018	All	Not Applicable
Q5	2018	All	Not Applicable

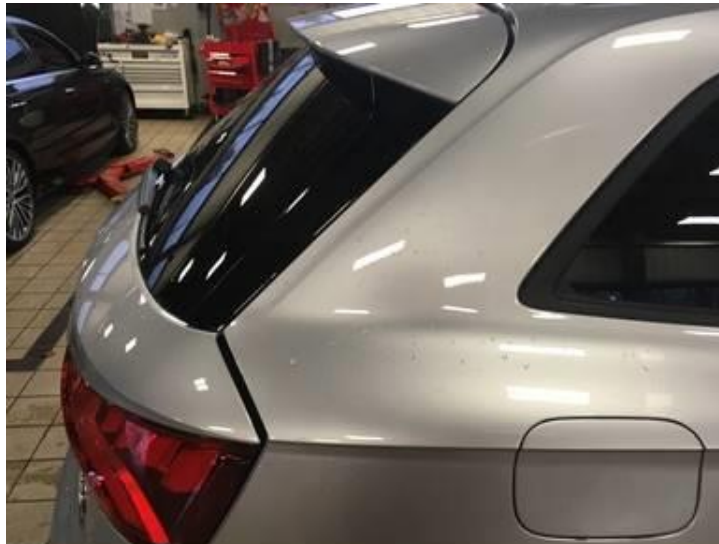
- The rear lid opens or closes with difficulty.
- They also may mention that the rear lid does not appear to be adjusted correctly as the gap at the top of the rear lid to the body is excessive and the clearance between the rear lid and the rear bumper cover appears to be too small (Figures 1 – 2).

Figure 1. An out of alignment rear lid.

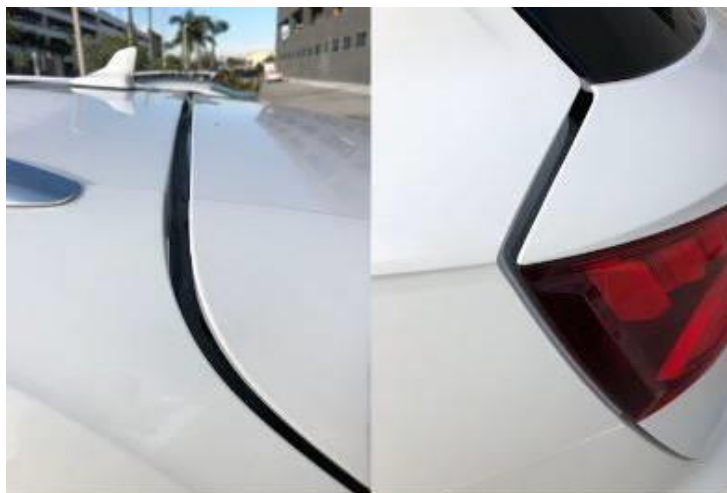
Figure 2. Excessive rear lid gap.

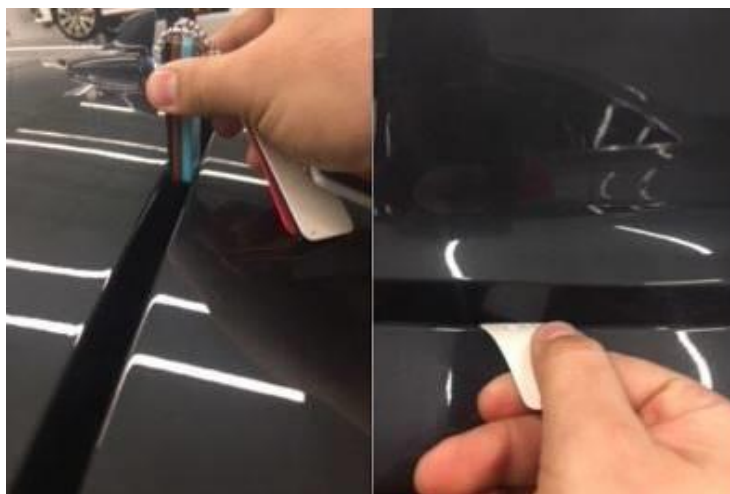
On vehicles equipped with power rear lid if an open rear lid is manually forced closed enough leverage is concentrated on the portion of the body structure where the rear lid hinge mounts are located. The structure can be bent in this area before the automatic rear lid drive de-clutches. When this portion of the roof structure is bent the rear lid alignment is then out of specification (Figure 3).

Figure 3. Rear lid alignment out of specification after manually forcing closed an open rear lid.

The rear lid hinge mount perches have been reinforced with steel plates.

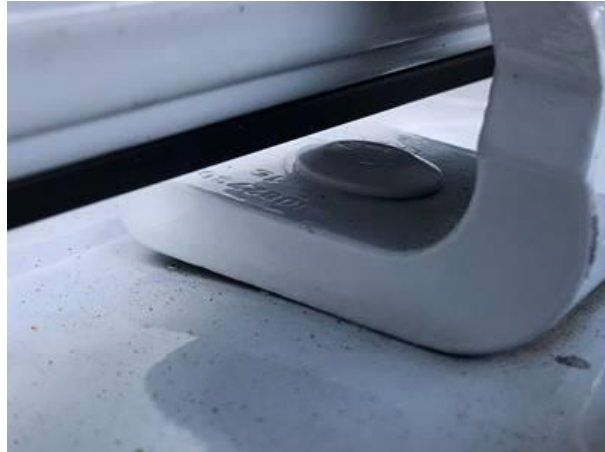
1. Visually inspect the rear lid hinge mount areas. This distortion issue is likely to be apparent viewing the outer area (Figures 4 -5).

Figure 4. Rear lid hinge mount distorted.

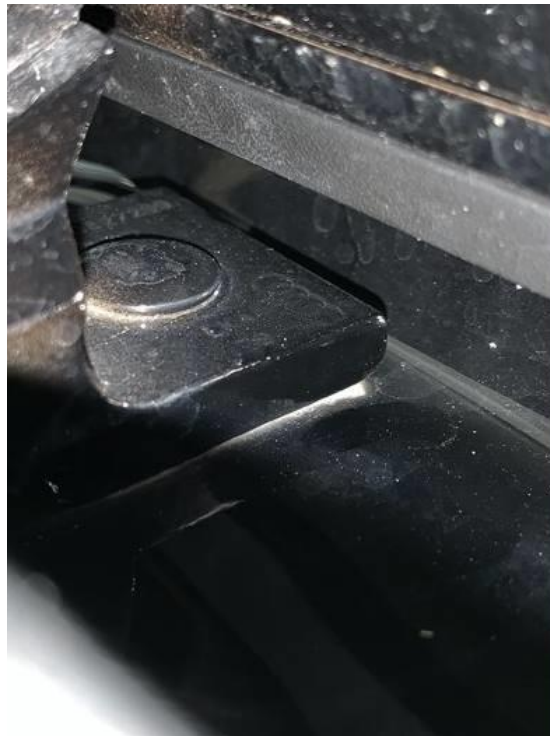
Figure 5. Rear lid hinge mount not flat to the body.

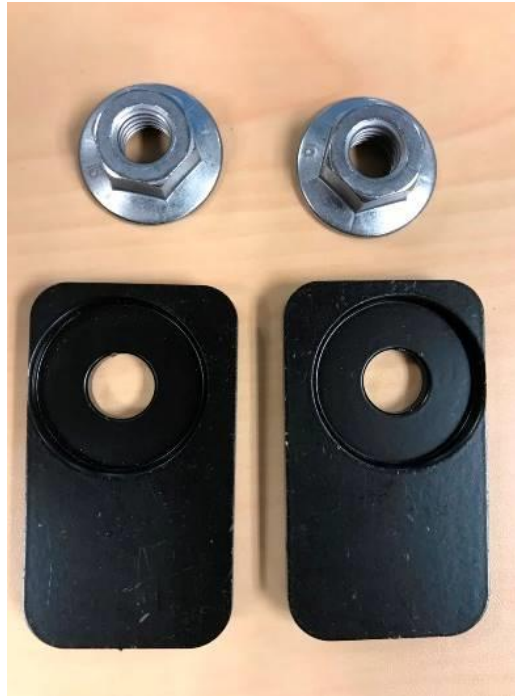
Figure 6. 80A 827 477 (left side) and 80A 827 478 (right side) reinforcement plates and 2 x N 907 988 09 nuts.

2. If the vehicle being repaired is an Q5 order 1 x 80A 827 477 reinforcement plate (left side), 1 x 80A 827 478 (right side) reinforcement plate and 2 x N 907 988 09 nuts (Figure 6).

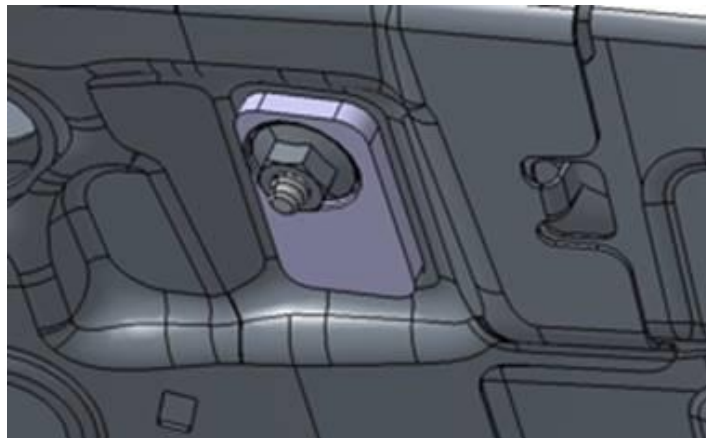
Figure 7. Left side reinforcement plate installation on the Q5.

3. The vehicle will need to be sent to an Audi authorized collision facility to have the rear lid mounting area straightened. Supply the collision facility with the reinforcement plates and nuts. They will need to install them after the rear lid hinge mounting area is repaired.
4. After the rear lid hinge mounting area is restored to normal, install the reinforcement plates and nuts (Figures 7 – 8). Torque the nuts to 35 Nm.

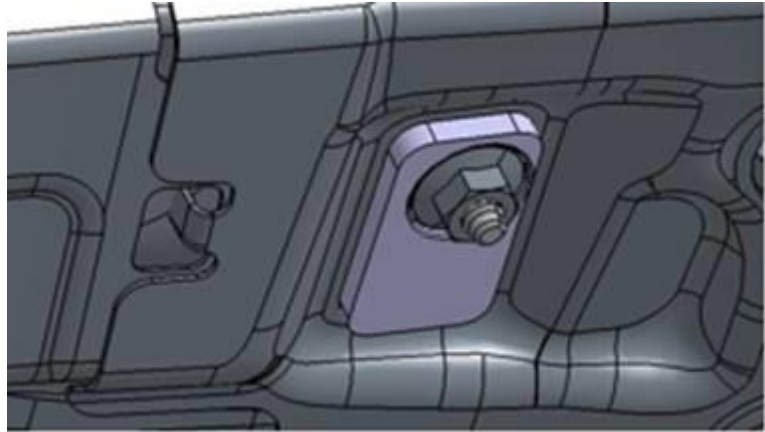
Figure 8. Right side reinforcement plate installation on the Q5.

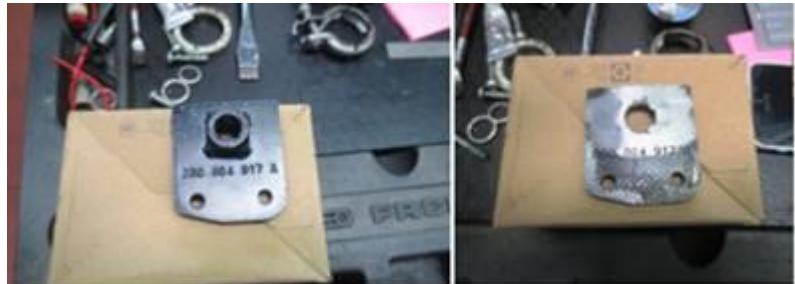
Figure 9. WHT 007 853 reinforcement plates modified.

6. The WHT 007 853 reinforcement plates will need to be modified before installation. Remove the pressed on nut and grind any remaining material that could compromise a flat fit. Make certain to re-coat the bare metal on the reinforcement plates for corrosion protection (Figure 9).

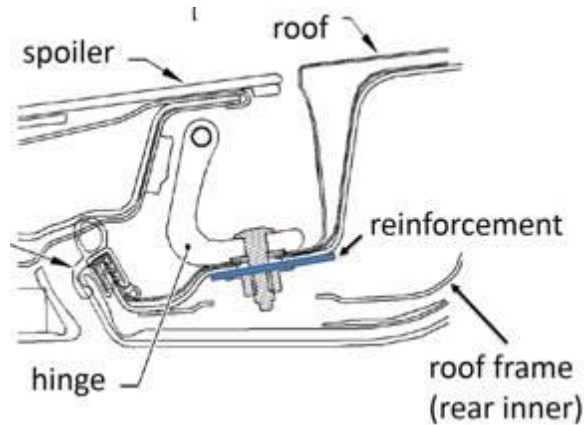
Figure 10. Reinforcement location on an Q3.

8. Install the modified reinforcement plates using 2 x N 905 115 05 nuts (Figure 10). Torque the nuts to 35 Nm.

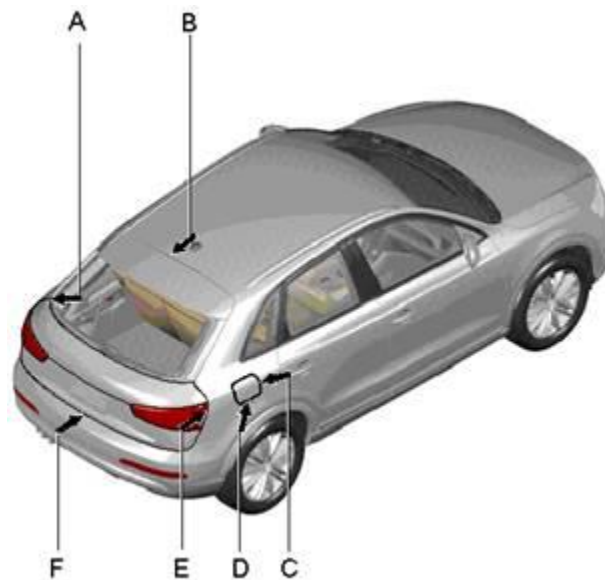
Figure 11. Rear lid gap specifications.

9. Make any necessary rear lid adjustments to restore the rear lid to the correct fit specifications (Figure 11).
