STAR ONLINE PUBLICATION

Case Number: S2008000137

Symptom/Vehicle Issue: Airbag Light Is On Or Power Door Locks Inoperative. DTC's U113D-00, B25AF-2A, B1830-11, B182C-11, And B007F-11 May Be Present.

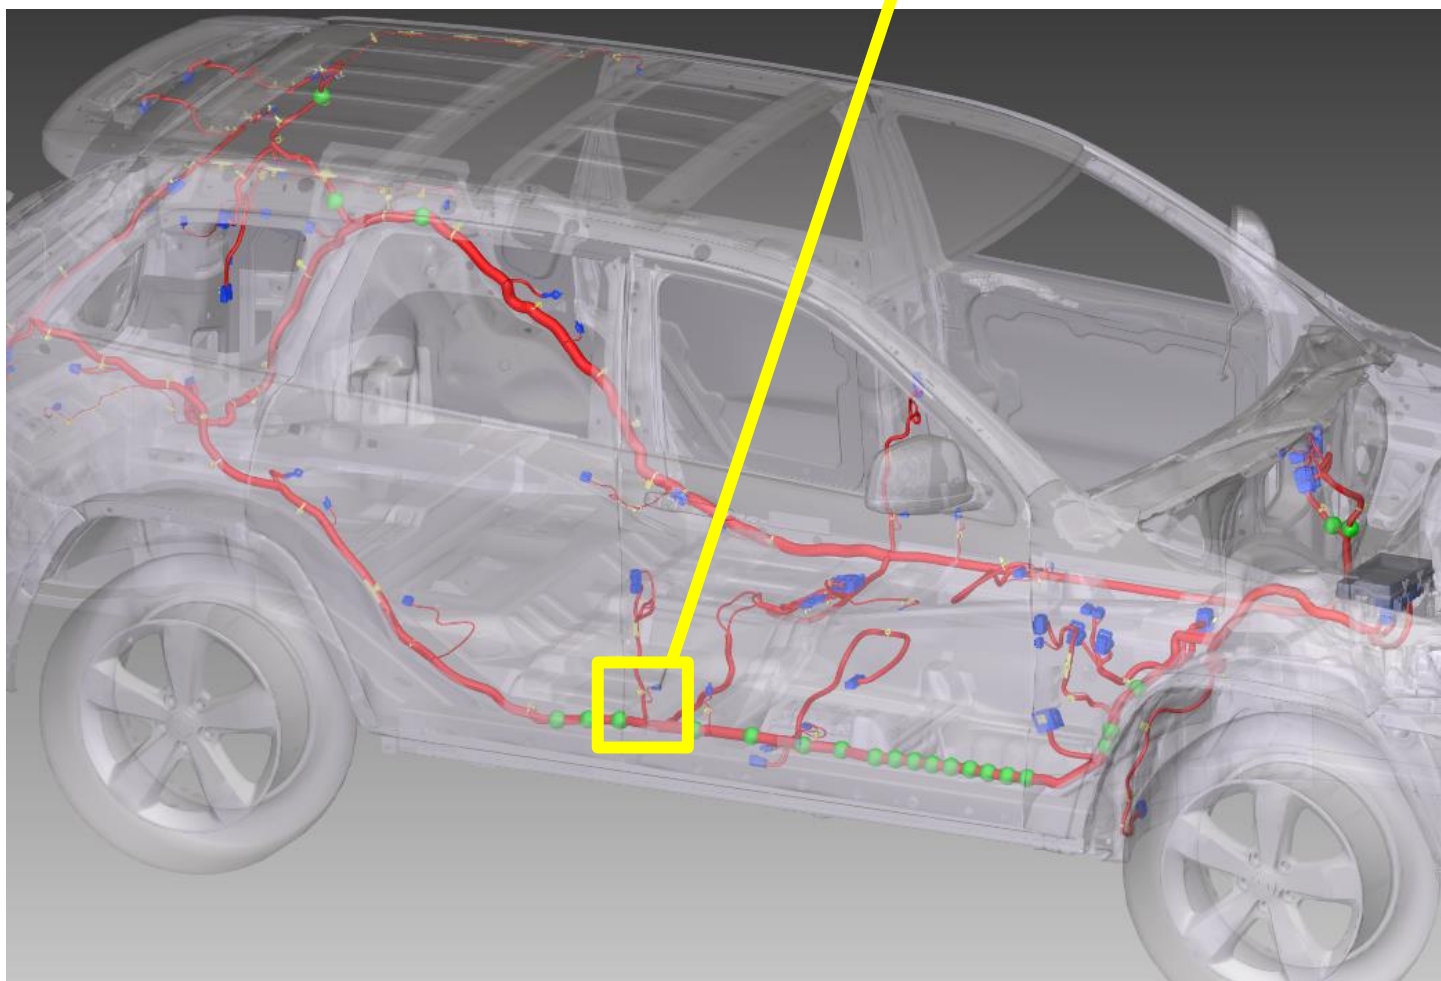
Passenger B-Pillar Body Cutout Location

Discussion: The vehicle body harness may have been pinched at the bottom of the passenger side B-pillar in between the trim retainer and the designated body cut out. The Airbag Light may be on and/or Power Door Locks may be inoperative. Some or all of following DTC's may be present.

Diagnosis: Inspect the areas below for a possible pinched or damaged harness.

Repair: If possible, repair the wires using standard procedures. If necessary, replace the body harness. Reroute the harness to avoid the body cutout. The application of felt tape around the cutout can be used to further protect the harness.

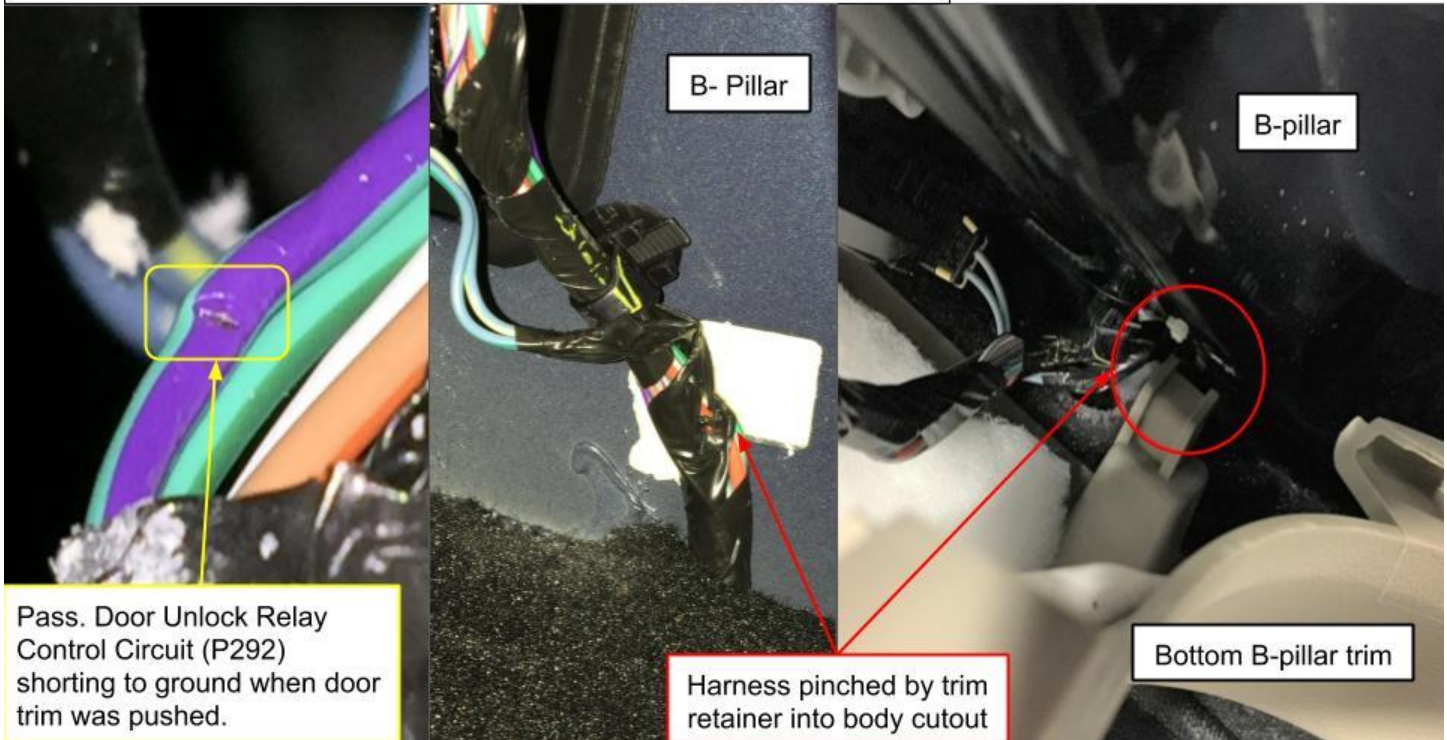
Customer Concern: Power door locks are in INOP

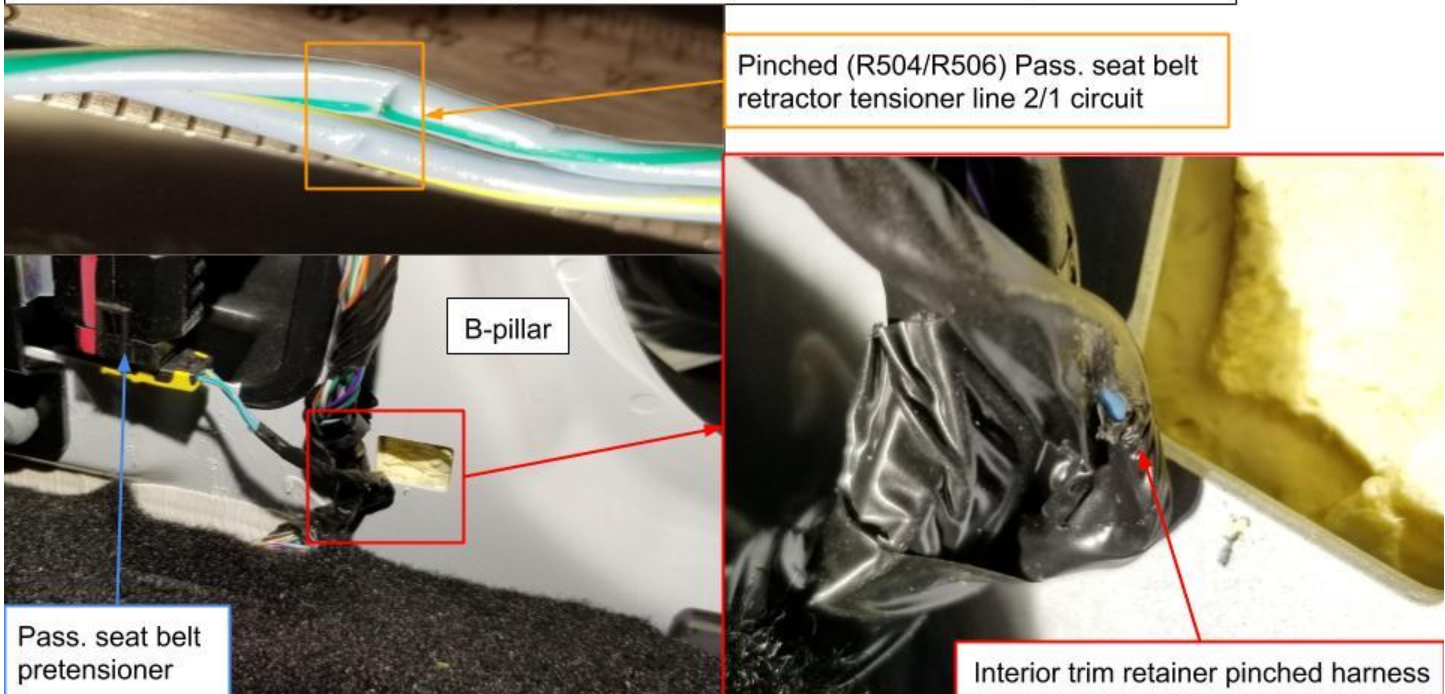
Customer concern: Airbag light is on - active B007F-11 passenger seat belt pretensioner deployment control circuit short to ground
