NUMBER: 08-080-20

GROUP: 08 - Electrical

UAQ and UCQ Radio Enhancements

2020	(JL)	Jeep Wrangler
2020	(JT)	Jeep Gladiator

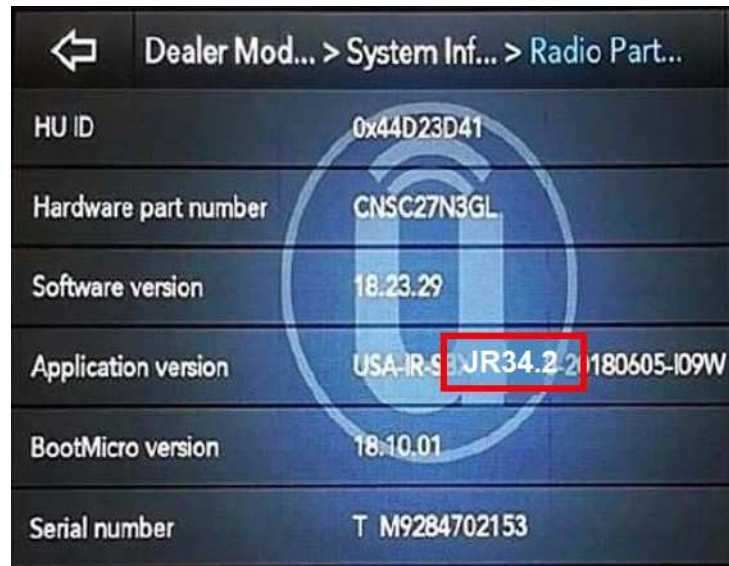
Fig. 1

Radio Software Level Screen

2. Is the radio software level (Application Version) at or higher than 34.2?
 - YES >>> The radio software is already up to date. Normal diagnostics should be performed.
 - NO >>> Proceed to [Step 1](#) of the Repair Procedure.

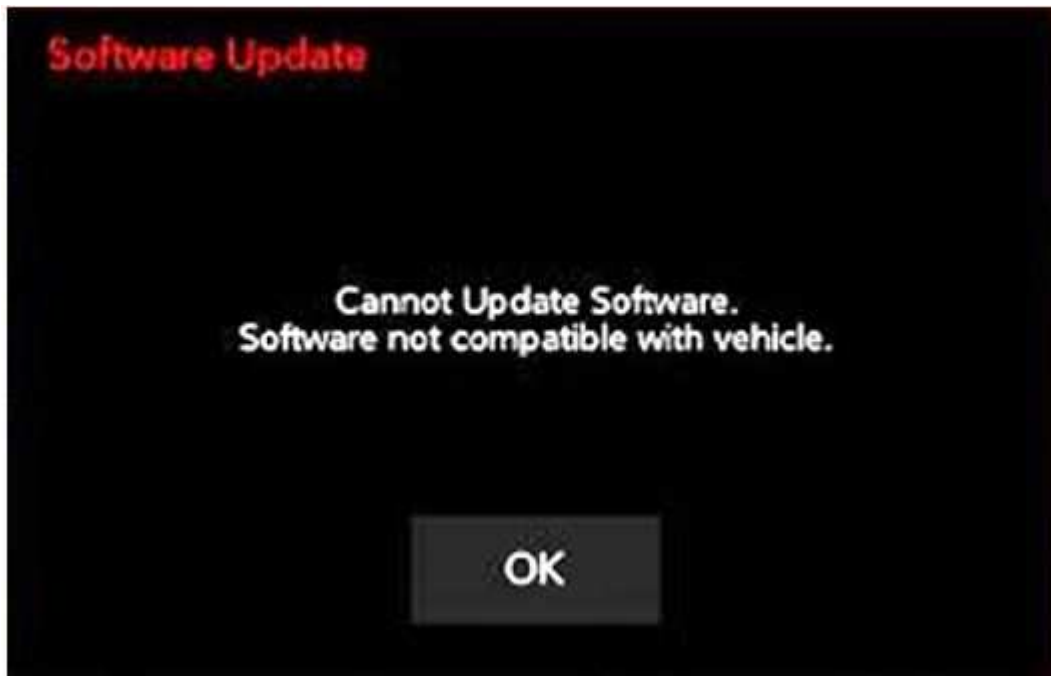
Fig. 5
Software Not Compatible

10. If the screen in (Fig. 5) is displayed, the USB flash drive was not set up correctly. Use a top name brand USB flash drive like Kingston and create a new flash drive and start the update again.
