Service Bulletin

Bulletin No.: 19-NA-105

Subject: Information on Front Seat Back Cover(s) Loose Near Side Air Bag Cover

Brand:	Model:	Model Year:		VIN:		Engine:	Transmission:
		from	to	from	to		
Chevrolet	Bolt EV	2017	2019	—	—	All	All
Opel / Vauxhall	Ampera-e	2017	2019	—	—	All	All

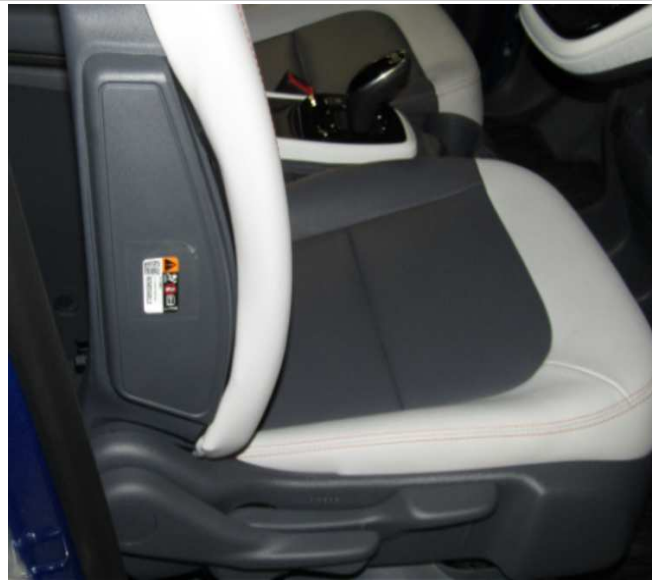
5331852

Note: Examples of a driver and passenger seat exhibiting the condition are shown in the graphics above.

Some customers may comment on one, or both, of the front seat back cover(s) coming loose around the side air bag cover.

Correction	<p>If found to be the original design, replace the seat back cover(s) with the new design cover; and if the cover is new design, reinstall the seat cover and replace the upper support bracket(s) as necessary.</p> <p>Note: Refer to SI for the updated front seat back cover replacement procedure. Also, more detail on the procedure can be attained by viewing the Emerging Issues article and video: April 2019: 10219.04V Bolt EV Seat Cover Replacement (in Canada, refer to TAC TALK May 2019: 52019.05D-0D).</p> <p>Refer to <i>Front Seat Back Cover and Pad Replacement (2nd Design)</i> in SI.</p>
-------------------	---

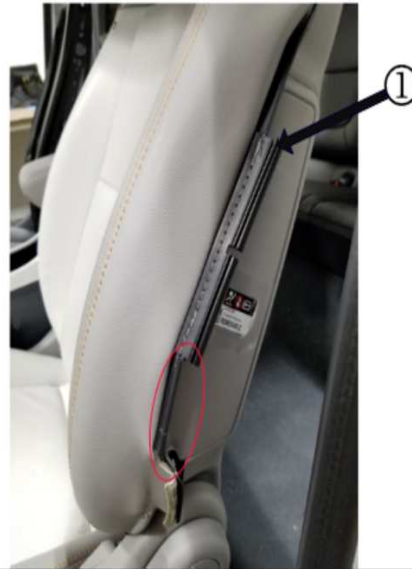
5331854

- The seat cover may be an early design, which didn't include side J-channels (1). These J-channels were recently added to improve the fit and retention of the cover. The lower area circled is an area of intended non-attachment.
- The upper support bracket on the outboard side of the seat, may be damaged or warped out of shape.
- The seat contained a 2nd design seat cover, however the J - channels were not installed correctly onto the seat frame.
