# Technical Service Bulletin

## 51 Cracking noises in right rear roof area during steering thrust

51 20 16 2060145/2 October 16, 2020. Supersedes Technical Service Bulletin Group 51 number 20-14 dated July 24, 2020 for reasons listed below.

Model(s)	Year	VIN Range	Vehicle-Specific Equipment
Q8, SQ8	2019 - 2021	All	Not Applicable
RSQ8	2020 - 2021	All	Not Applicable

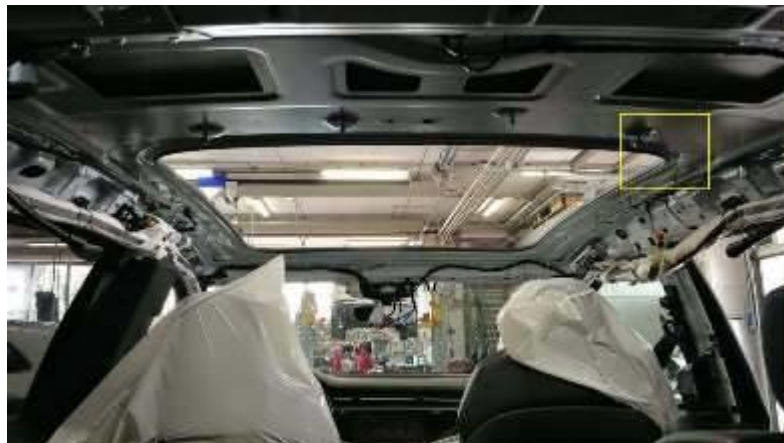
**Figure 1.** Right rear area of sunroof opening to be reworked.

1. Remove the headliner and sliding sunroof assembly. Figure 1 shows the area to be reworked in the rear of the sunroof opening, beginning with the right rear.

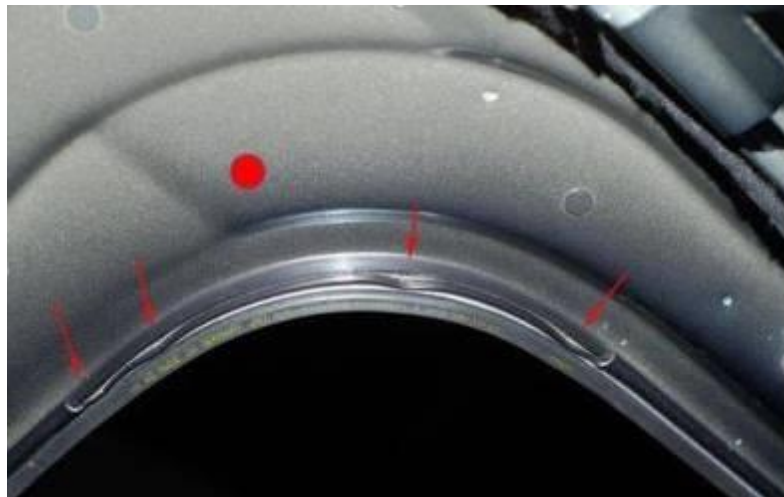
**Figure 2.** The red dot shows the location of the 10 mm hole to be drilled.

2. A 10 mm diameter hole is to be drilled in the spot marked with the red dot shown in Figure 2.

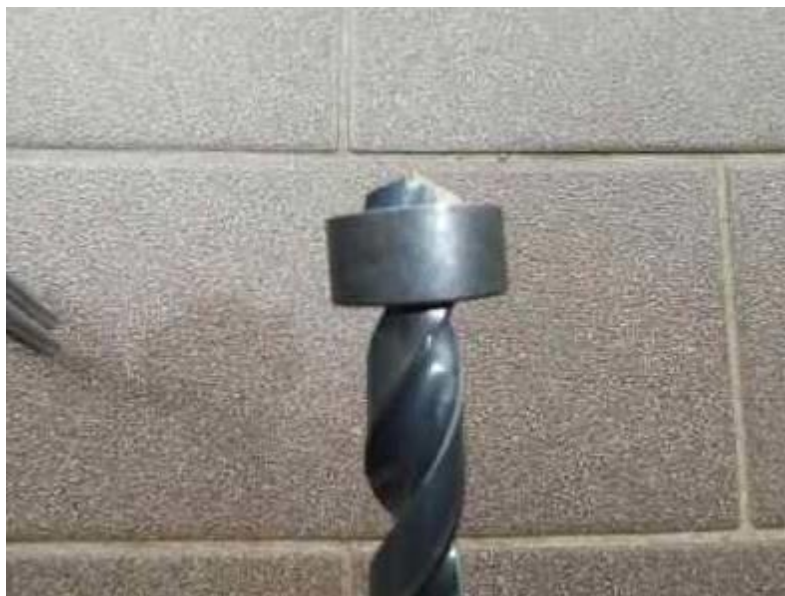
*Figure 3. 10 mm drill bit with a depth stop installed.*

The penetration depth of the drill bit must not exceed 3 mm. If this depth is exceeded irreparable damage can be done to the roof structure requiring replacement.

3. There are a number of methods for limiting the drill depth. Among them is the use of a drill bit depth stop (Figure 3).

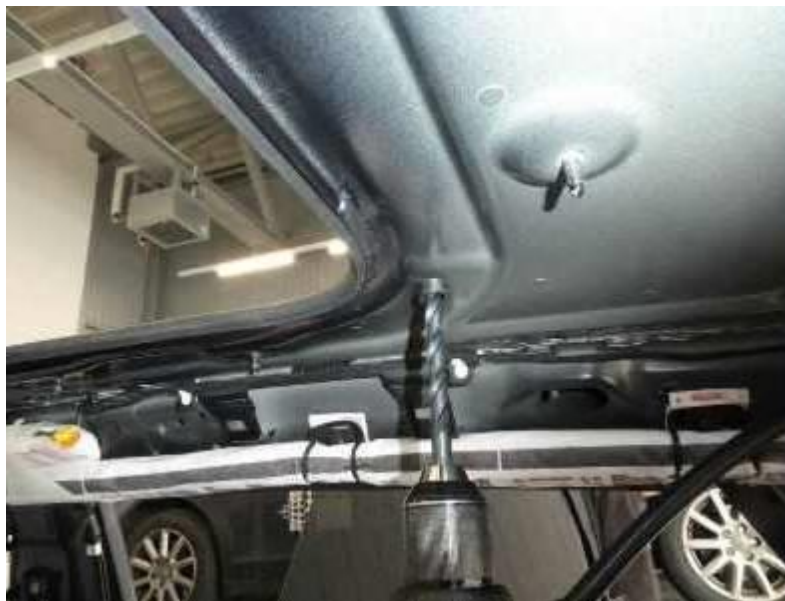
*Figure 4. Drilling the 10 mm hole.*

4. Drill the 10 mm hole no deeper than 3 mm (Figure 4). Make certain to contain the drilling shavings so they can be removed from the cabin.

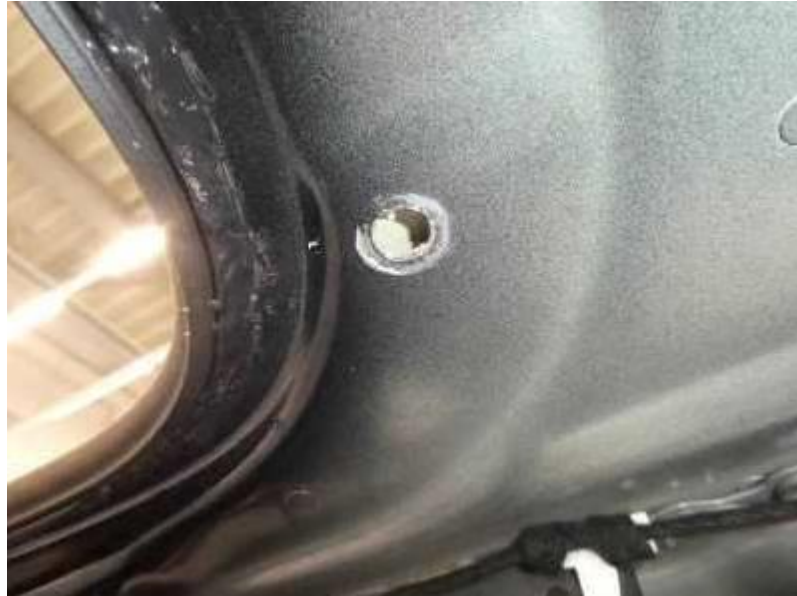
*Figure 5. Hole drilled.*

5. Figure 5 shows the drilled hole.

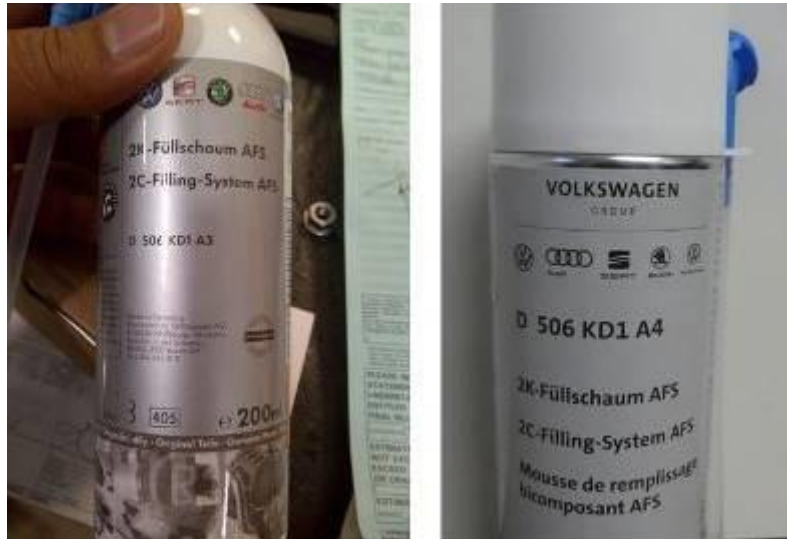
*Figure 6. Foam to be used in the rework procedure.*

6. 2K insert foam D 506 KD1 A3 – or- D 506 KD1 A4 will be needed for the rework procedure. Shake the can for two full minutes plus an additional 20 shakes to ensure a homogenized mixture (Figure 6).

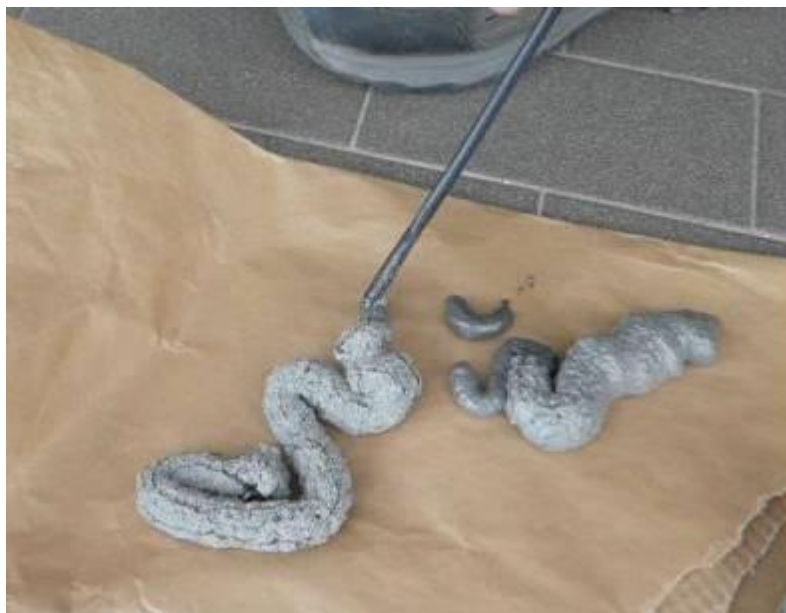
**Figure 7.** Purging air from the nozzle in preparation of the cavity fill.

7. The canister must be held vertically with the nozzle pointing down whenever the foam is ejected. Before injecting the foam the nozzle and tube must be purged of air released (Figure 7). Blow out about a 20 cm stream of foam.

Remember to hold the can vertically with the nozzle pointing down. When the trigger is fully pulled, about 0.25 liters of foam is ejected per second. The foam will expand up to 100%.

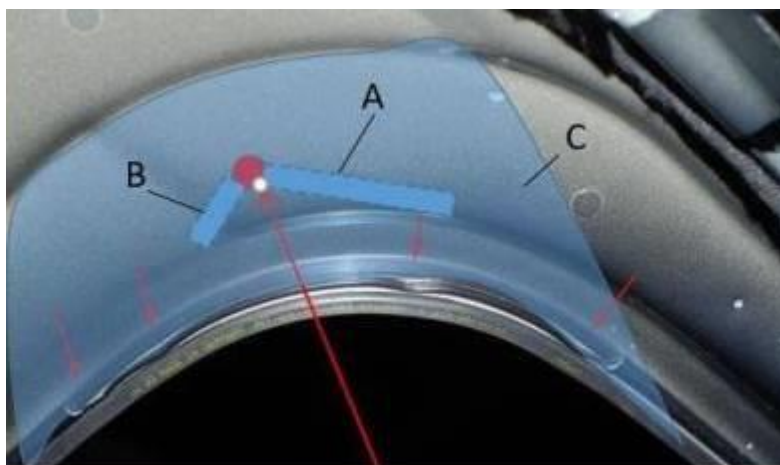
**Figure 8.** Foam nozzle hose positioning and cavity fill area.

8. The shaded area in Figure 8 is the area on each side where the foam is to be injected. To do this the foam must fill the cavity by first inserting the hose in the 'B' direction to a length of 2 cm, then inserted in the 'A' direction 3 – 4 cm and filling for 1 full second of trigger activation per hose direction shown in Figure 8. This should fill the area with the appropriate volume. Do not exceed 1 full second of trigger pulse per fill as the volume of foam injected will be too great.

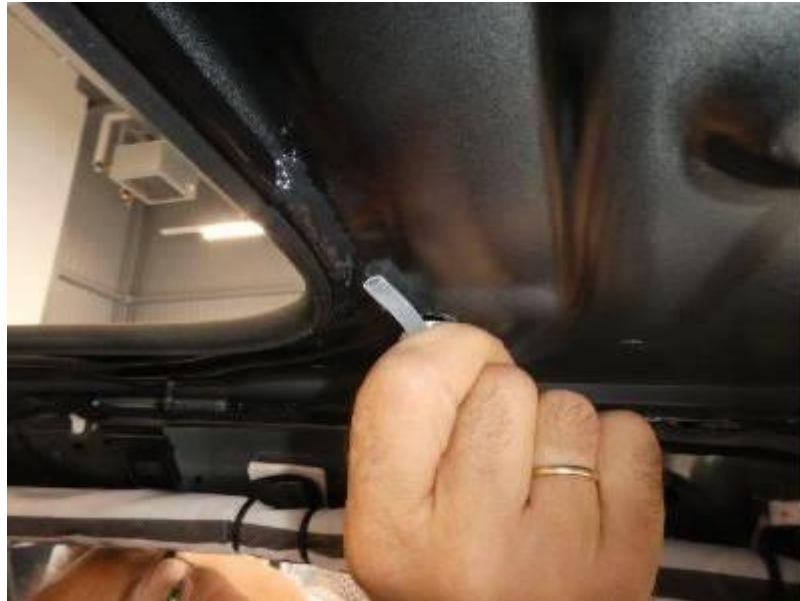
*Figure 9. Hose insertion simulation in the 'B' direction.*

9. Figure 9 illustrates the hose as it will be inserted in the 'B' direction.

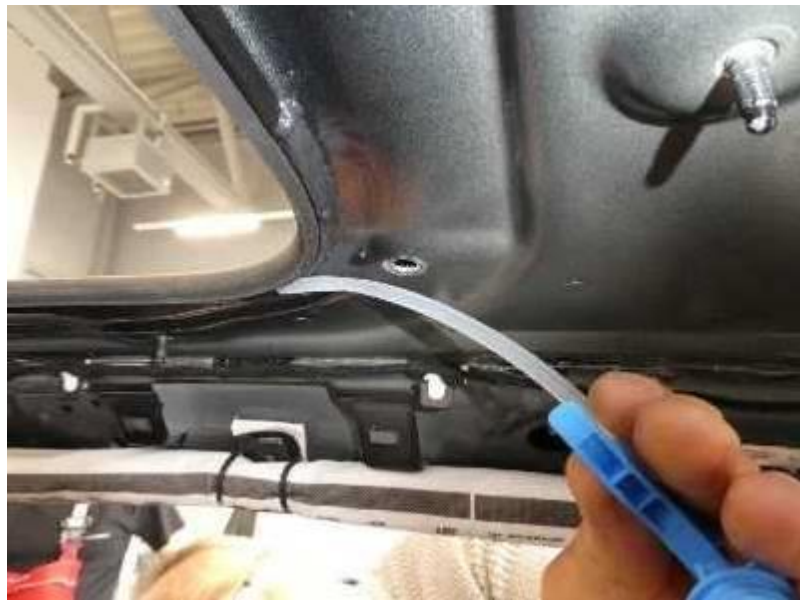
*Figure 10. Hose insertion simulation in the 'A' direction.*

10. Figure 10 illustrates the hose as it will be inserted in the 'A' direction.

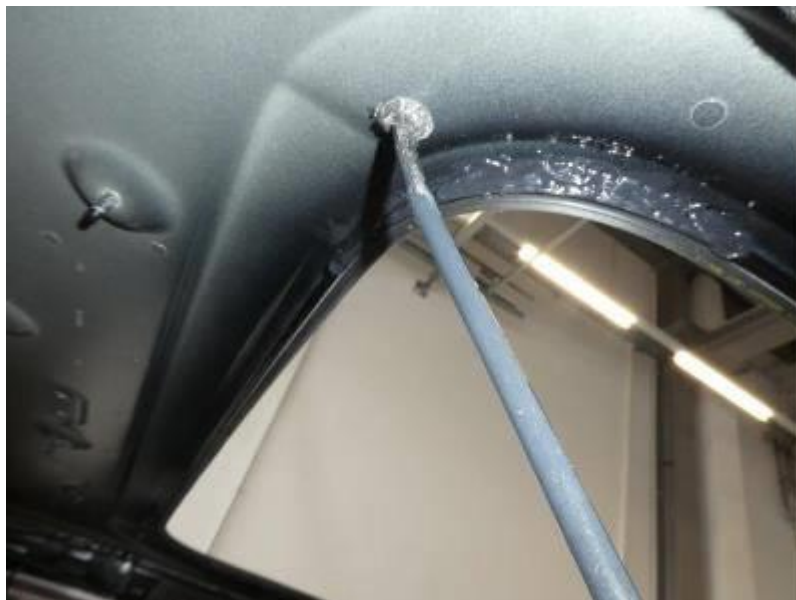
*Figure 11. Filling the cavity with foam.*

11. Fill the cavity (Figure 11).

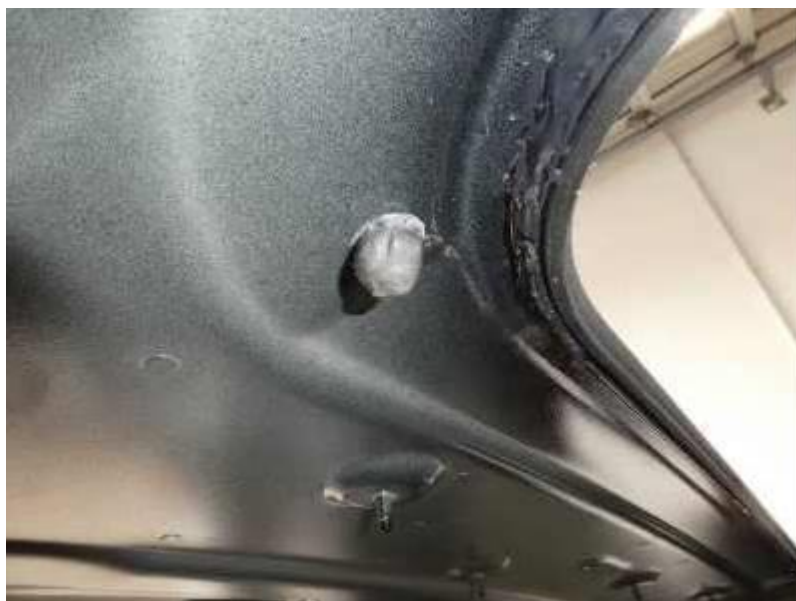
*Figure 12. A filled cavity.*

12. Cavity filled with the correct volume of foam (Figure 12). Allow the foam to cure for 12 hours.

Again, perform this procedure to both rear corners. Test drive the vehicle thoroughly and ensure that the noises have been eliminated.
