Technical Service Bulletin

91 No diagnostics communication to the telematics control module

91 20 21 2056076/9 October 19, 2020. Supersedes Technical Service Bulletin Group 91 number 20-77 dated June 12, 2020 for reasons listed below.

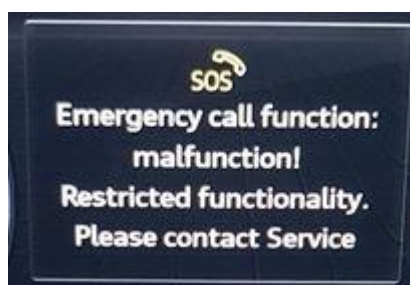
- An SOS Warning is displayed in the instrument cluster (Figure 1).

Figure 1. Emergency call malfunction warning.

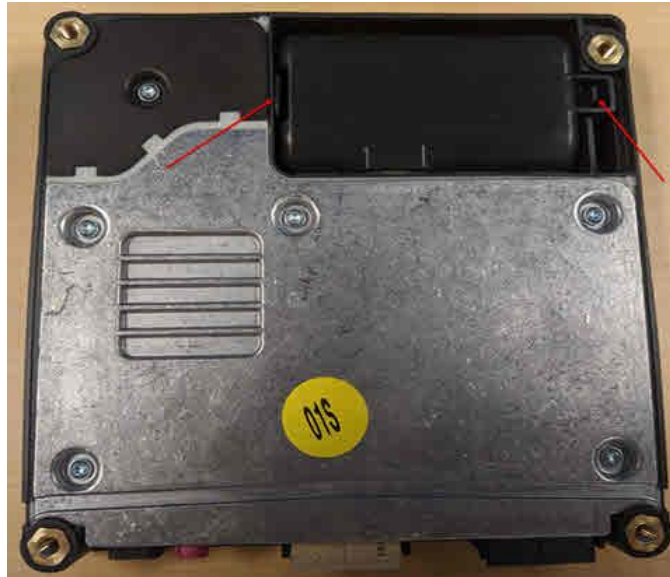
Figure 2. Backup battery compartment location.

1. Remove and unplug the telematics control module, J949 (address word 0075) according to the repair manual in Elsa.
2. Open the battery compartment of the telematics control module, J949 (address word 0075) and disconnect the backup battery (Figures 2 - 3).

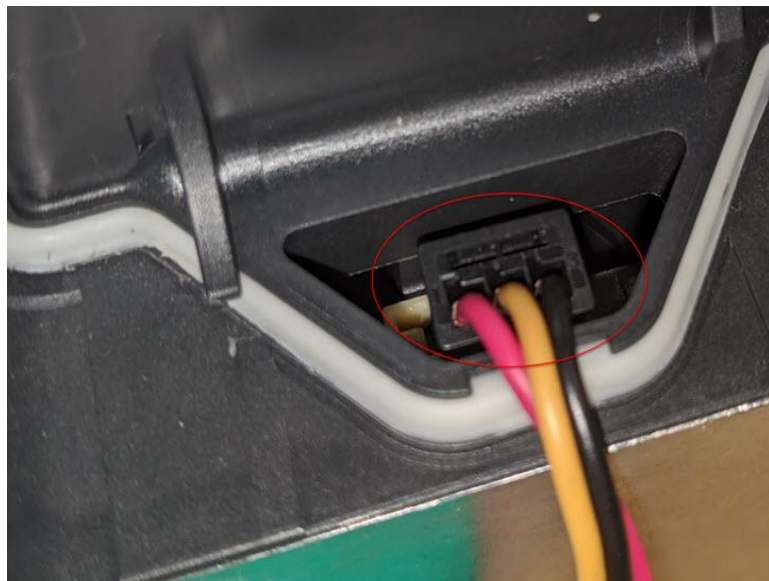
Figure 3. Backup battery connector (no release mechanism).
