Technical Service Bulletin

91 SOS Emergency call function deactivated message in the cluster, DTC U153E00 is stored in the telematics module

91 20 22 2055945/5 October 19, 2020. Supersedes Technical Service Bulletin Group 91 number 19-19 dated December 16, 2019 for reasons listed below.

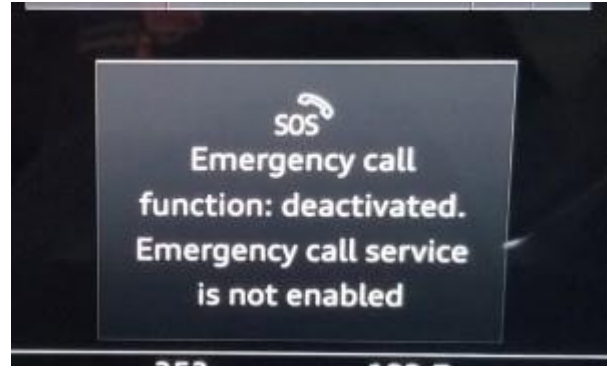
- The warning message “SOS Emergency call function deactivated” is seen in the instrument cluster (Figure 1 or 2).

Figure 1. SOS warning in the instrument cluster.

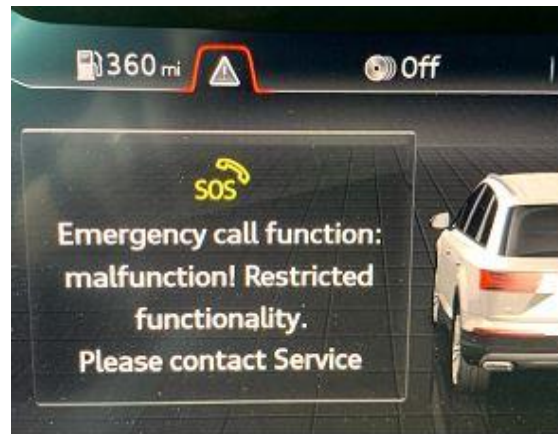
Figure 2. SOS warning in the instrument cluster.
