# Technical Service Bulletin

## 55 Various rear lid malfunctions, rear lid to body gap dimensions incorrect

55 20 50 2060901/2 October 22, 2020. Supersedes Technical Service Bulletin Group 55 number 20-49 dated October 15, 2020 for reasons listed below.

Model(s)	Year	VIN Range	Vehicle-Specific Equipment
Q3	2015 - 2018	All	Not Applicable
Q5	2018	All	Not Applicable

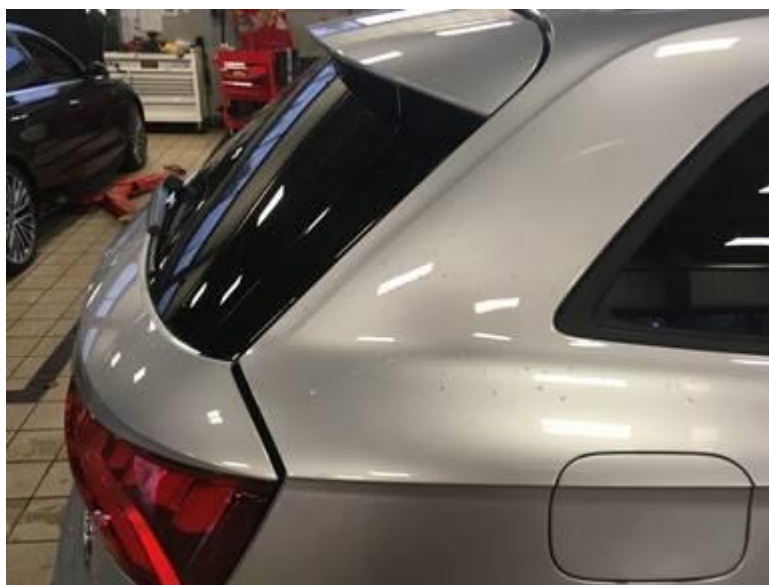
- The rear lid opens or closes with difficulty.
- They also may mention that the rear lid does not appear to be adjusted correctly as the gap at the top of the rear lid to the body is excessive and the clearance between the rear lid and the rear bumper cover appears to be too small (Figures 1 – 2).

**Figure 1.** An out of alignment rear lid.

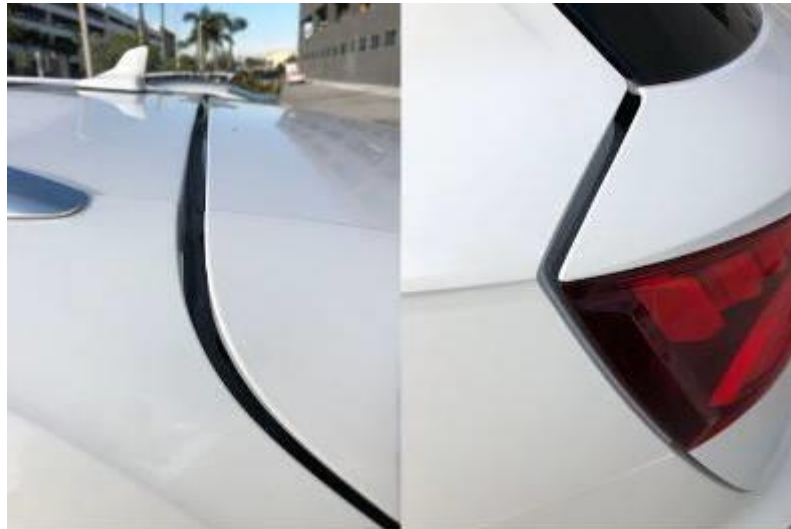
**Figure 2.** Excessive rear lid gap.

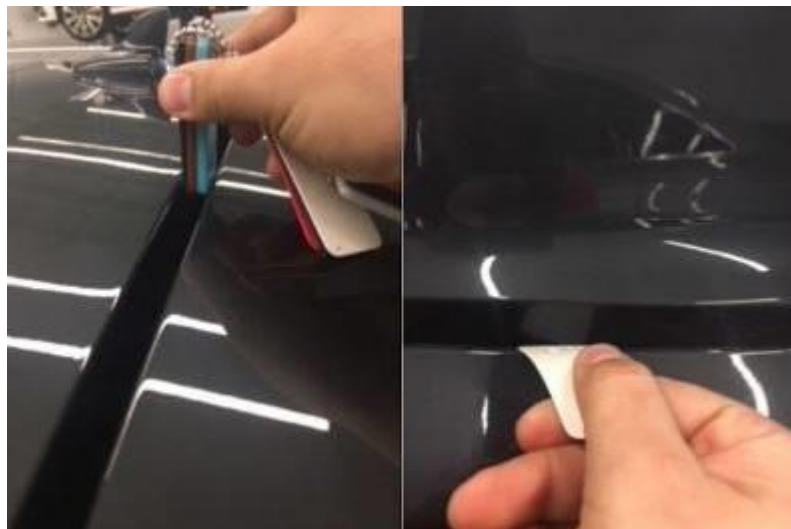
On vehicles equipped with power rear lid if an open rear lid is manually forced closed enough leverage is concentrated on the portion of the body structure where the rear lid hinge mounts are located. The structure can be bent in this area before the automatic rear lid drive de-clutches. When this portion of the roof structure is bent the rear lid alignment is then out of specification (Figure 3).

**Figure 3.** Rear lid alignment out of specification after manually forcing closed an open rear lid.

The rear lid hinge mount perches have been reinforced with steel plates.

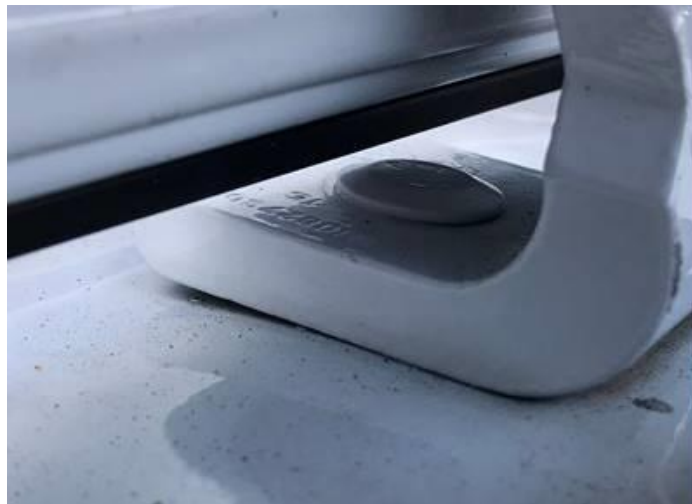
1. Visually inspect the rear lid hinge mount areas. This distortion issue is likely to be apparent viewing the outer area (Figures 4 -5).

*Figure 4. Rear lid hinge mount distorted.*

3. The vehicle will need to be sent to an Audi authorized collision facility to have the rear lid mounting area straightened. Supply the collision facility with the reinforcement plates and nuts. They will need to install them after the rear lid hinge mounting area is repaired.
4. After the rear lid hinge mounting area is restored to normal, install the reinforcement plates and nuts (Figures 7 – 8). Torque the nuts to 35 Nm.

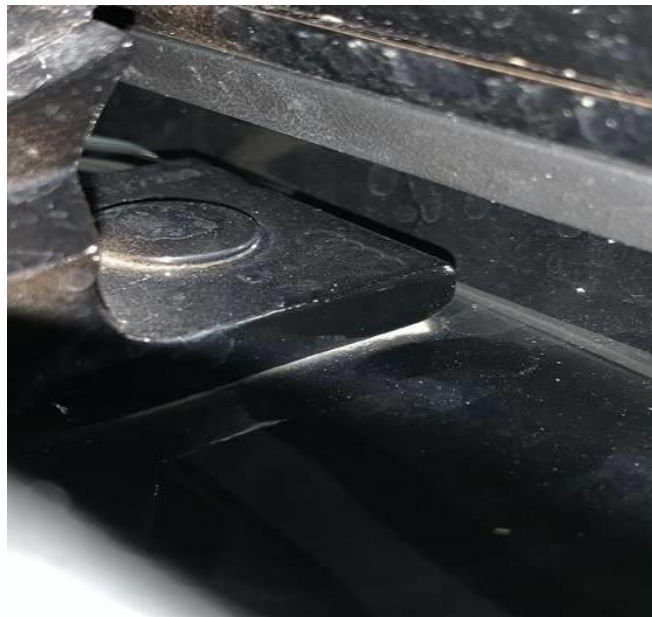
*Figure 5. Rear lid hinge mount not flat to the body.*

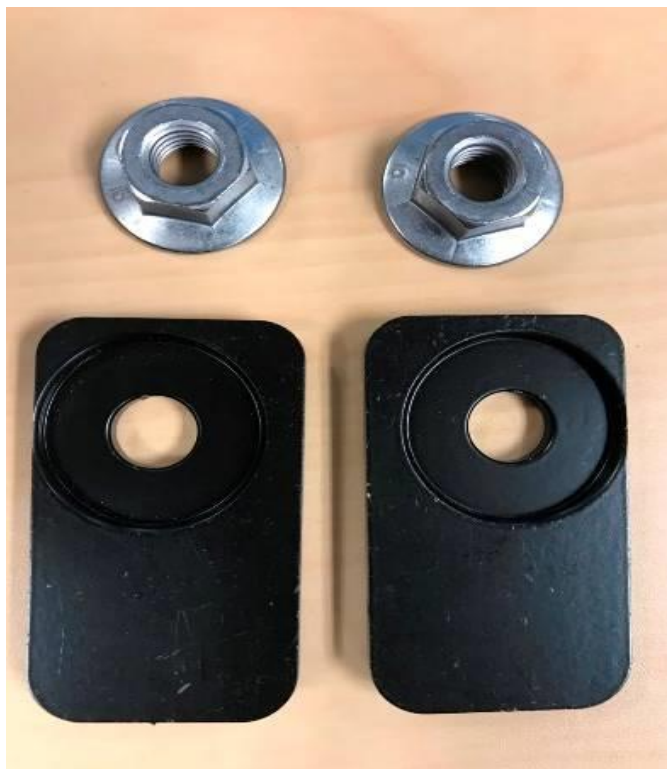
**Figure 6.** 80A 827 477 (left side) and 80A 827 478 (right side) reinforcement plates and 2 x N 907 988 09 nuts.

2. If the vehicle being repaired is an Q5 order 1 x 80A 827 477 reinforcement plate (left side), 1 x 80A 827 478 (right side) reinforcement plate and 2 x N 907 988 09 nuts (Figure 6).

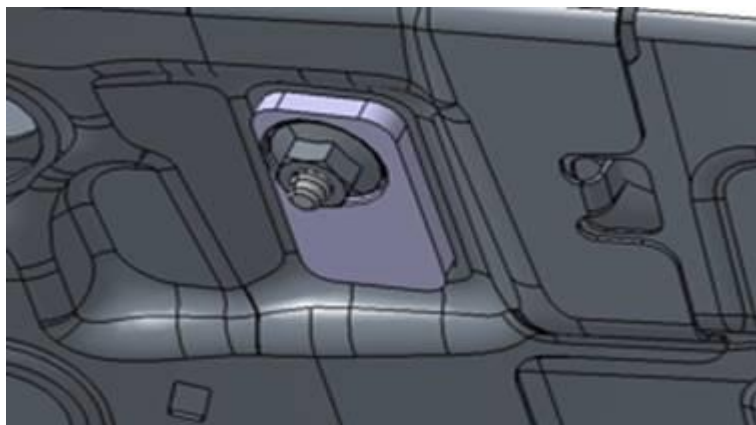
**Figure 7.** Left side reinforcement plate installation on the Q5.

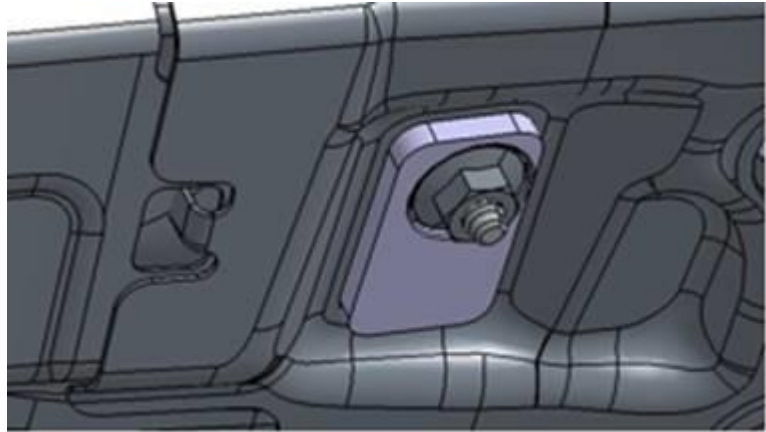
**Figure 8.** Right side reinforcement plate installation on the Q5.

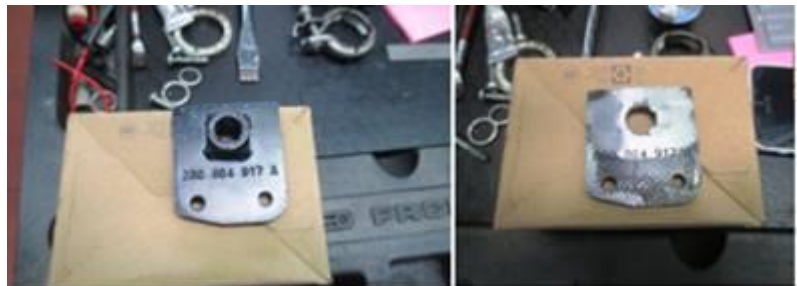
**Figure 9.** WHT 007 853 reinforcement plates modified.

6. The WHT 007 853 reinforcement plates will need to be modified before installation. Remove the pressed on nut and grind any remaining material that could compromise a flat fit. Make certain to re-coat the bare metal on the reinforcement plates for corrosion protection (Figure 9).

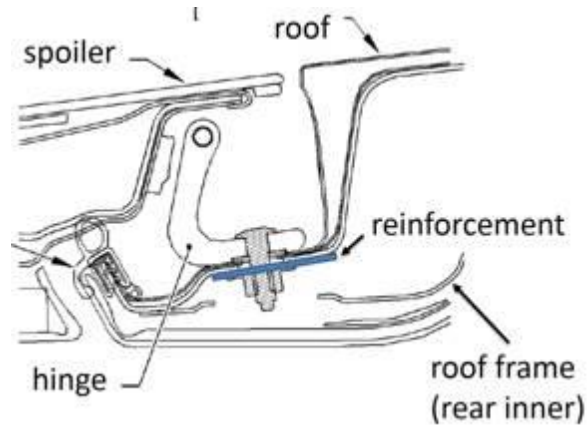
**Figure 10.** Reinforcement location on an Q3.

8. Install the modified reinforcement plates using 2 x N 905 115 05 nuts (Figure 10). Torque the nuts to 35 Nm.

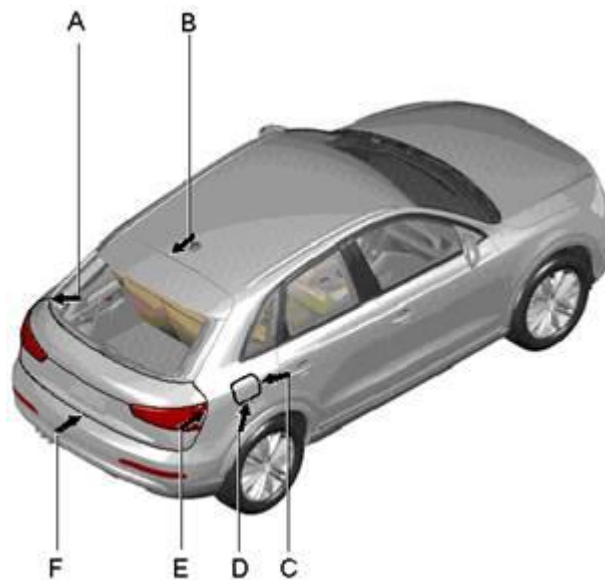
**Figure 11.** Rear lid gap specifications.

9. Make any necessary rear lid adjustments to restore the rear lid to the correct fit specifications (Figure 11).
