TECHNICAL SERVICE BULLETIN

Electronic Shift On-The-Fly (ESOF) 4WD - Intermittent Grinding Noise While Driving

20-2278
15 October 2020

Ford 2013-2018 F-150

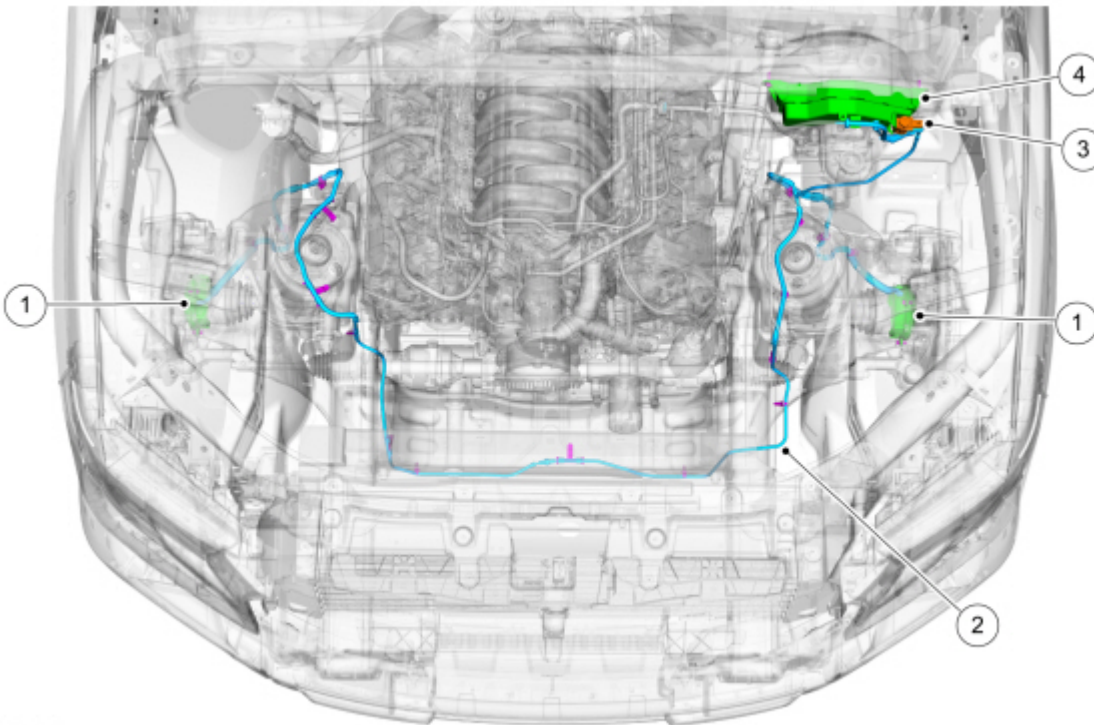
Figure 1

2. Inspect the IWE vacuum hoses. Refer to Workshop Manual (WSM), Section 308-07A. Are there any disconnected or damaged vacuum hoses? (Figure 1)

(1). Yes - reconnect or replace the vacuum hose as required. Refer to WSM, Section 308-07A.

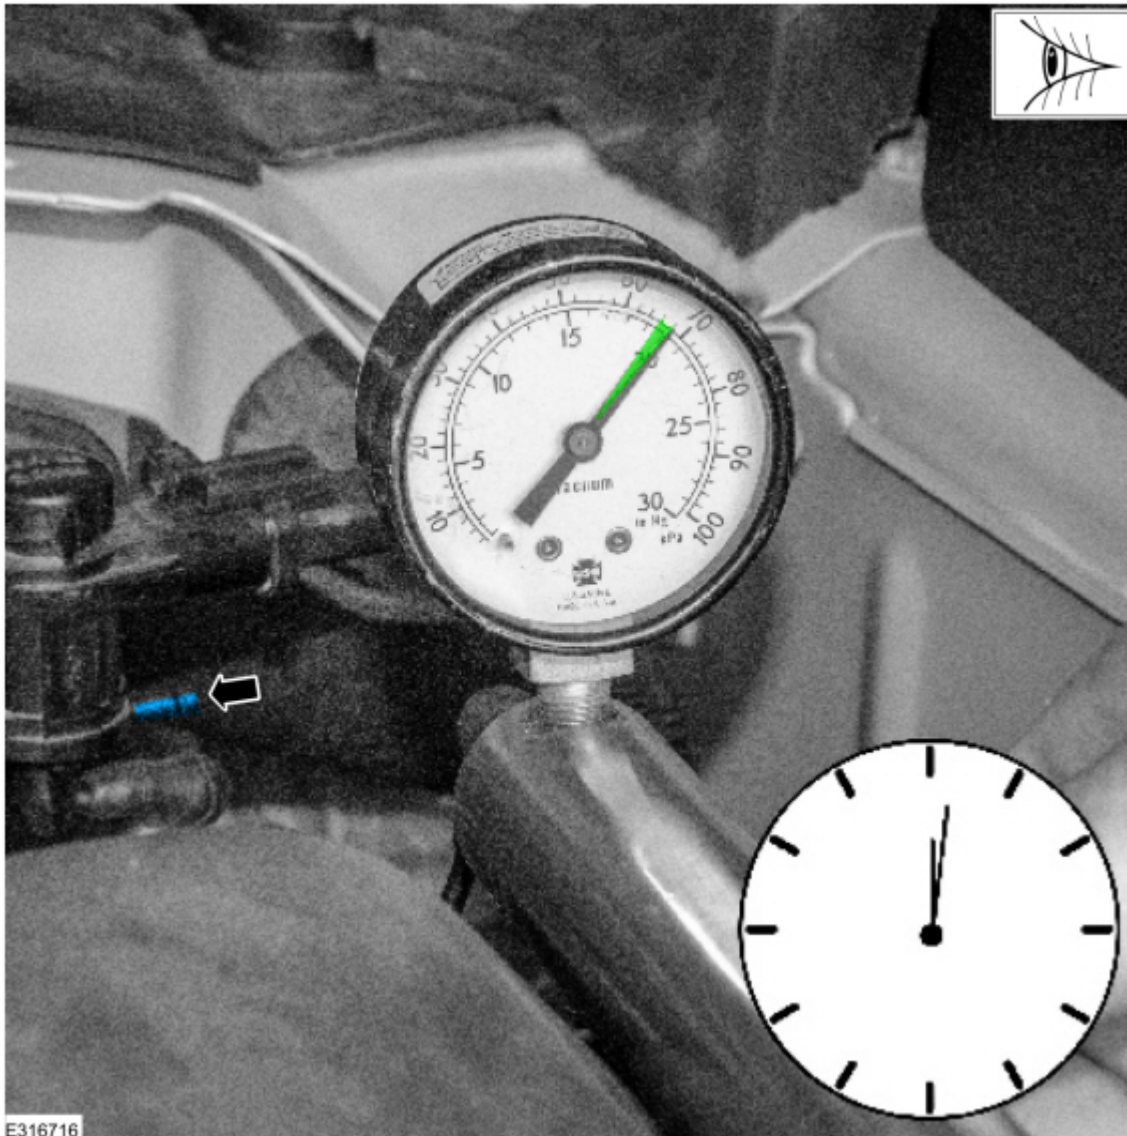
Figure 2

5. Connect a hand vacuum pump to the IWE vacuum supply line and apply 508 mm-Hg (20 in-Hg) of vacuum. Does the vacuum drop more than 12.5 mm-Hg (0.5 in-Hg) per minute? (Figure 2)

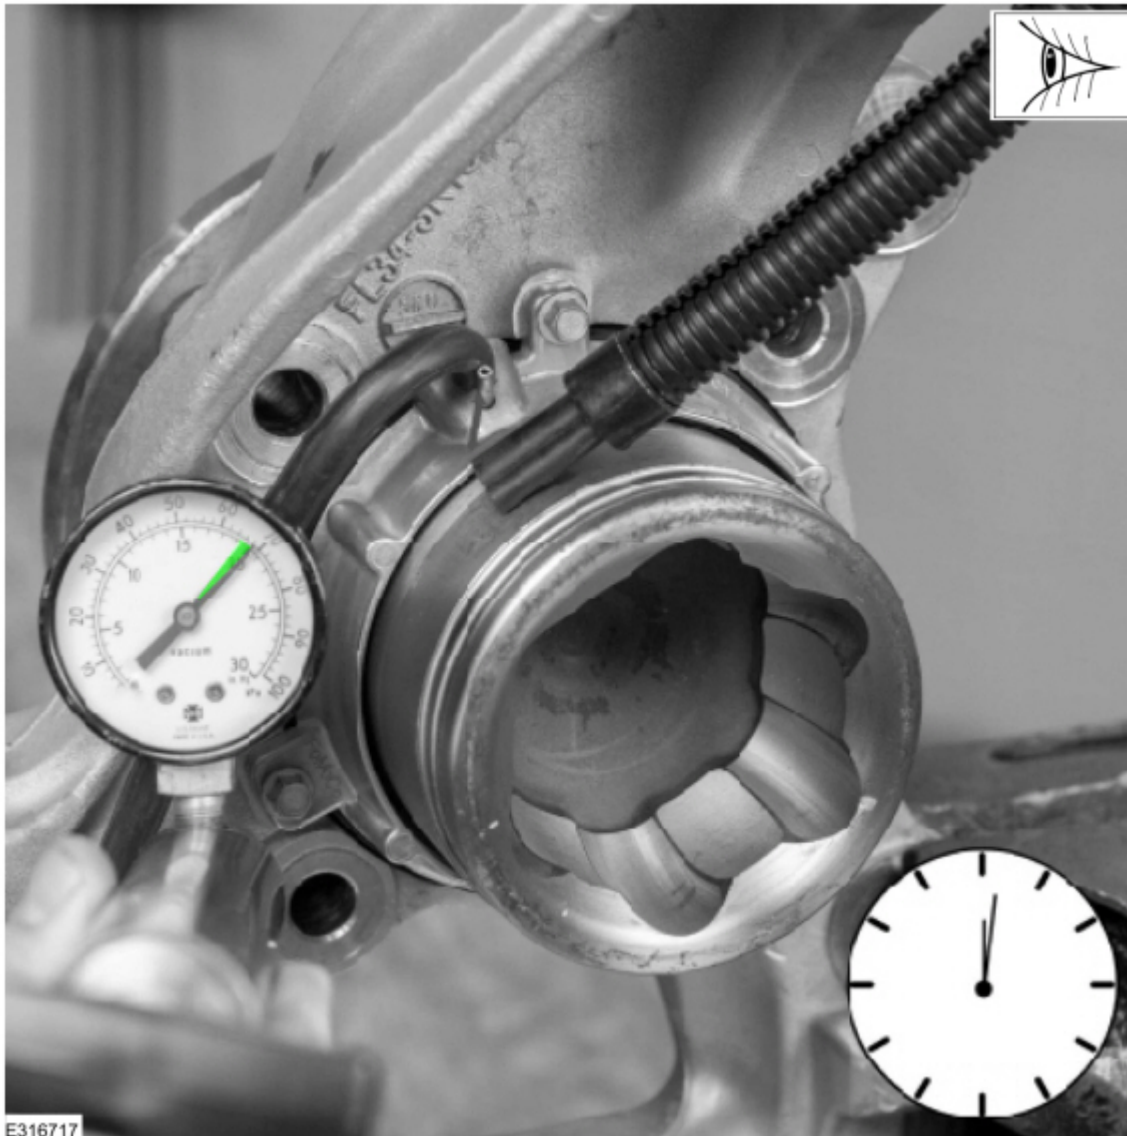
6. Using a hand vacuum pump, apply 508 mm-Hg (20 in-Hg) of vacuum to each IWE, one at a time, and monitor the vacuum gauge. Does the vacuum drop more than 12.5 mm-Hg (0.5 in-Hg) per minute? (Figure 3)

- 7.** Replace the vacuum lines between the solenoid and IWEs. Refer to the WSM, Section 308-07A. Proceed to Step 12.
- 8.** Remove the IWE assembly from the affected wheel. Refer to WSM, Section 308-07A.

- 9.** Inspect the wheel bearing splines for damage or excessive wear. Are the wheel bearing splines damaged or showing signs of excessive wear?
- (1). Yes - replace the IWE assembly and wheel bearing. Refer to WSM, Section 308-07A and 204-01B. Proceed to Step 12.

- (2). No - replace the IWE assembly. Refer to WSM, Section 308-07A. Proceed to Step 12.
- 10.** Test the IWE vacuum supply lines.
- (1). Disconnect the vacuum supply line at the left or right IWE and connect a vacuum gauge to the supply line as shown in Figure 4.

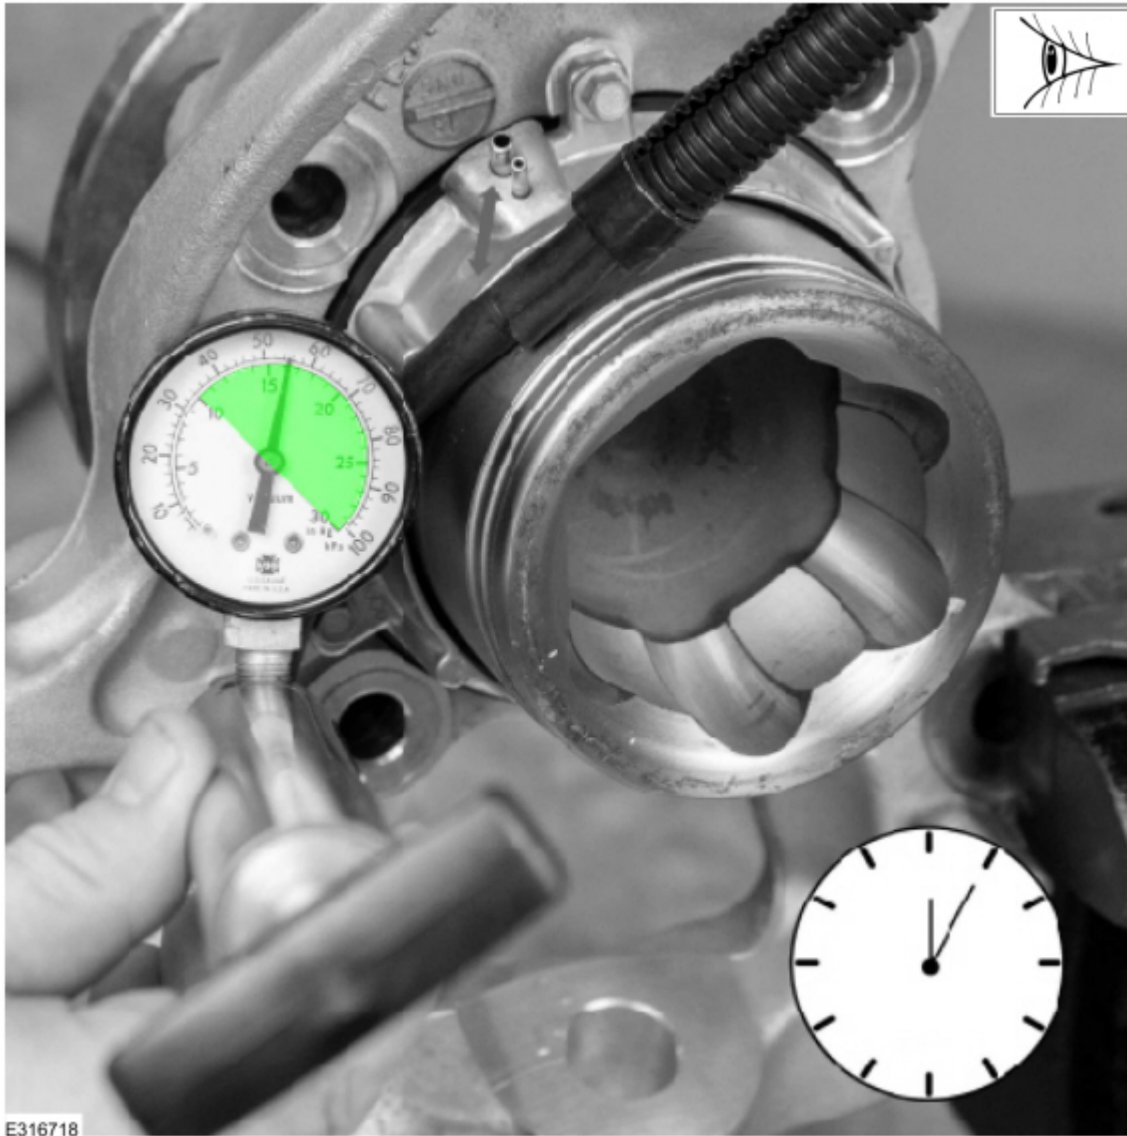
Figure 4

11. Is the vacuum at both left and right supply lines greater than 254 mm-Hg (10 in-Hg)?

(2). No - replace the vacuum lines between the solenoid and IWEs. Refer to the WSM, Section 308-07A. Proceed to Step 12.
