## Technical product information

<b>Topic</b>	Headlamp operation issues
<b>Market area</b>	Bentley: worldwide (2WBE),Hongkong-Macau (5HK)
<b>Brand</b>	Bentley
<b>Transaction No.</b>	2054599/6
<b>Level</b>	EH
<b>Status</b>	Released for publishing
<b>Release date</b>	22-Oct-2020

Headlamp operation issues

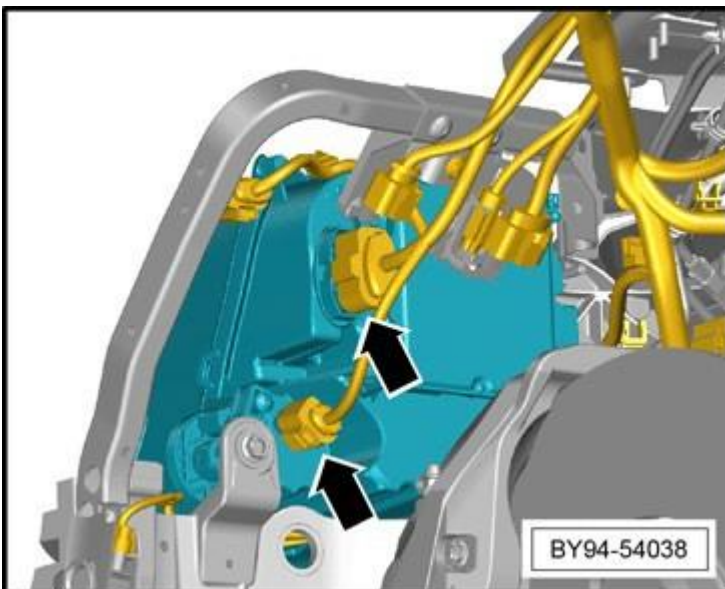
Figure 1

2) Referring to the examples shown in Figures 1 and 2

Disconnect the applicable headlamp plugs (right and/or left hand side) - During disconnection look out for any abnormalities for example a plug which is loose/broken or is easily disconnected

3) Check the condition of the headlamp plug and terminals

- 4) Check the condition of the headlamp assembly connection pins
- 5) Using the applicable Elsa pro wiring diagrams – Check the electrical integrity of the complete headlamp circuit

- Should NO concerns be identified – Carry out the remaining instructions
- 6) Reconnect the headlamp plugs NOTE: An audible click will be heard once the plug is refitted/connected correctly

- 7) Carry out a pull check to confirm correct fitment
- 8) Erase any related DTC's using offboard Diagnostic Information System (ODIS)
  - Carry out a road test (maximum of 50 time units) to confirm the headlamps are fully functional
