Technical Service Bulletin

Subject: GRINDING NOISE FROM REAR BRAKES	Bulletin No.: 04-007/20
	Last Issued: 10/12/2020

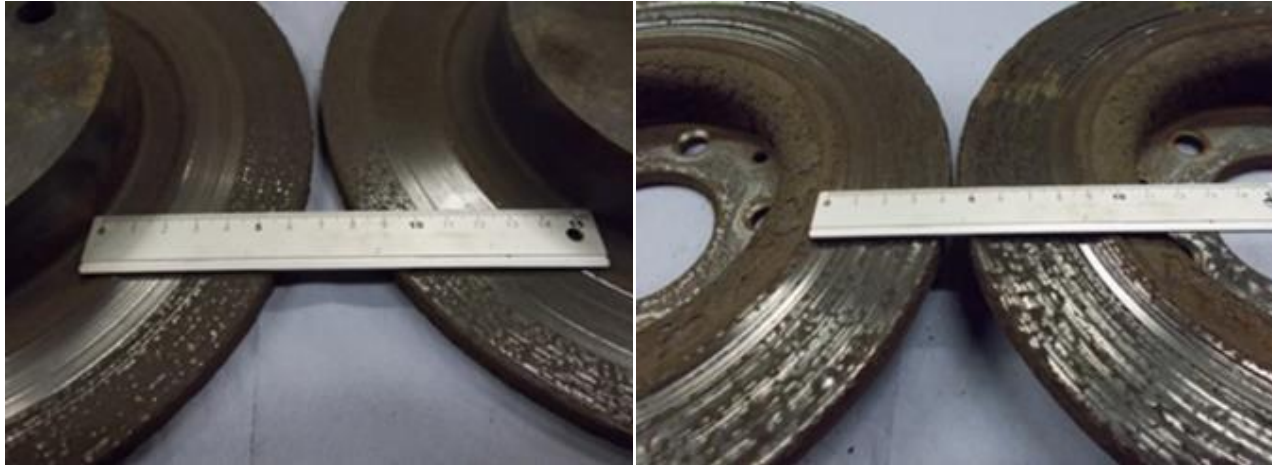
Some vehicles equipped with electric parking brake (EPB) may exhibit a grinding noise from the rear brakes when braking. This may be caused by the rear brake pads not having the capability to remove the rust from the rear brake discs. The red rust accumulated on the discs is exposed to high temperatures during braking, and consequently the rust turns black. As the black rust is too hard to be removed by the brake pads, the rust progress is accelerated, resulting in the grinding noise.

Outer Side

Inner Side

To eliminate this concern, the brake pad material has been changed in order to improve the rust-removing capability.

1. Verify the customer concern.
2. Replace the rear brake pads with modified ones according to MGSS online:
 - CX-3: REAR BRAKE DISC PAD REMOVAL/INSTALLATION
 - CX-5: REAR BRAKE DISC PAD REMOVAL/INSTALLATION
 - CX-9: REAR BRAKE DISC PAD REMOVAL/INSTALLATION
 - Mazda6: REAR BRAKE DISC PAD REMOVAL/INSTALLATION
3. Replace the rear disc plates with new ones according to the MGSS online:
 - CX-3: REAR BRAKE DISC REMOVAL/INSTALLATION
 - CX-5: REAR BRAKE DISC REMOVAL/INSTALLATION
 - CX-9: REAR BRAKE DISC REMOVAL/INSTALLATION
 - Mazda6: REAR BRAKE DISC REMOVAL/INSTALLATION
